Basslink Review Report 2006-12
Gordon River Basslink Monitoring Program
The Appendices

May 2013

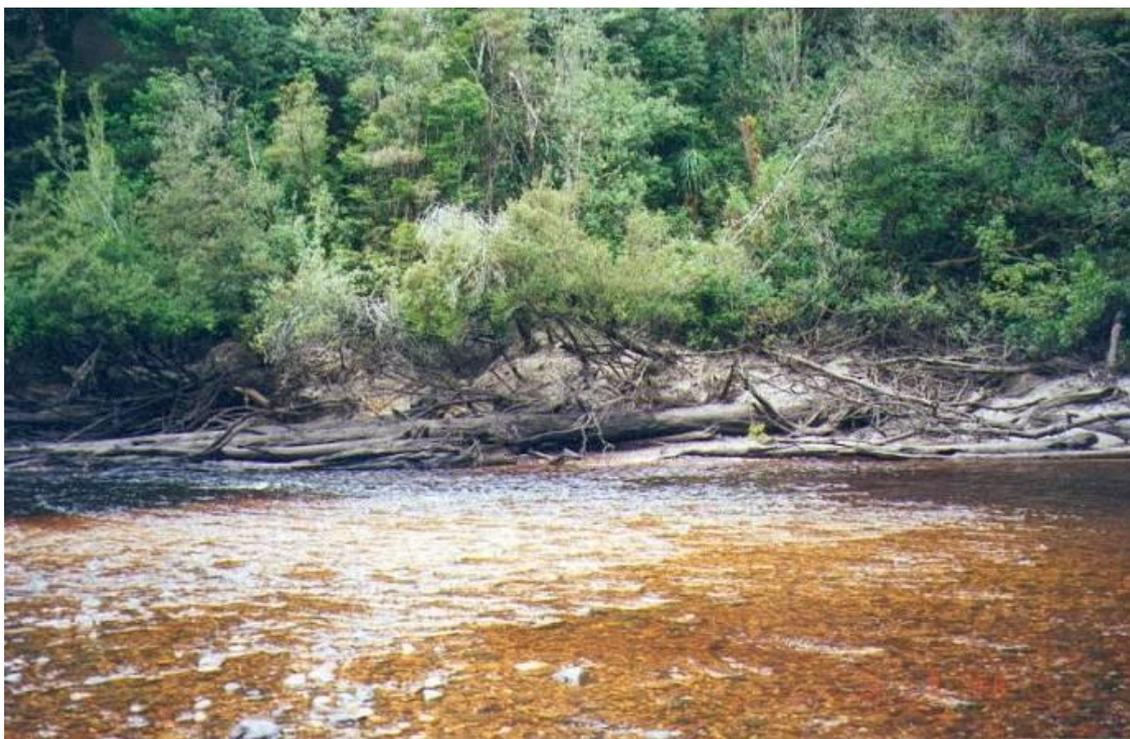
Figure 2.4: Example of alluvial bank from zone 2.

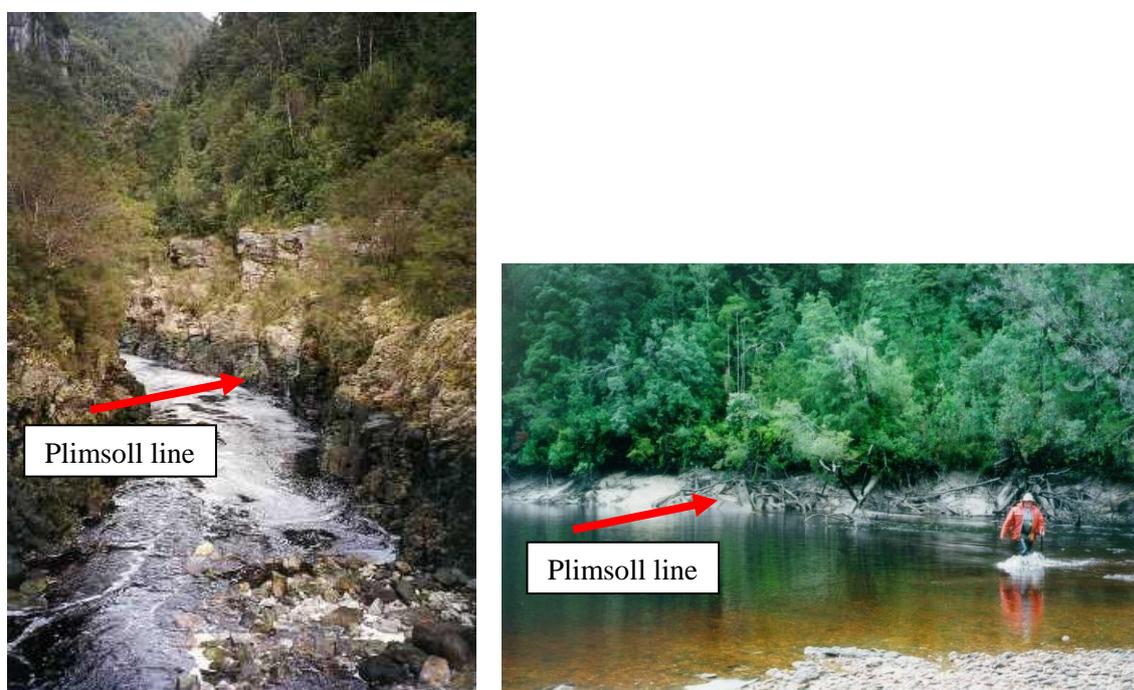
Figure 2.9: (Left) bedrock controlled reach downstream of power station showing the 'Plimsoll line' and encroachment of vegetation down to the Plimsoll line. (Right) Alluvial reach upstream of the Splits showing the distinct 'Plimsoll line'. (L. Koehnken photos).

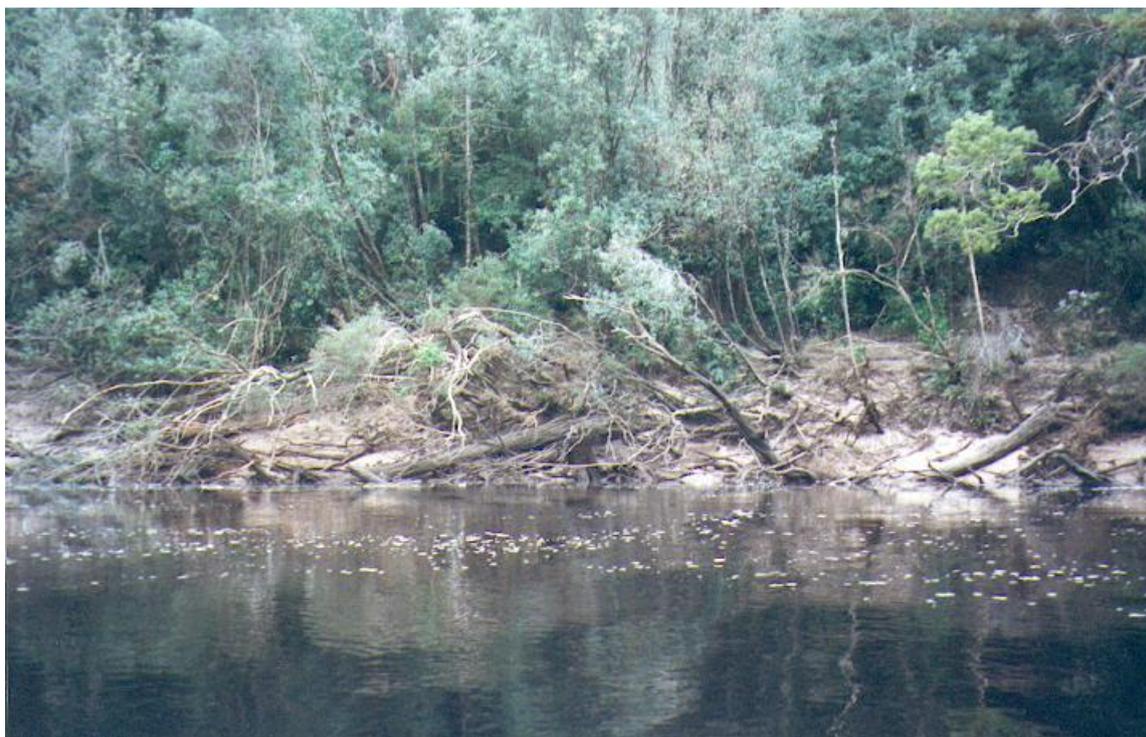
Figure 2.11: Zone 5 alluvial bank showing less defined Plimsoll line and greater occurrence of vegetation compared to zones upstream of the Denison confluence.

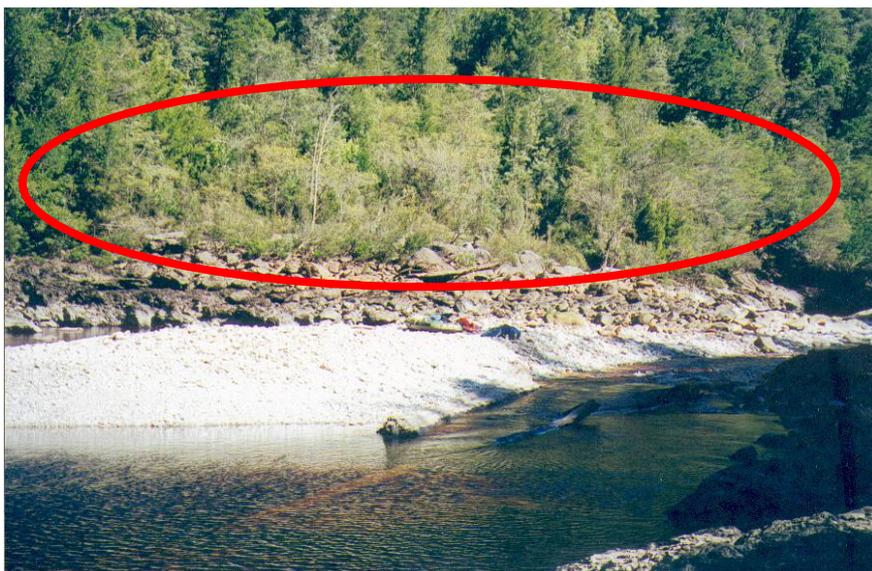
Figure 2.12: Increase in vegetation above power station-controlled operating level in zone 1. Vegetation above the Plimsoll line has grown since the power station began operating.

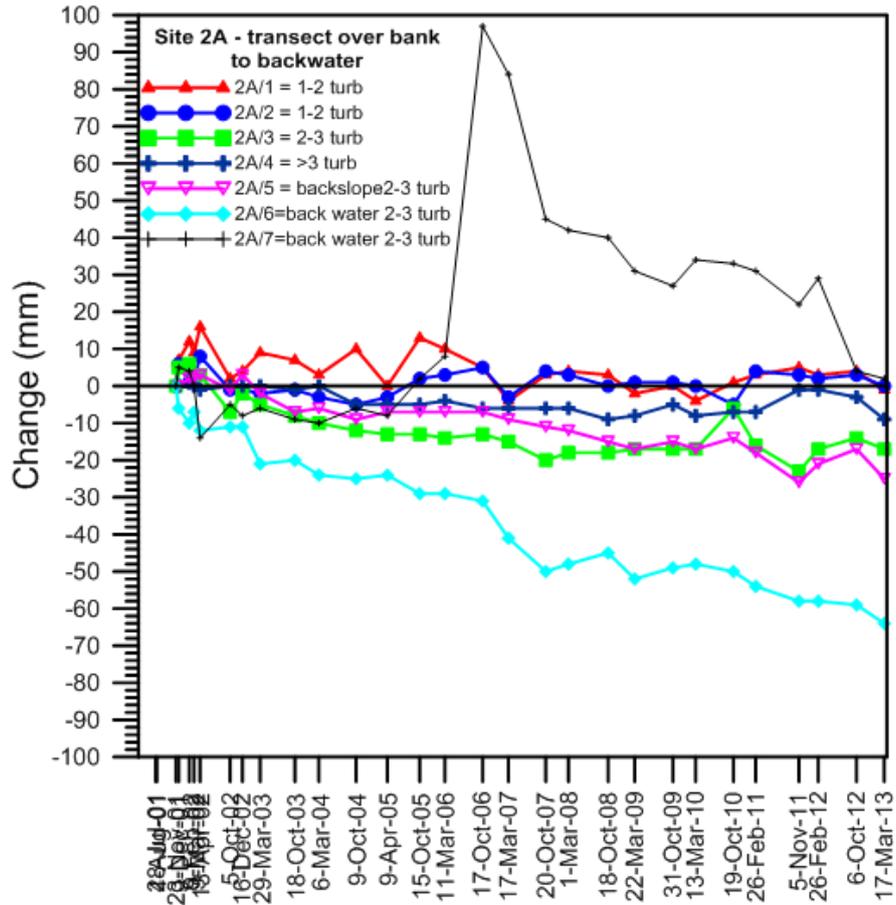
Figure 4.48: Erosion pin results from site 2A.

Erosional processes: The river-side of the bank has shown little change in the 1-2 turbine level. The 2-3 turbine level has shown flattening (deposition through seepage) on both sides of the crest. The pin in the bed of the back channel has shown the largest changes due to a scour hole forming at the base of the pin, and then subsequently refilling. The vegetation in the back water has varied from almost non-existent at the start of the monitoring program to abundant following the several years of low power station usage. The left bank of the back channel is prone to seepage erosion.

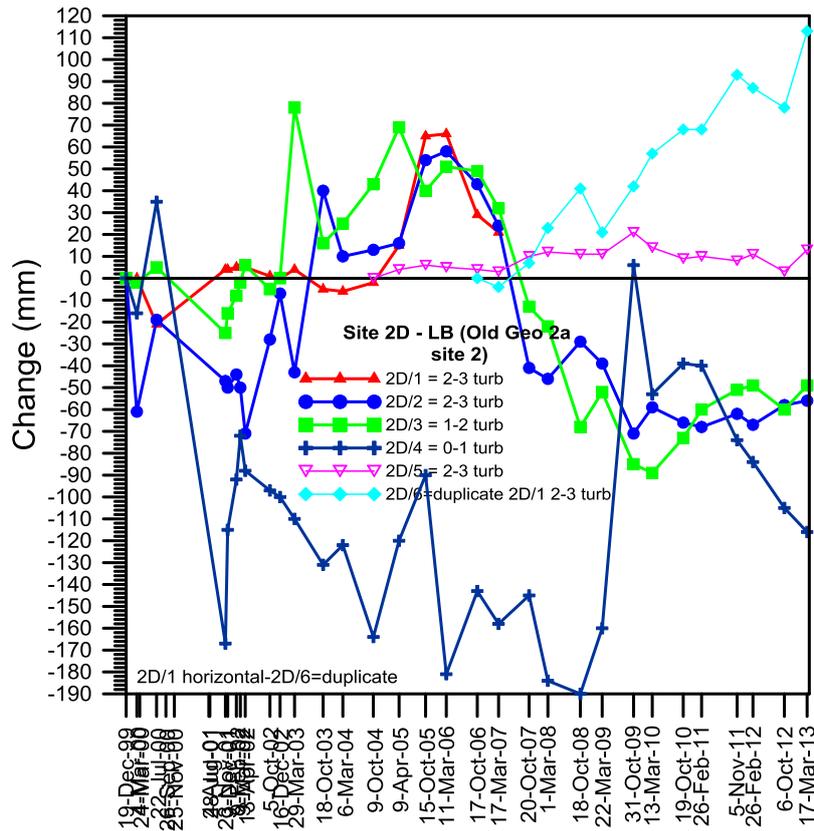
Figure 4.81: Erosion pin results from site 2D.

Comment: it is likely the toe of this bank is subjected to very different hydraulic conditions under different flow rates, ranging from scour to fluvial deposition as part of a back-water eddy.
