### **Right to Information Request 2 November 2016**

## Basslink High Voltage Cable Recovery & Repair from 20 December 2015 Failure

### Hydro Tasmania Project Investigator Daily Checklist

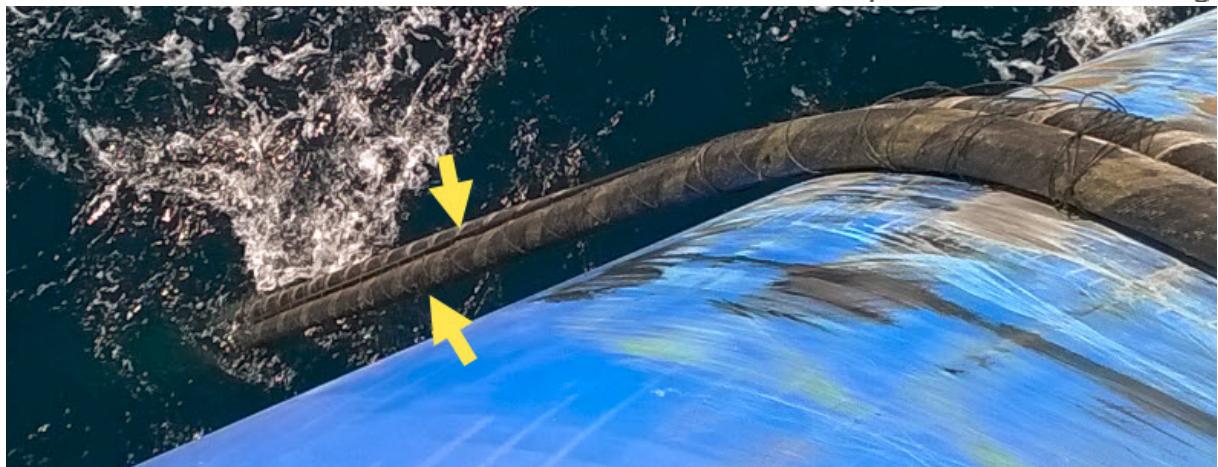
The fault was spotted by myself at 1200 hours just coming up out of the water and stopping short of the cable chute. One more cable cut was required before it could be brought on board. A photo of it coming out of the water is attached – it is quite difficult to spot unless you know what to look for.

Photo 1. Fault coming aboard indicated by bulges in the outer serving (arrowed)

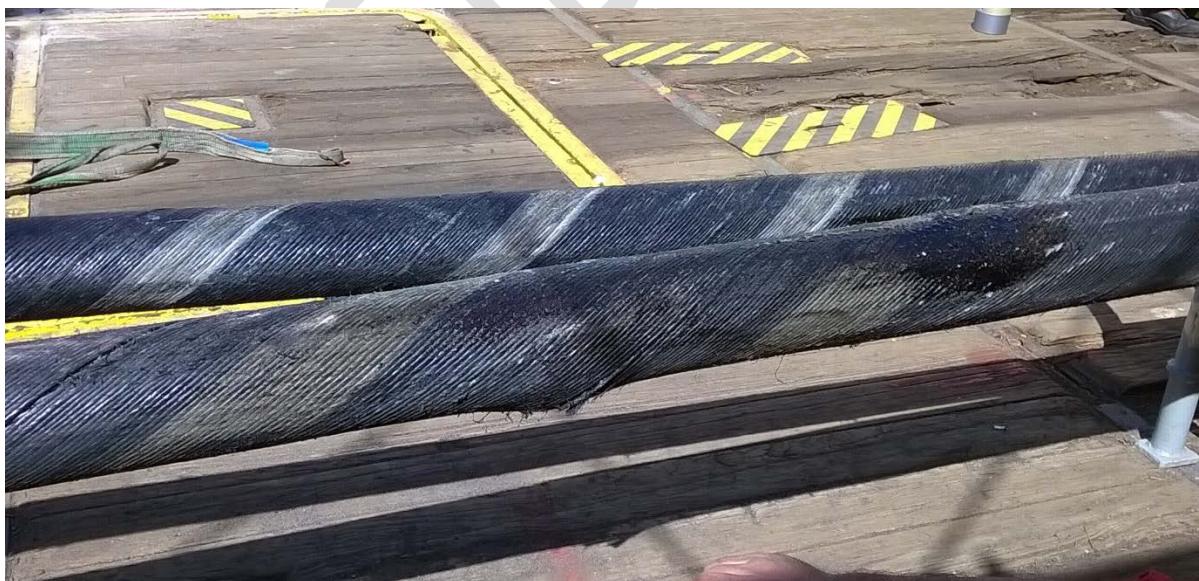
The fault had bulged the armour wires in two places close together but had not broken or fused them as I would normally expect to see in land cable fault. Thinking about this however, it is probably to be expected in a submarine environment with such a good earth surrounding the cable. I'm certain that beneath the main bulge in the armour wires there will be a sizable hole burnt right through to the conductor. The fault began to ooze burnt compound once it was on board.

Photo 2. Main bulge at fault and secondary bulge nearby oozing compound.

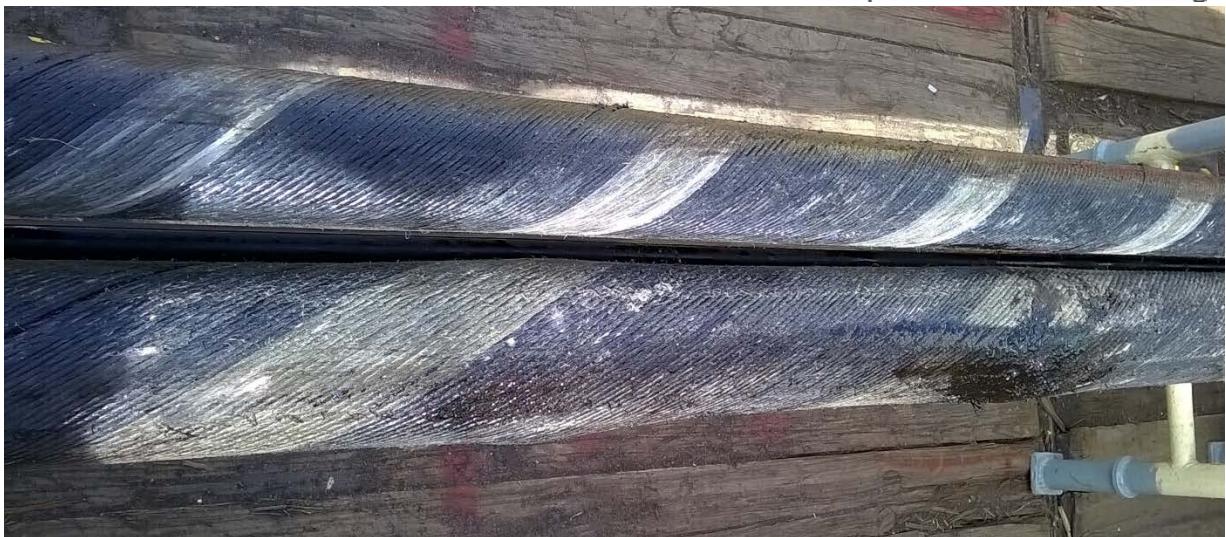
Photo 3. Fault position viewed from top.

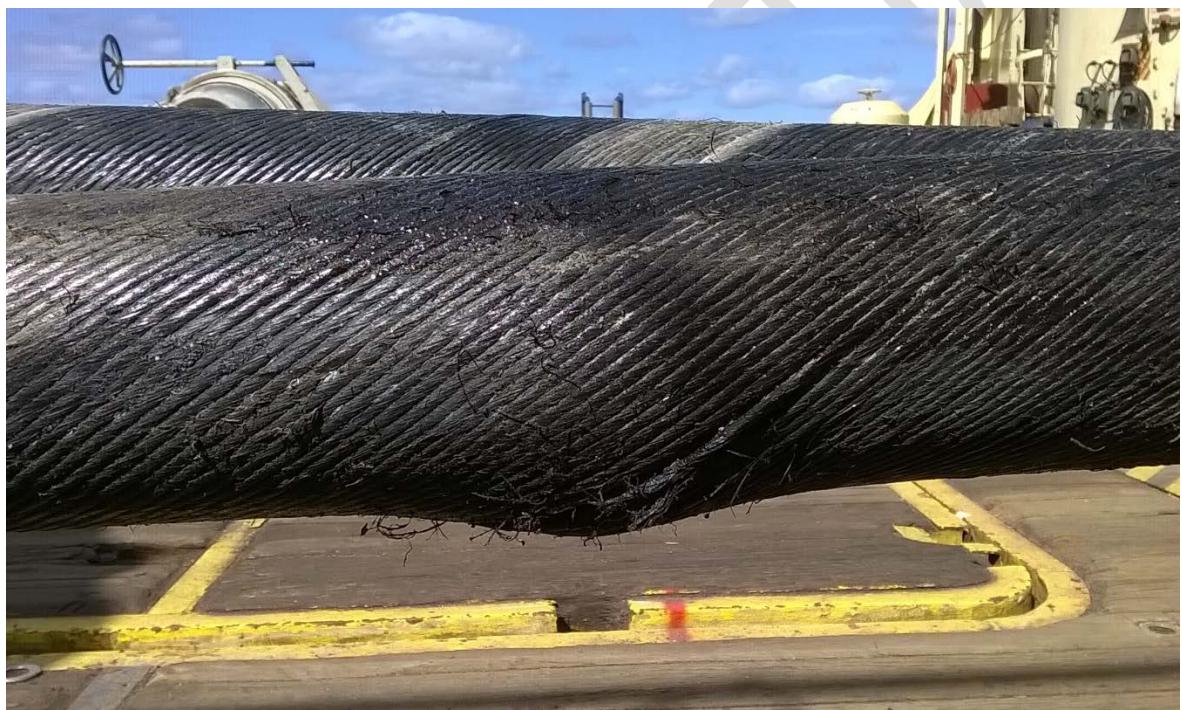
Photo 4. Side view of fault.

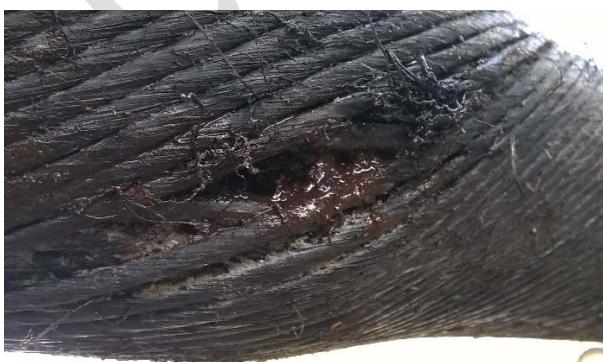
Photo 5. Fault from underneath

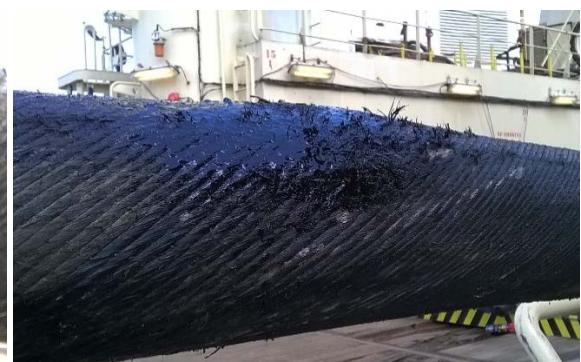
Photo 6. Secondary bulge oozing compound

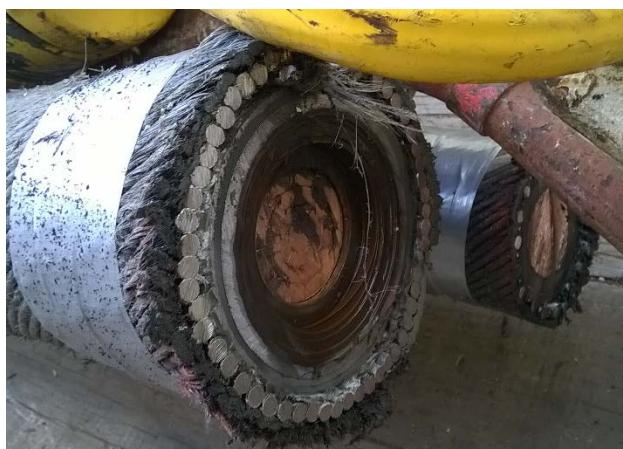
I noticed on lengths 142 and 143 that the conductor had pulled back into the cable a little (or more correctly the armour, sheathing and some of the insulating papers had slid over the conductor. I had not noticed this on any lengths before and it made me suspicious that these lengths could have been part of a factory joint where I would expect the whole construction would not be as tight as that made on cable making machinery.

Photo 7. Cable end - length 143

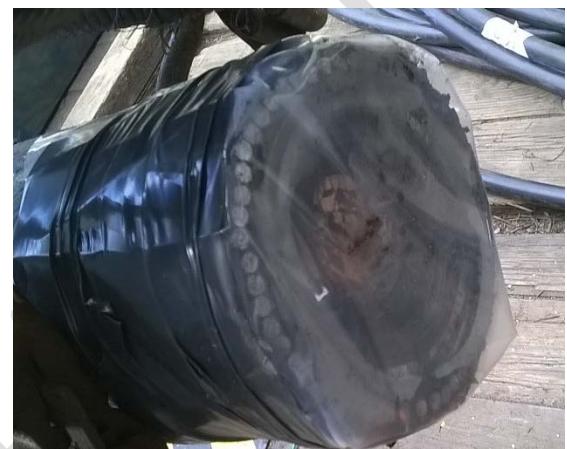
Photo 8. Cable end - length 142
