Hydro Tasmania

SAFETY BRIEF

Life Safety Equipment Damage

Brief Number (YYMMDD)	250114	Date Issued	14 January 2025
SAP Number (if applicable)	INC61756, INC62512	Approved By	Head of WHS
Action Required?	Yes

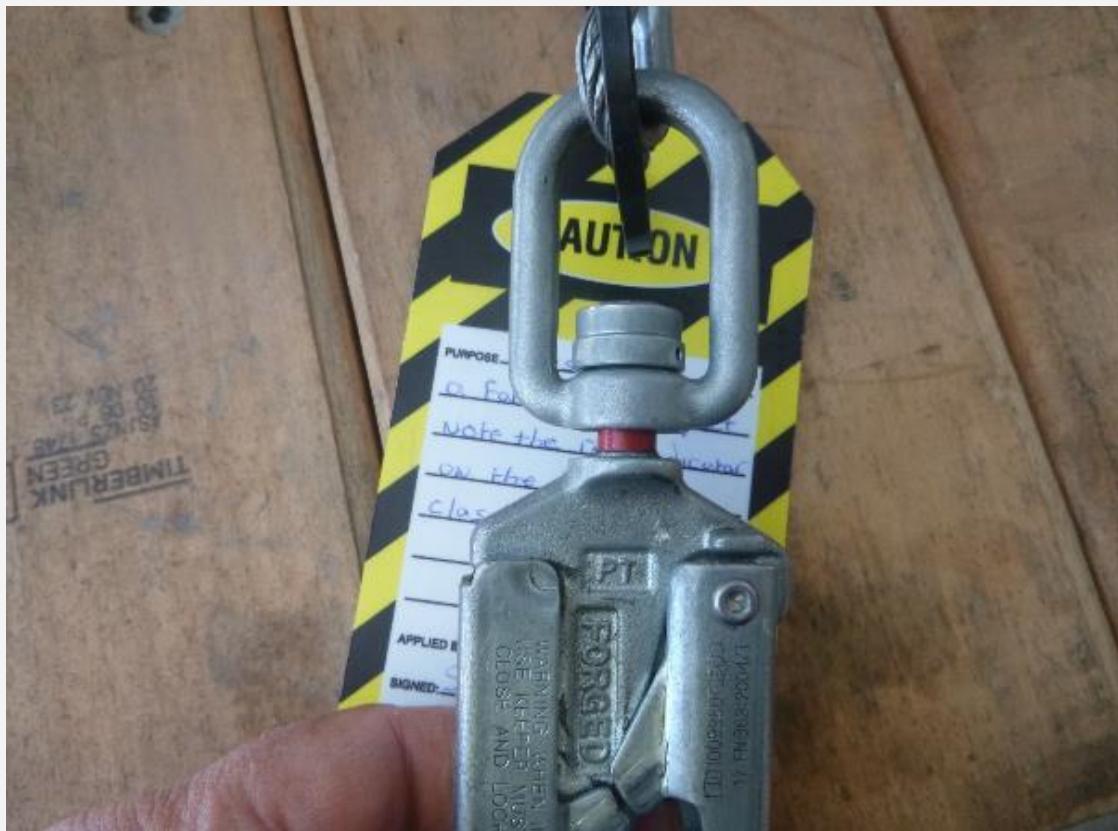
1. Retracting lanyard fall indicator had been activated suggesting a fall had occurred or the device had been subjected to a significant loading/force.
2. R550 rescue device had damage to the rope. The rope was showing signs of contamination with discolouration and reports of an oily feel.

Self-retracting lanyard (SRL) fall indicator on connector showing red indicator.

- Complete pre-start checks to highlight any equipment faults.
- Life safety equipment should only be used for life safety purposes. e.g. R550 is designed by manufacturer for descent and rescue hauling not for hauling of tools and equipment.
- Life rescue equipment is for rescue purposes only (or practice/training).
- Any damaged equipment should be tagged out of service, reported, and steps taken to check and repair.

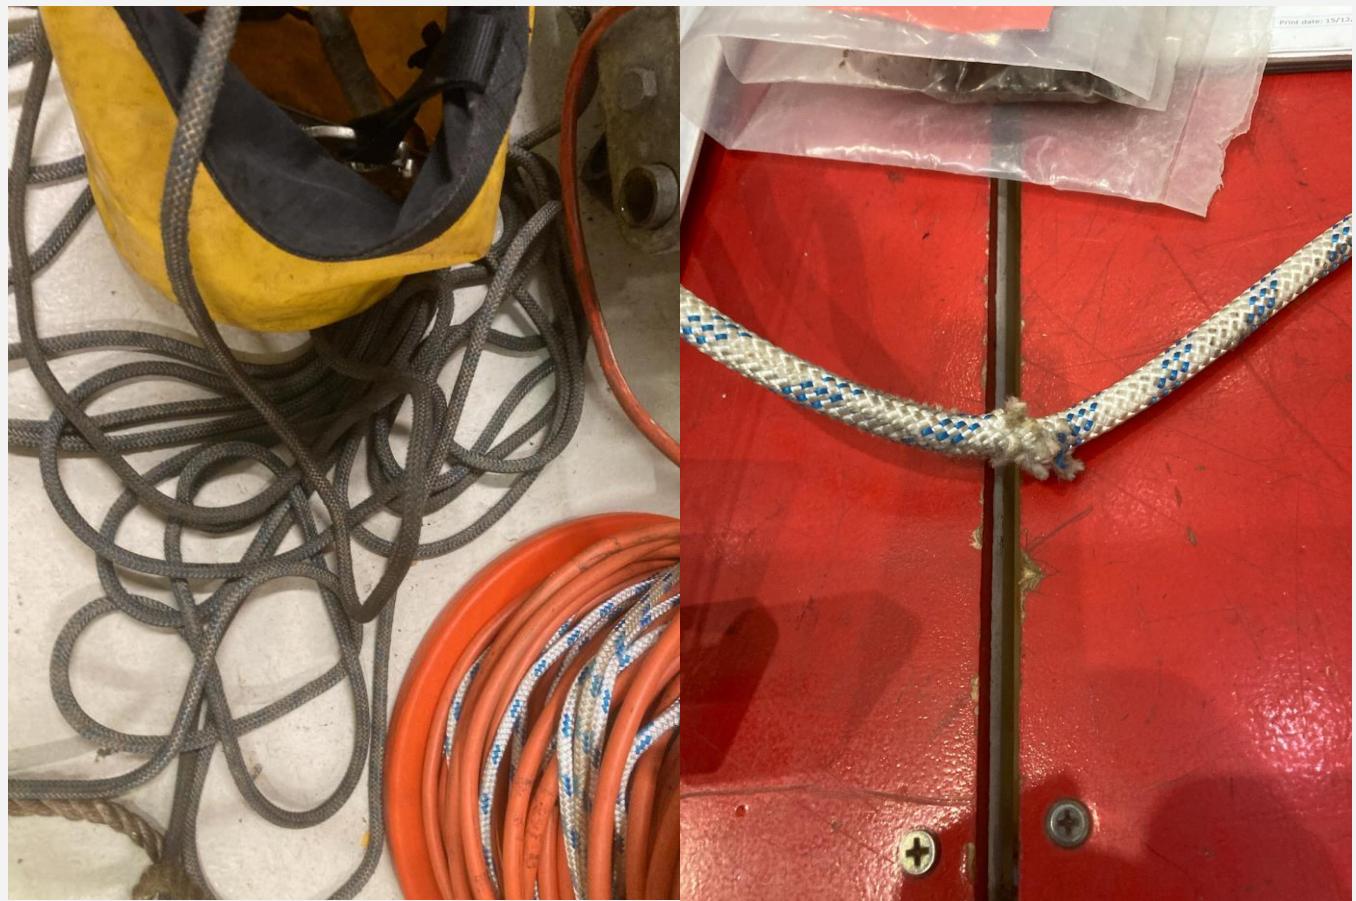
R550 rescue device rope damage. Rope is also excessively oily/dirty (original colour is white).
