# Hydro Tasmania

## SAFETY BRIEF

### Damage to Plant While Removing Floor Plates

Brief Number (YYMMDD)	250320	Date Issued	20 March 2025
SAP Number (if applicable)	64679	Approved By	Head of WHS
Action Required?	Yes

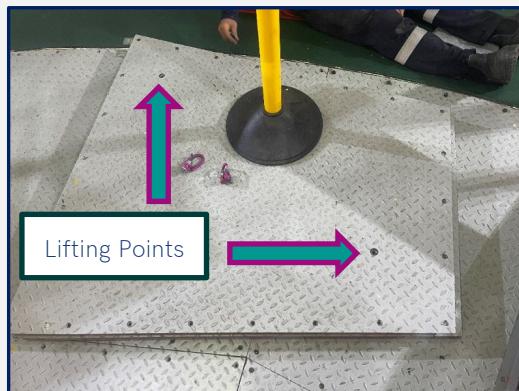
Floor Cover

The design of the lifting plate is such that the floor plates have only 2 x lifting points on opposing corners of the plate (see image). This creates instability during the lift, requiring precise balancing by workers and some manual handling.

- Conduct inspections of floor cover lifting attachment points within your area. Where imbalanced configurations are identified, notify the asset owner and initiate a maintenance NOTI in SAP to redesign the covers with a balanced lifting arrangement (i.e. four evenly distributed lifting points).
- Prior to remedial work, share hazard information to all workers required to remove the imbalanced covers to ensure appropriate controls are in place.

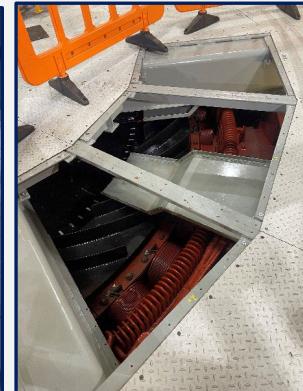
Alternator Winding

To undertake maintenance of the machine at Meadowbank Power Station, a crane was being used to lift the generator floor plates. During one of the lifts, a floor plate rotated in the air and struck the alternator winding, leading to damage of the winding coating.
