Hydro Tasmania

SAFETY BRIEF

Yellow Lock Fell Off Permit Lock Box

Brief Number (YYMMDD)	250326	Date Issued	26 March 2025
SAP Number (if applicable)	66659	Approved By	Head of WHS
Action Required?	Yes

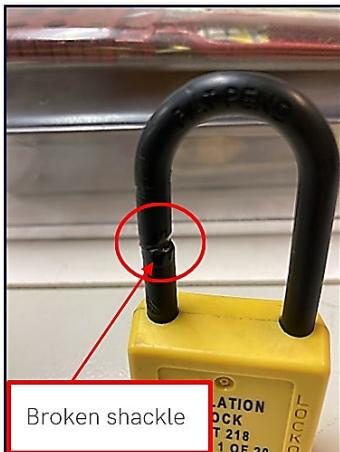
The investigation has revealed that the lock has been worn and damaged, not cut as first thought. Damage to the shackle of the lock has caused it to fail, potentially as a result of the permit box being dropped.

Photo 1 – Actual broken lock.

- Regularly inspect isolation lock shackles for wear or damage.
- Remove any locks with potentially damaged shackles from service immediately.
- Follow the 'Lock and Key Management' section of the Isolation Procedure for lost or damaged lock procedures.

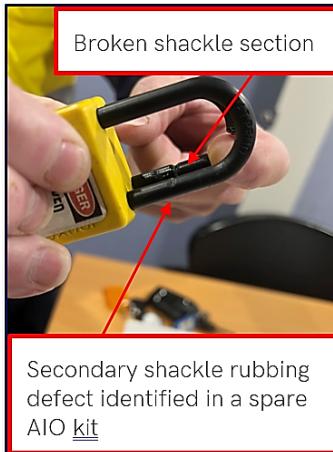
Photo 2 – Broken lock shackle compared to other identified damaged lock.

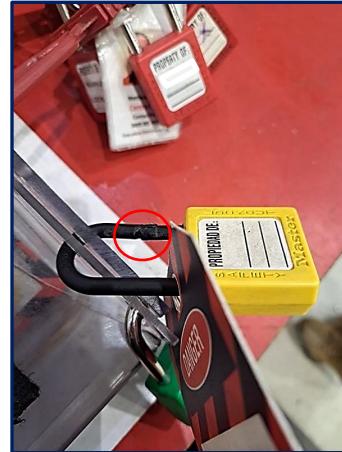
Photo 3 – Damaged lock location on PTW box.
