Hydro Tasmania

SAFETY OR ENVIRONMENT BRIEF

| Brief Number (YYMMDD) | 250827 | Date Issued | 28 August 2025 |

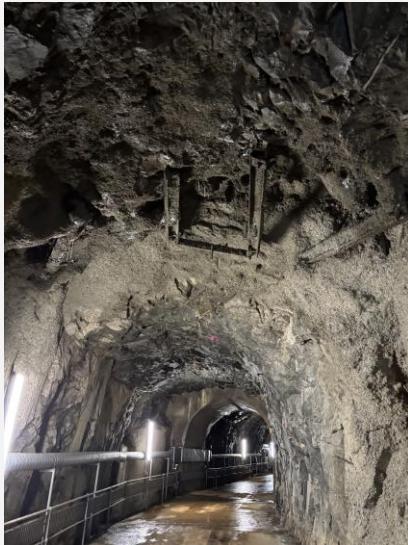
A contractor sustained a head injury while removing a cable tray in the hilltop valve tunnel at Poatina. During the task, the tray unexpectedly swung, dislodging the worker's helmet and in swinging back a second time striking their head, causing a laceration.

Ceiling of tunnel where cable trays were installed

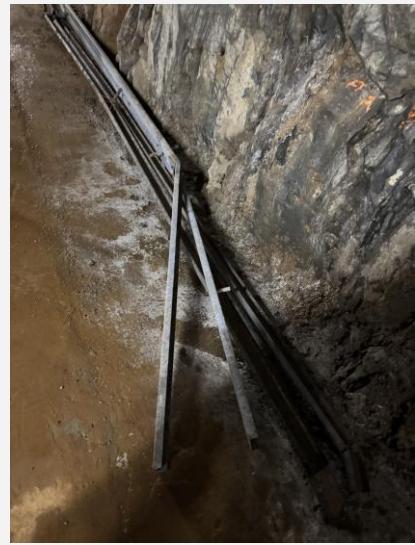
6m length removed cable tray

The cable tray swung unexpectedly during removal, striking the contractor and causing a head injury. This highlights a risk associated with handling long, unsecured materials overhead.

The task was performed by one person using one scissor lift and handling 6m tray lengths, instead of the planned two-person, two-lift method with 2.5m sections. This variation increased manual handling risks and reduced control over the equipment.

This incident highlights the importance of assessing potential for stored energy and movement in structural components before undertaking work. Routine tasks like bolt removal can pose serious risks if underlying tension or instability is present. It is important that prior to undertaking work an assessment of potential hazards is undertaken:

- Use Take 5's or safe work method statements as a tool to identify hazards and assess risks
- Conduct a thorough visual and physical inspection before starting work
- Consider the possibility of stored energy or movement in components
- Use appropriate restraints or supports when removing fasteners
- Communicate hazards clearly during pre-starts and toolbox talks.
- Monitor control effectiveness and respond to any necessary changes
- And as a last line of defence (hierarchy of controls), ensure effective use of appropriate PPE
