Hydro Tasmania

SAFETY ALERT

Alert Number (YYMMDD)	300725	Date Issued	28 August 2025
SAP Incident Number	76217	Approved By	Head of WHS
Alert Category	Safety	Action Required?	Yes

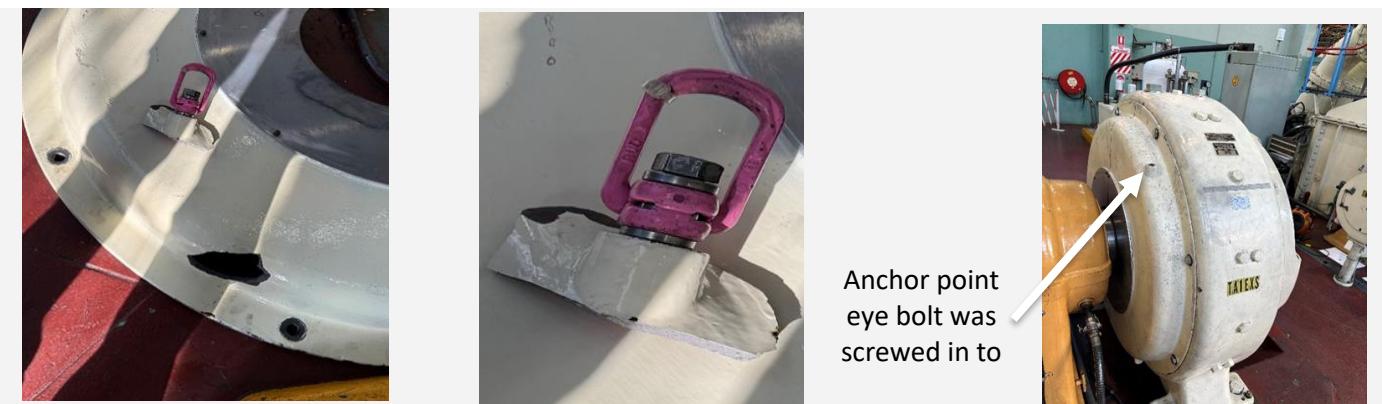
On 30 July, during routine maintenance on Tarraleah Machine #2, a team was removing the exciter cover to clean the windings during routine maintenance. The cover was secured with four bolts. After three bolts were removed, the last bolt was loosened to hold it in place while a crane took up the slack of the sling which was attached to the eye bolt. When the crane was activated, it lifted too quickly, putting excess force on the lifting point. A 150mm section of the cover broke away and was ejected about 3 metres into the air before landing safely away from workers. No one was injured.

- Having a licence, qualification, or training doesn't always safeguard against incidents when working in unfamiliar sites or with unfamiliar equipment.
- Take 5 was completed however risk assessments can miss hidden hazards if not used effectively. An electronic version could prompt deeper consideration of risks.
- There's uncertainty about when a certified rigger is required. The current guideline does not appear to be well known with the employees involved.

- Review and progress the development of an electronic Take 5 tool with better hazard prompts.
- Deliver refresher awareness/training on all lifting and rigging procedures.
- Develop a work instruction allowing certain simple or routine lifts to be performed without a certified rigger, where appropriate.
