# Hydro Tasmania

## SAFETY OR ENVIRONMENT BRIEF

### Incident Notification

Brief Number (YYMMDD)	251017	Date Issued	17 October 2025
SAP Number (if applicable)	81533	Approved By	Head of WHS
Action Required?	Yes

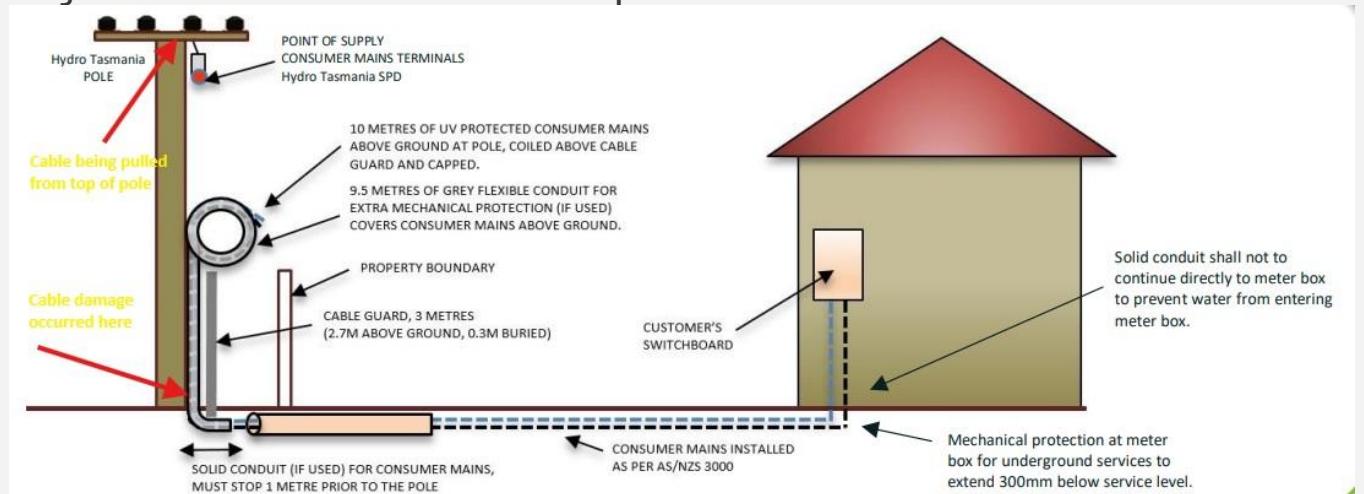
**Diagram of Under Ground Consumer Mains up Service Pole**

On 17<sup>th</sup> October a Line Worker received an electric shock from the aluminium guard protecting the customer supply mains.

As part of distribution works the mains were being pulled from the pole top assembly, this caused insulation damage to the cable coming in contact with the bottom edge of the cable guard (underground). On energising the service the aluminium cable guard became live with a ground based Worker making contact during restoration works.

- Maintain a high level of vigilance around electricity, follow safe work procedures and encourage high quality work.
- Even 240 volts can present a serious risk to personnel.
- Give consideration to the dynamic nature of hazards during the course of work and doing regular reassessments
