Hydro Tasmania

SAFETY OR ENVIRONMENT BRIEF

Brief Number (YYMMDD)	251104	Date Issued	4 November 2025
SAP Number (if applicable)	82804	Approved By	Head of WHS
Action Required?	Yes

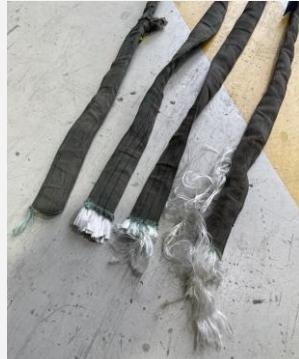
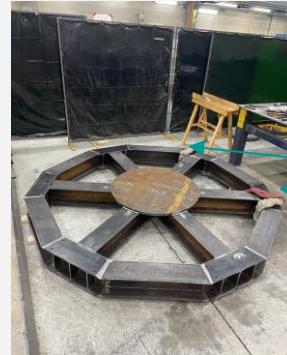
Photos

On 3 November 2025, an incident occurred in the Cambridge workshop fabrication area. Two soft slings were used to lift/tilt a fabricated frame weighing approximately 1,200 kg. During the lift, both slings were in contact with the frame's sharp edge. The frame was initially tilted to about 600 mm off the ground to test the weight, with no issues observed. However, when the frame was lifted further to approximately 1,200 mm, one sling sheared and failed, causing the load to drop to one side. This sudden shift overloaded the second sling, which also failed, resulting in the frame dropping to the ground. Both employees involved were clear of the drop zone and no one was injured.

- Use certified lifting chains whenever sharp edges may be present. If chains cannot be used, ensure soft slings are protected with appropriate edge protection.
- Never assume that an edge isn't sharp enough to cause damage, even slightly sharp edges can cut or weaken slings.
- Plan for lift failure by identifying potential risks and putting controls in place to keep people clear of the fall zone.
- Preventing falls from heights, lifting safely and remaining clear of suspended loads are part of Hydro Tasmania's Life Saving Rules. In addition, timely reporting of events as per incident management procedure.
