Hydro Tasmania

SAFETY OR ENVIRONMENT ALERT

Electric shock from consumer mains – Investigation Findings

Alert Number (YYMMDD)	251107	Date Issued	7 November 2025
SAP Incident Number	81533	Approved By	Head of WHS
Alert Category	Safety / Environment	Action Required?	Yes

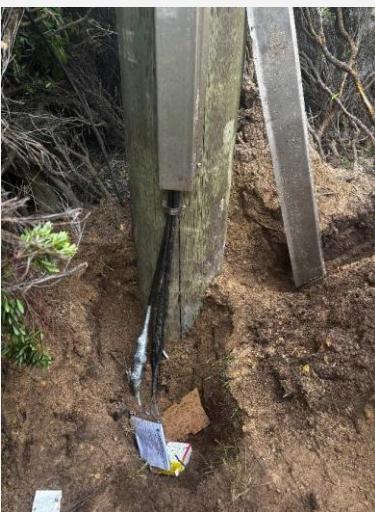
Initial investigations identified the presence of 240V on the cable guard. Further inspection revealed physical damage (a cut) on the customer supply mains cable (XLPE rated cable) at the lower edge of the guard. This damage caused the guard to become energised.

Incident scene – cable repair under grey tape.	Stainless steel cable guard (finished product)

The bottom section of cable guard is applied first and the cable lifted and tensioned removed using a rotor/come along. At this time the cable has been damaged by the sharp bottom edge of the cable guard.

- The methodology used to lift, tension, and secure cabling to ensure a neat/quality installation will be improved to increase protections to cable integrity.
- Improve electrical testing methodology when disturbing customer owned installations.
- Reviewing supporting risk management documents such as the SWMS for this task with consideration to this incident.
- Reviewing Hydro Tasmania's Bass Straight Islands Service & Installation Rules to consider the mandatory inclusion of flexible conduit (including for installations using XLPE cable). This is currently optional.
