# Mersey-Forth Water Management Review

FACT SHEET

## Land Rehabilitation at Lake Mackenzie Study

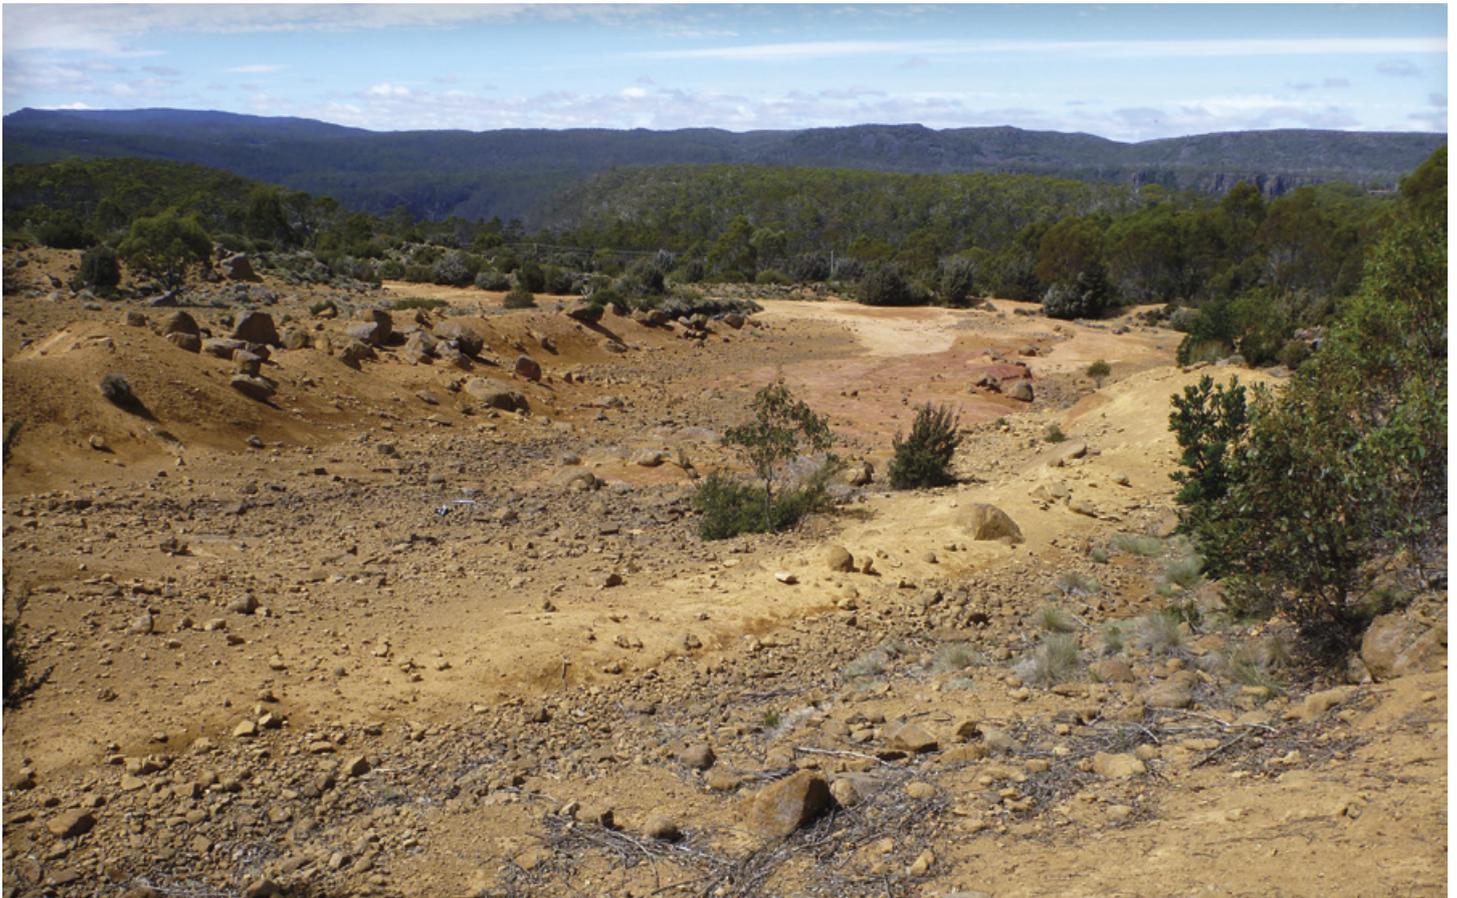
*Old claypit above Fisher Forebay to be revegetated in 2014.*

Some areas of land have remained bare since the vegetation was removed and the ground disturbed during the construction of the dam, canals, pipelines and road infrastructure. This bare land is subject to ongoing sheet and rill erosion by the action of wind, rain and ice.

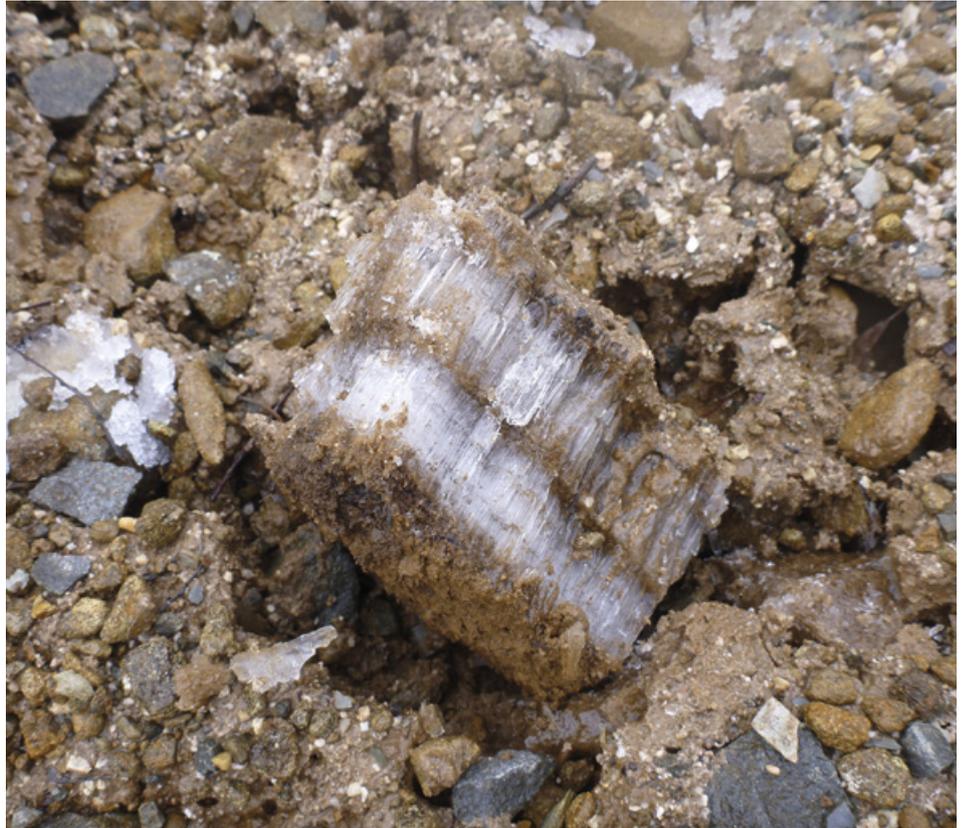
*One of the challenges to the establishment of new plant growth in the harsh alpine environment around Lake Mackenzie is the presence of frost heave.*
