# Mersey-Forth Water Management Review

TECHNICAL AND SOCIAL STUDY

## Acid Drainage Investigation Downstream of Wilmot Dam and in the Cethana Power Station

Technical Advice on Water

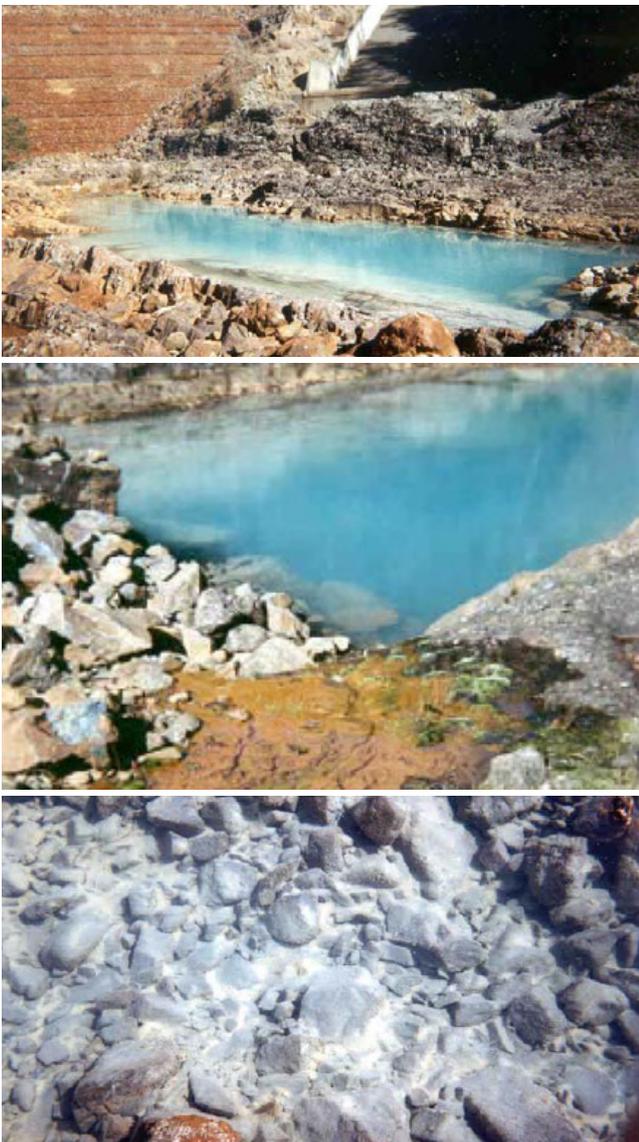
The limited water quality results available for the Wilmot River downstream of Wilmot Dam are summarised in Table 2.1. Also available are photos of the pool at the toe of the dam taken in October 1999 (Photograph 2.2), and presented in an internal Hydro Tasmania memo prepared by Mick Howland, and similar photos obtained in November 2012 (Photograph 2.3).

The water quality results (Table 2.1) show that metal concentrations associated with the samples collected in 2010 and 2011 are low, but elevated in the sample collected in October 2012, especially in the V-notch weir at the base of the dam. Given the blue coloration of the water in the photos in 1999, along with the white and red precipitation in the pool, it is probable that water quality during this period was also characterised by elevated metal concentrations. These results suggest that metal concentrations are intermittently elevated downstream of the dam.

Photograph 2.2: Photos obtained of 'blue pool' at toe of Wilmot dam (top), iron floc deposition (middle), and white floc deposition (bottom)

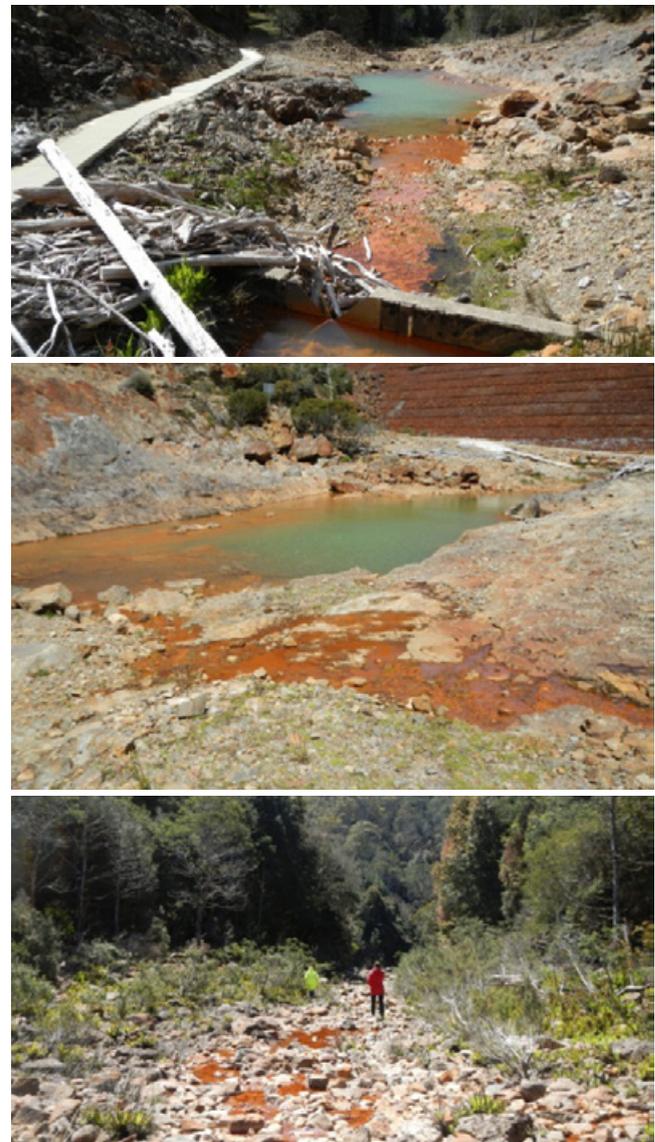
Field observations in November 2012 found seepage entering the pool from the toe of the dam and from the nearby diversion tunnel. These waters had a low to moderate pH, and there was extensive iron staining in the channel. The water upstream of the V-notch, indicative of dam seepage, also had low oxygen levels (~50% saturation).

Iron staining was also present in the Wilmot River downstream of the dam, associated with natural seeps entering the river. The seepage from the dam is undoubtedly related to the fill material in the dam, but the seepage from the diversion tunnel and in the natural seeps is indicative of naturally iron-rich ground water in the region. Iron rich ground water is not necessarily indicative of acid drainage,

Photograph 2.3: Photos taken on 12 Nov 2012 downstream of Wilmot Dam. V-notch at toe of dam (top), pool downstream of V-notch showing seepage from diversion tunnel entering downstream end of pool (middle), and Wilmot River downstream of dam (bottom)

The concentrations of metals present at the V-notch weir in August 2012 are very high compared to the concentrations recorded downstream. Several processes are likely contributing to the decrease. As the acid water mixes with less acidic water, the pH will increase, and metals such as iron and aluminium will precipitate at pH levels between 3.5 (iron) and 5.0 (aluminium). The presence of the iron-staining in the channel and white floc in the photos obtained in 1999 are consistent with these precipitation processes. The concentrations of metals which are not precipitated at the pH range in the Wilmot (e.g. zinc and manganese) will be reduced through dilution. Based on the water quality results, there was a 10 to 20-fold dilution of metal concentrations within the first 500 m downstream of the dam.

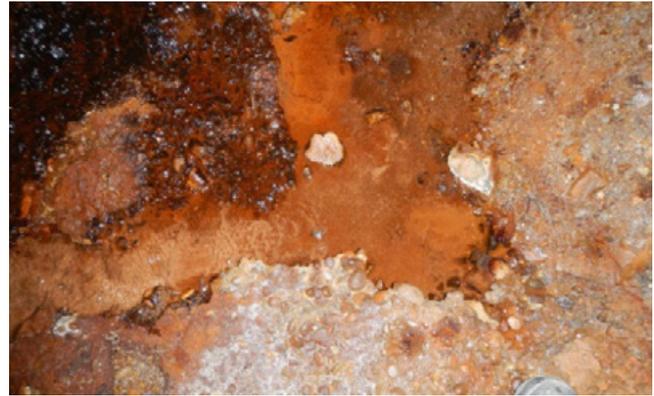
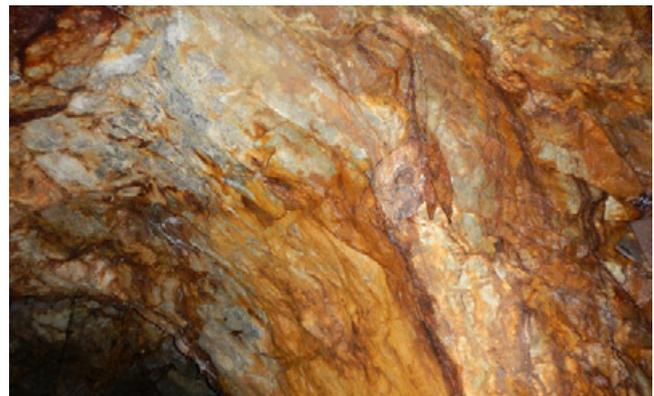
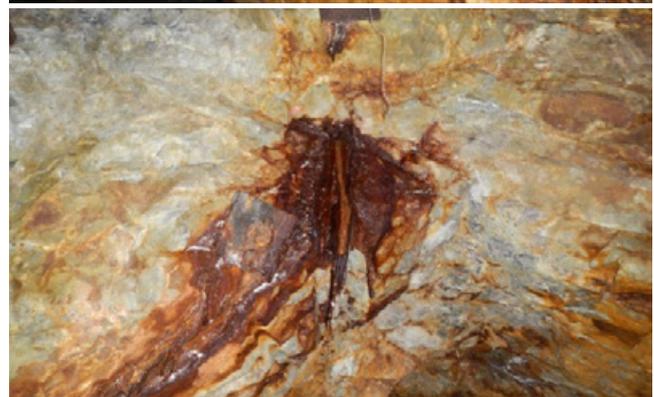
In the tunnels within the Cethana Power Station, there is acidic seepage, and the walls and floors of the tunnels show extensive iron-staining. Observations are difficult due to the lack of light, but water pathways appear to be associated with typical ground water pathways such as rock bolts and shear zones (Photograph 2.4). Where there was sufficient flow to be sampled, the pH was low (as low as 2.8).

Although no water quality results are available, the Cethana Power Station is situated in a mineralised area, and it is possible that the seepage has an acid drainage component as well as an iron-rich ground water component. The volumes of flow were very low, and are unlikely to have any environmental impact on the downstream environment. The acidic water may create management issues within the power station with respect to corrosion of materials which come into contact with the acidic flows.

Photograph 2.4: Iron staining and acidic water in the Cethana Power Station

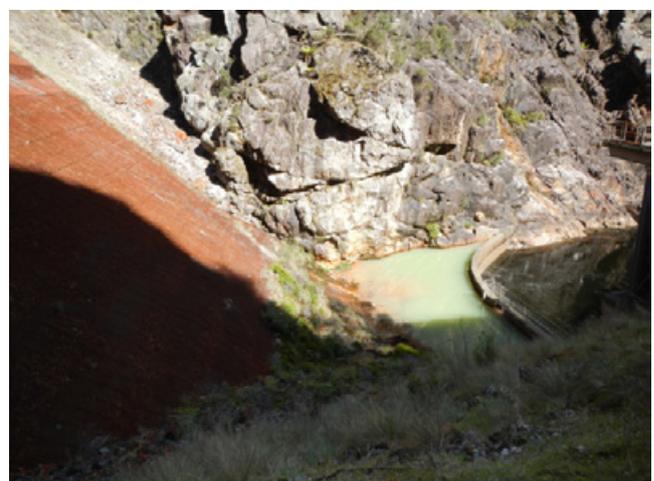
The seepage at the toe of the Cethana Dam (Photograph 2.5) was similar in colour to that at Wilmot Dam, and consistent with iron-rich water oxidising on contact with air.

Photograph 2.5: Seepage at the base of Cethana Dam showing iron coloration
