Hydro Tasmania

SSL/INJURY/ILLNESS INCIDENT OUTCOME

Damaged power cable Nive rive picnic area

Document Number	260610_IO	Date Issued	12 June 2026
Incident Owner	Connor Knight	Approved By	Head of WHS
SAP Number	92470	Type of Incident	Potential SSL

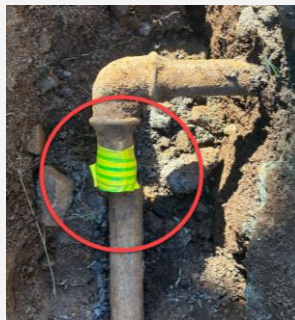
A galvanised water pipe was identified and excavation commenced. When workers exposed and cut into the galvanised water pipe, they discovered no water and unexpectedly cut into an energised electrical cable running inside the pipe.

Further investigation found the actual water pipe was located even deeper underground. No injuries occurred, RCD tripped.

- The electrical cable had been installed inside a pipe in a non-standard arrangement, thus available service drawings and detection methods did not identify the electrical cable
- Workers reasonably believed the identified pipe was the water service they intended to connect to, which had been isolated prior, thus it made sense to cut into the galvanised pipe
- The electrical service feeding into the picnic area building had been identified prior, but the concealed cable was a secondary service feeding the BBQ area which had not been identified

- 1) The service locating process did not prevent the event, but the layered controls helped prevent the event from escalating into a potentially serious injury (RCD protection on the electrical circuit, use of double-insulated/battery-powered equipment, appropriate PPE including gloves)
- 2) Even well-executed service location processes can be defeated by undocumented, non-standard infrastructure. Plan for uncertainty when working on legacy assets.
- 3) Treat underground or concealed services as potentially hazardous and always isolate and test for dead. Where practical, verify the services before cutting, drilling, penetrating, or modifying them.
- 4) Report unexpected findings – if site conditions differ from drawings or expected conditions
