Tungatinah Power Station Conservation Management Plan Review

Final Report prepared for Hydro Tasmania

AT0221

17 January 2018

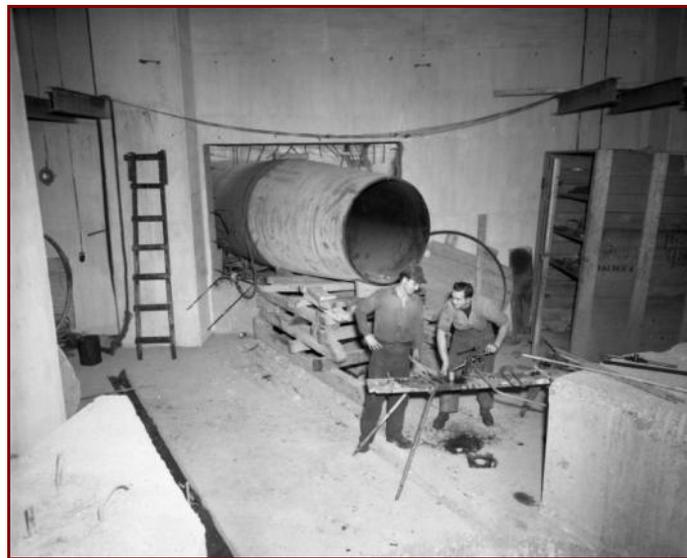
All the penstocks were regularly internally reconditioned, one occasion being between 1970 and 1974.¹⁰⁴ Initially this was done manually, by workers crawling through the tubes (Figure 2.22). In more recent times it has been carried out by a robotic device that blasts the interior to remove corrosion.

Parts of the penstock drain and the relief valve were not included in the reconditioning of the penstocks or the turbines.¹⁰⁵ On the 28th of March, 1985, while draining Tungatinah Tunnel, the drain valve on the No. 4 penstock was opened one inch and soon failed.¹⁰⁶ High pressure water began spraying into the station where operators were working. The dewatering pumps could not handle the volume and the water rose quickly. To prevent the turbine halls being flooded, the operators quickly opened the by-pass, main and relief valves, risking damage to the penstock in the process. The No. 4 hilltop valve was then closed, which reduced the flow at the leak. Then operators attempted to close the penstock drain valve, but it would not move in either direction. The penstock continued to drain through the relief valve for a further 15 minutes. Due to the quick response of the operators, there was no injury to personnel, only wetting, and no damage to other equipment occurred. If this had occurred during the lightly staffed early morning shift, the turbine floors would have been flooded before help arrived from Tarraleah. Some repairs involving the valve from the No. 1 unit were improvised and it was recommended that no draining of any of the penstocks take place until a thorough examination had been made.

During the 1988 reconditioning of the No. 4 machine, the pipes in the relief and penstock drain valves were found to be heavily corroded, to the extent that after blasting there were pin holes in the pipes.¹⁰⁷ Similar corrosion may explain why the penstock drain valve had failed and become inoperative in 1985. In early 1989 all the penstock drains were redesigned and replaced.¹⁰⁸

Figure 2.19: Inside penstocks, maintenance and construction, 1951.¹⁰⁹

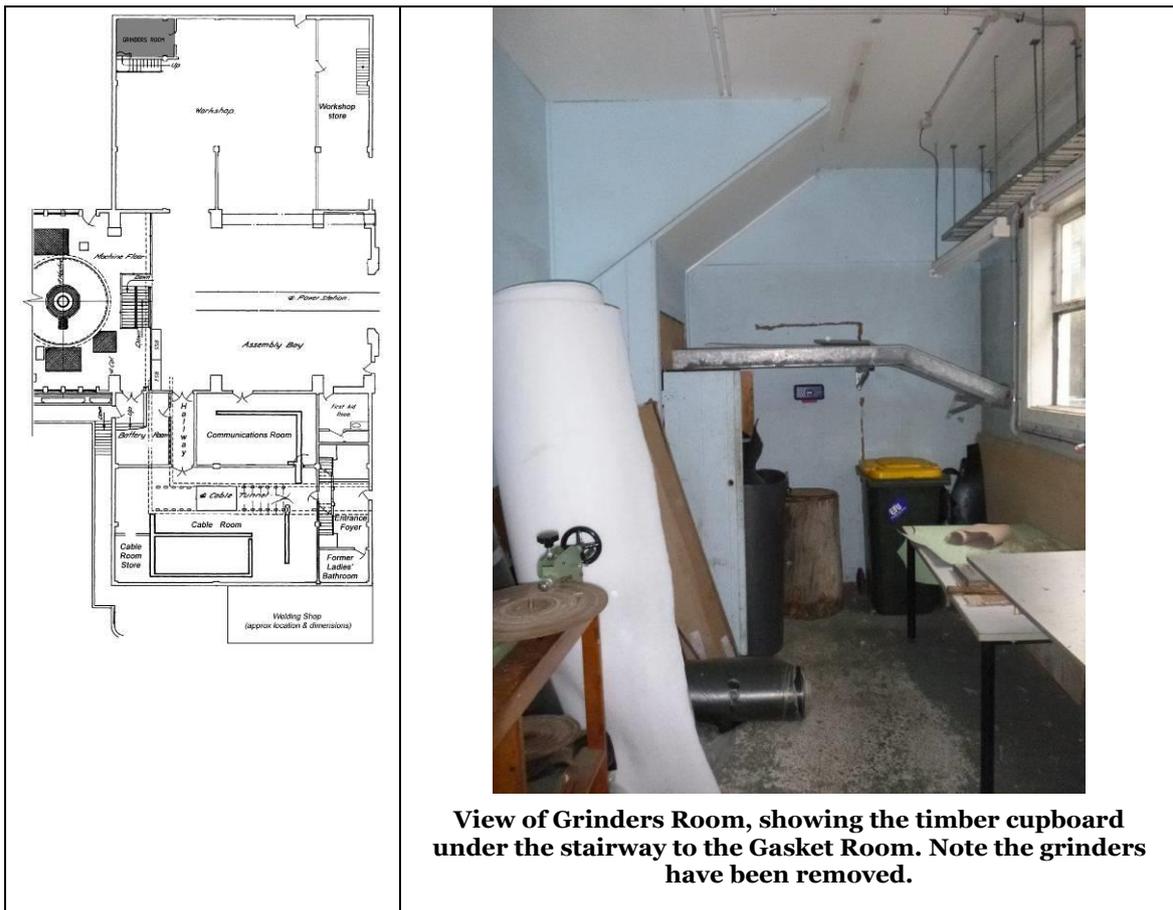
3.3.2.13 Grinders Room – S13

View of Grinders Room, showing the timber cupboard under the stairway to the Gasket Room. Note the grinders have been removed.

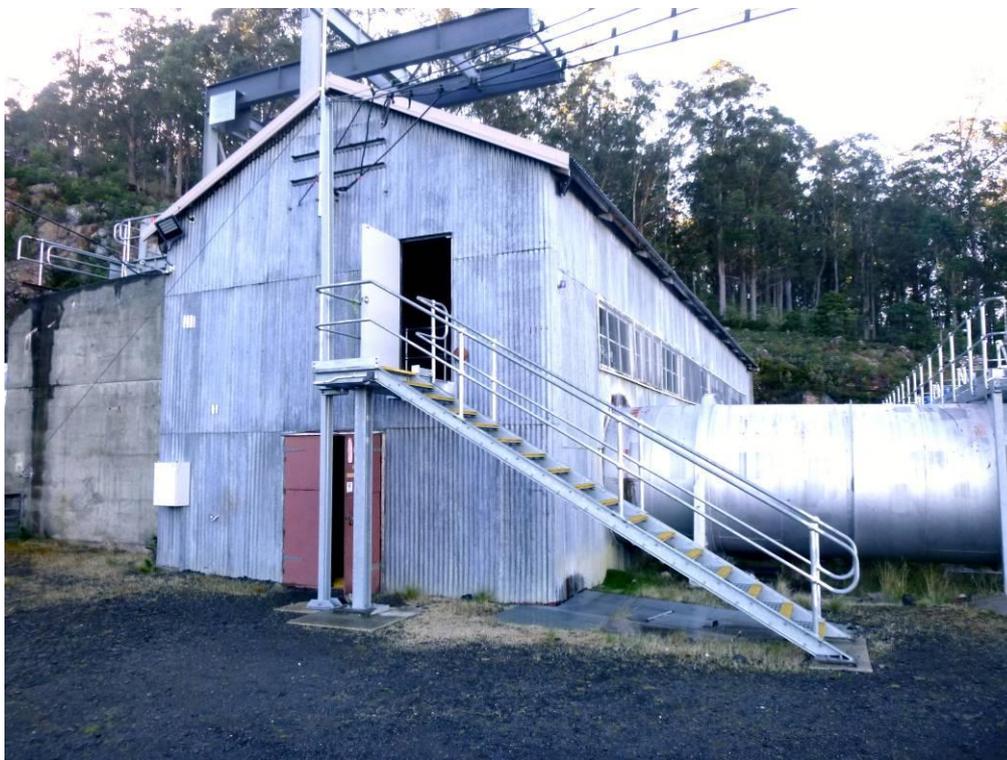
***Update 2017** – As recorded by Waight and Dilger¹¹⁹ modifications to the valve house had taken place after the 2007 conservation management plan. These modifications included the construction of a large gantry crane on the concrete block manifold that houses the penstocks, introduced to assist in the refurbishment of the valves but remaining in place. The whole of the roof had been replaced with new corrugated steel with small additions to the external cladding walls of the structure. During the refurbishment of the valves the old fittings had been left in place.*

A set of external stairs had been installed on the northwestern face of the structure and a new door opens above the earlier door. Through the new door a set of raised walkways has been added throughout the interior. A set of smoke alarms has also been installed along with new interior lights. A new distribution board has been installed on the second level of the northeastern wall of the interior, and oil accumulators and controls have been replaced. In addition to this a new fibreglass plate has been installed on the floor near to the lower entrance to the building. The concrete wall of the portal has a new steel stair installed on its face. There was no visible change associated with the surge tank, including the coiled steel rope which has been left in place.

Figure D.1 View to the north showing the refurbished valve house. Note the addition of the crane behind and above the main building as well as the set of stairs and new door to the second level of the building.

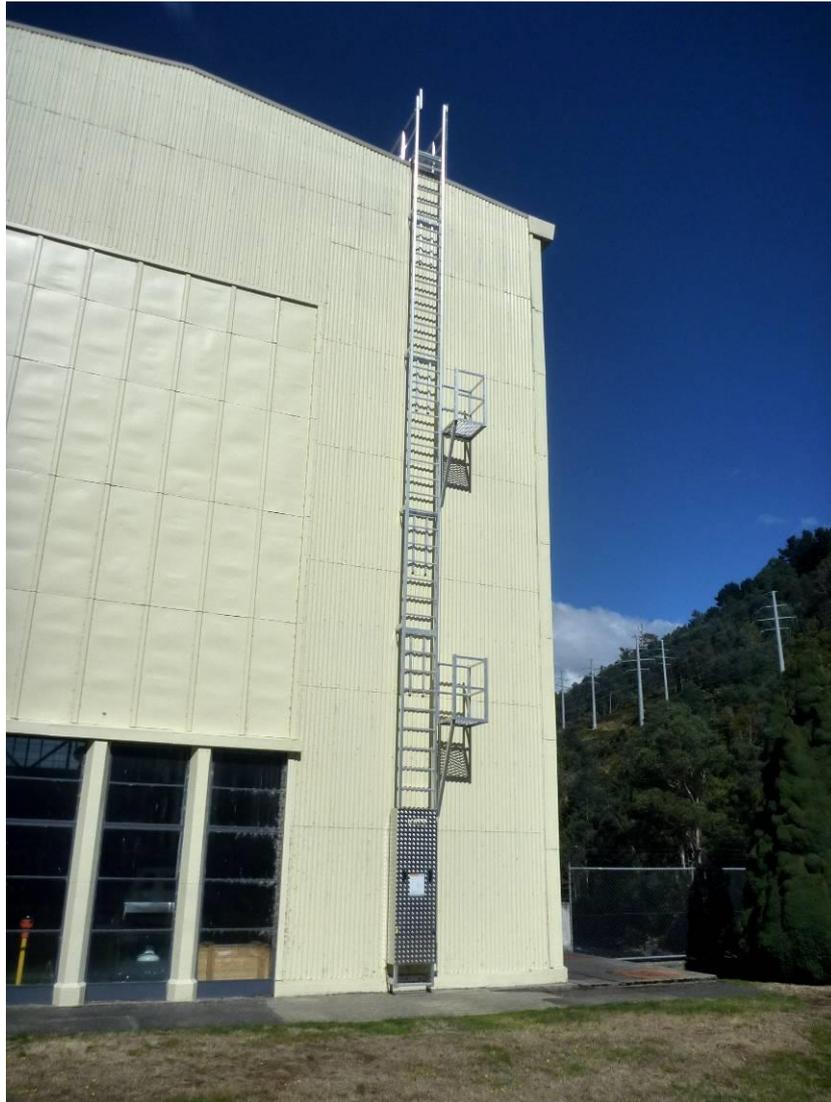
Update 2017 – As was noted by Jackman¹²¹ a roof access ladder has been installed onto the back, northwestern face, of the main bay of the building intended to connect to a rooftop walkway, and ventilation fans have been installed in the roof at the northwestern end of the main bay. Two large Hydro Tas signs have been installed on the external southeastern and northeastern faces of the main bay close to the roof line.

Figure D.2 View to the south showing the roof access ladder installed on the northwestern face of the exterior of the main bay of the power station.

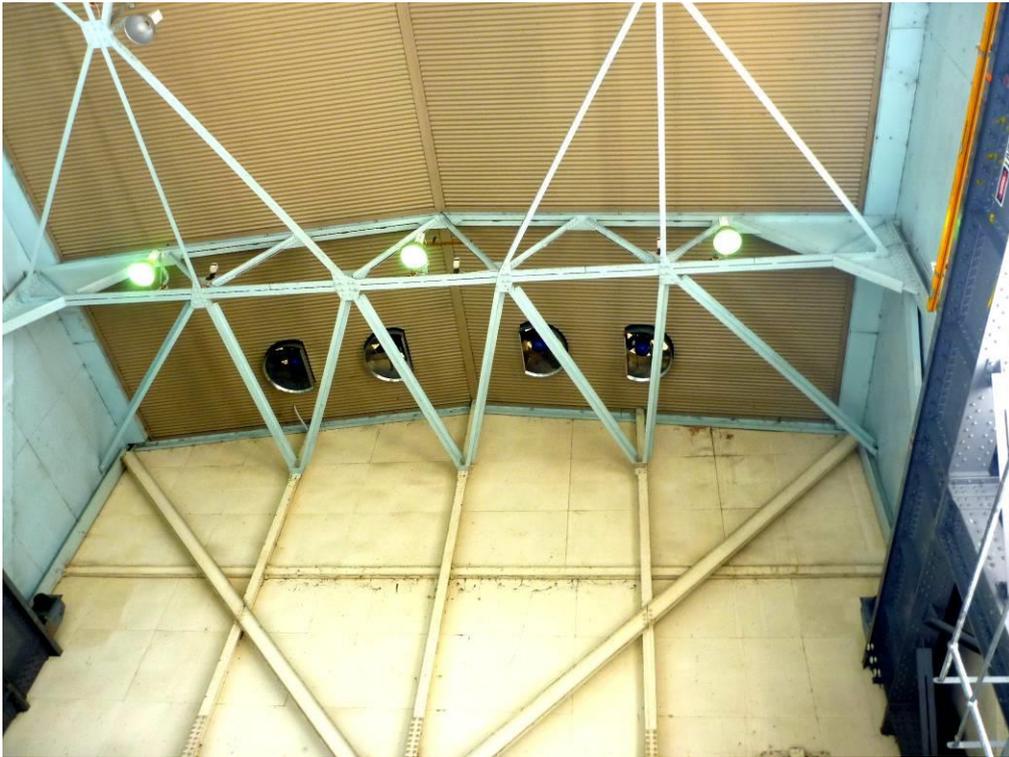
Figure D.3 View to the northeast showing the four fans installed in the roof of the main bay of the power station.

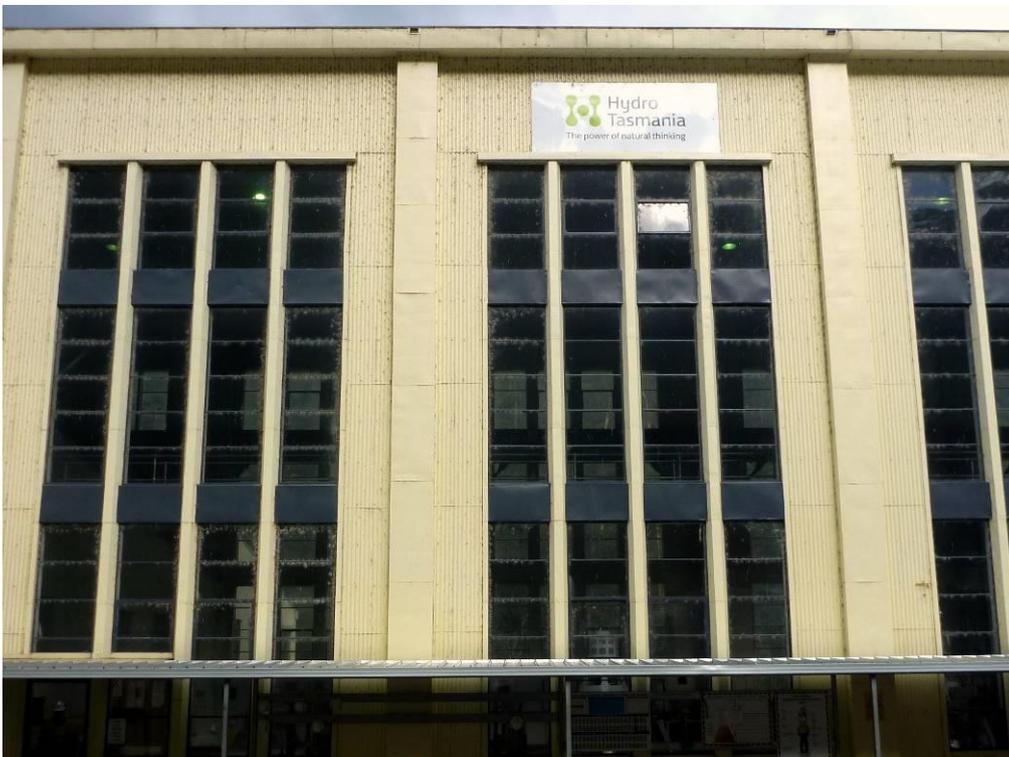
Figure D.4 View showing the northeastern face of the exterior of the main bay with the new Hydro Tasmania sign installed.

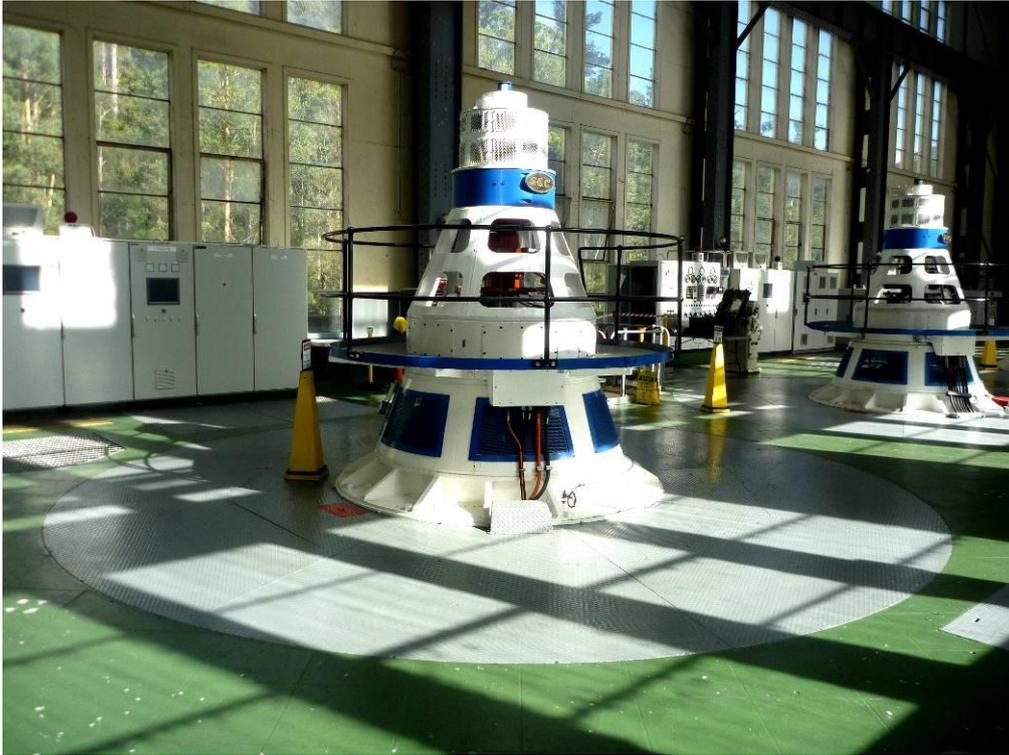
Figure D.5 View to the west showing the exciter cover for Machine 4, in the foreground, and Machine 3 after refurbishment.

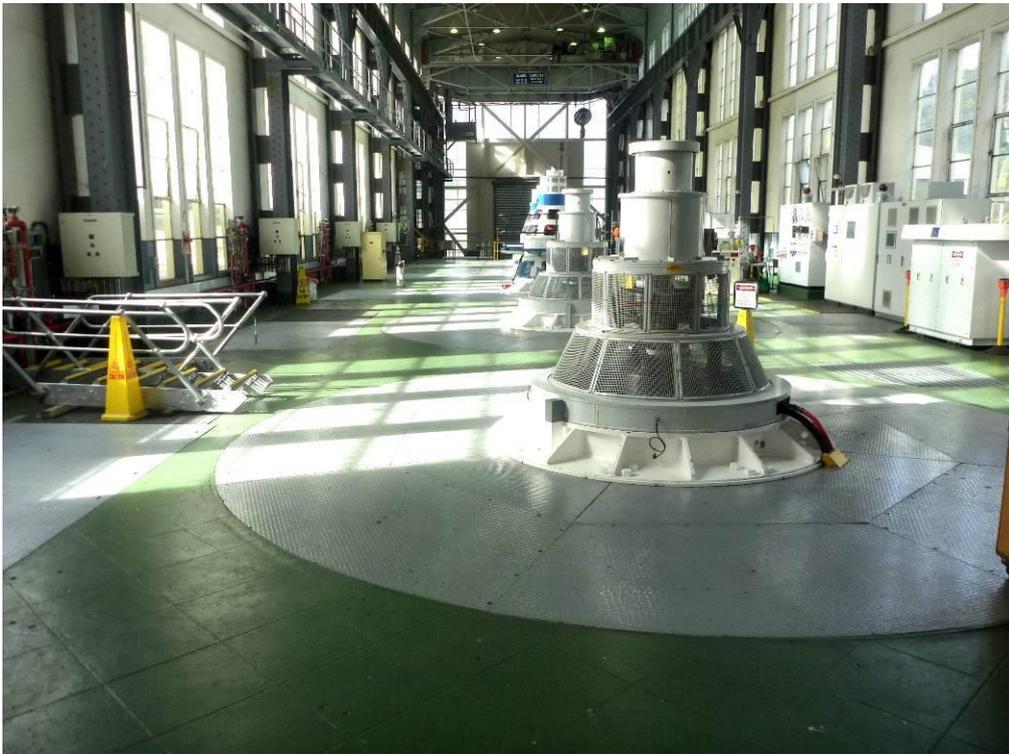
Figure D.6 View to the southwest showing the newly installed exciter for Machine 1 in the foreground and the other turbines behind

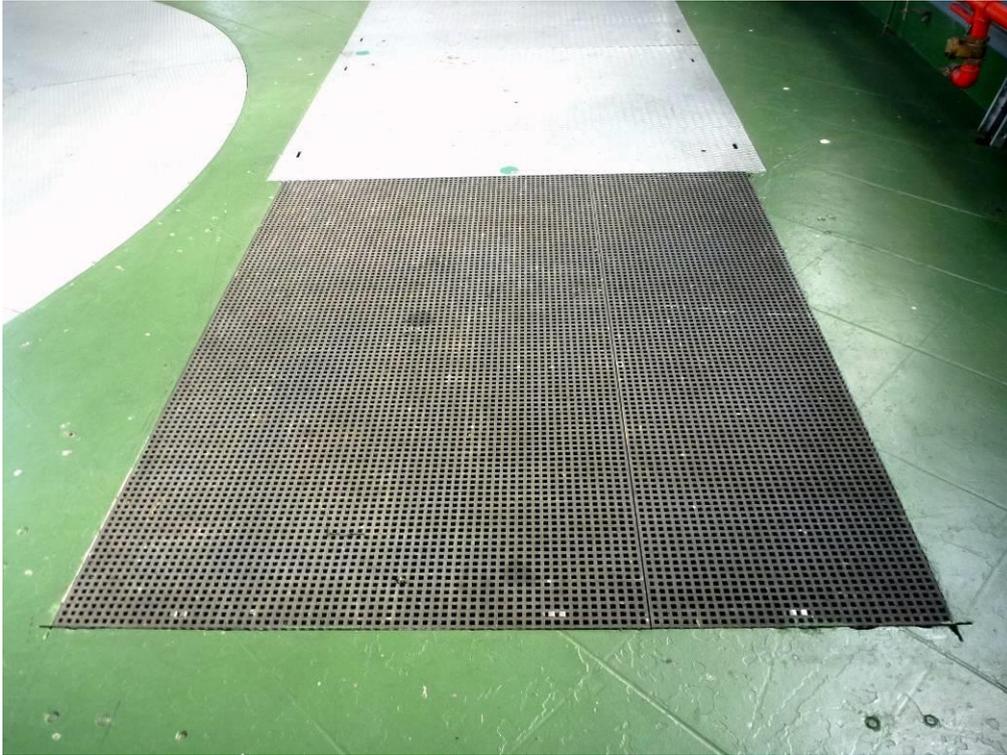
Figure D.7 View to the northeast showing the fibreglass panel installed after the widening of the access to the lower level

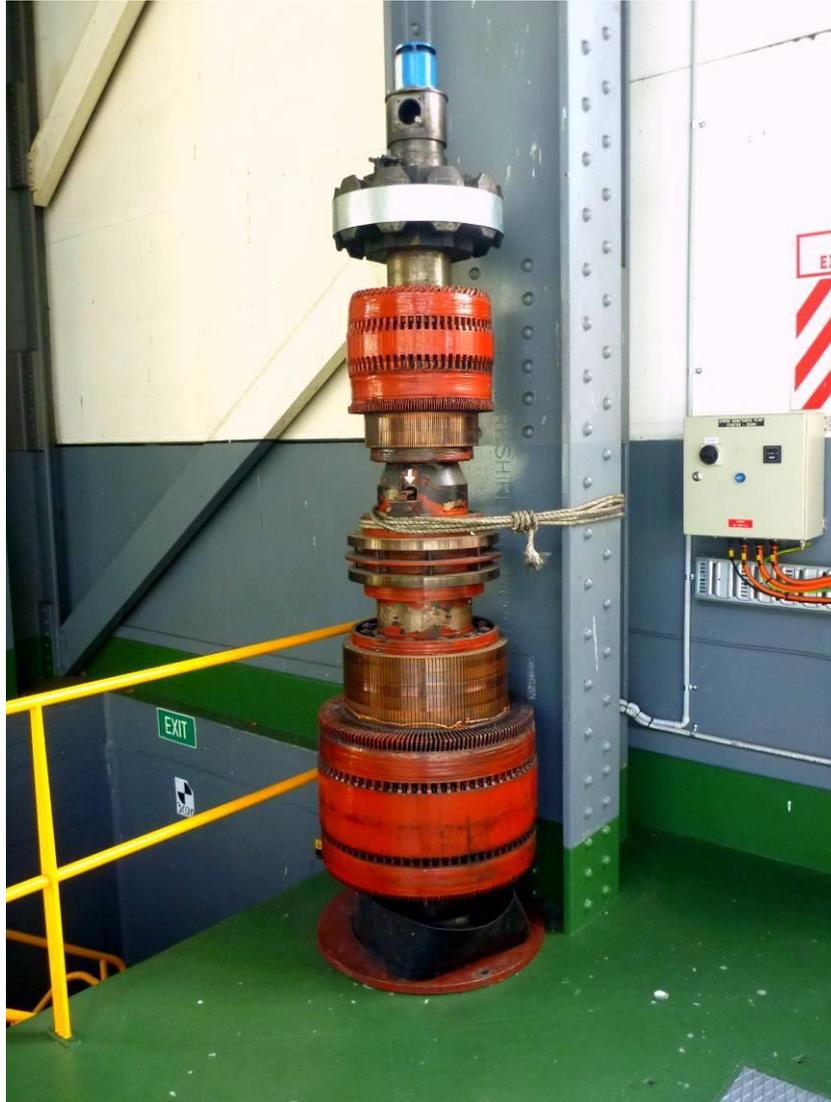
Figure D.8 View to the north of the exciter removed from an unspecified turbine but kept on generator floor.

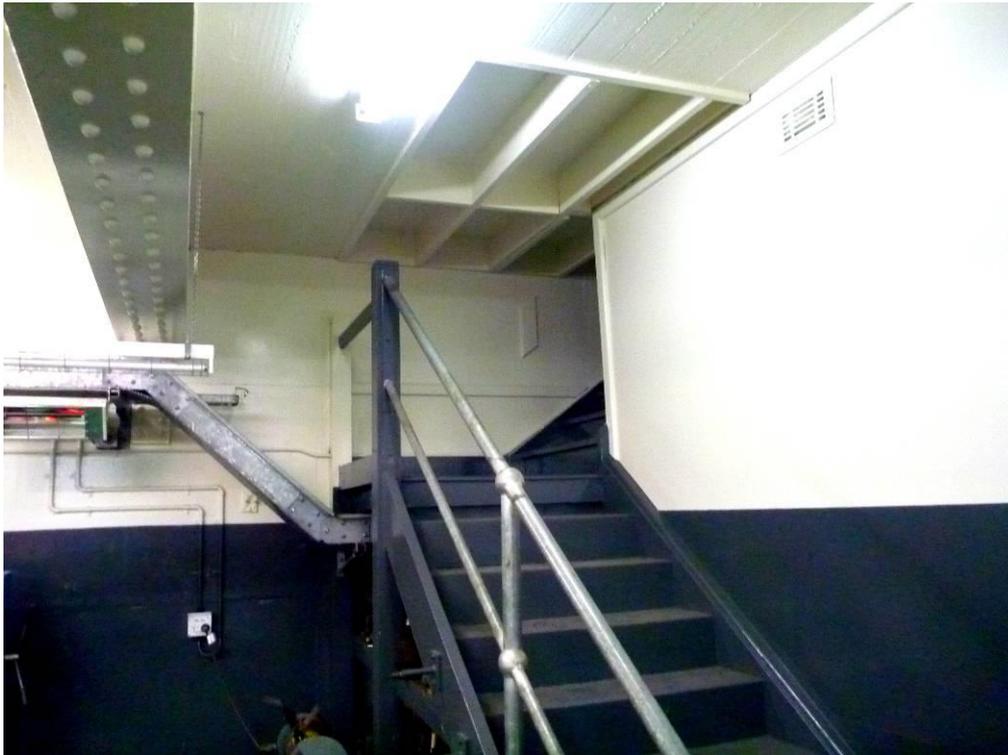
Figure D.9 View to the north showing the location of the blocked off stairway from the workshop to the former gasket room.

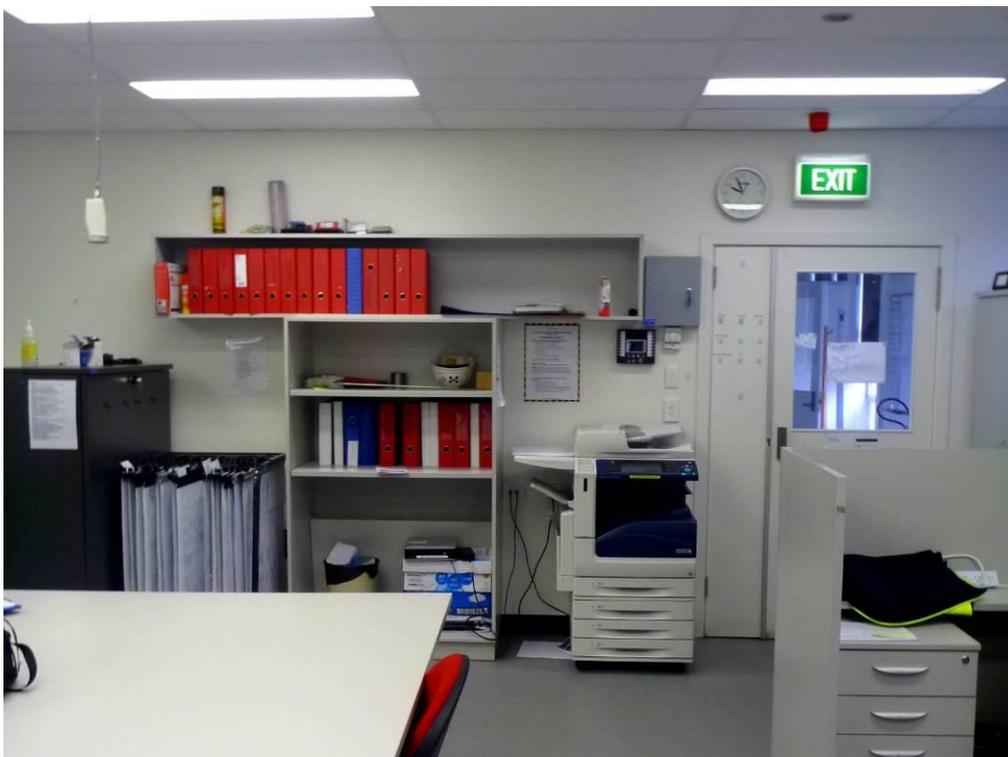
Figure D.10 Looking to the northeast showing the refitted gasket room, now offices. In the centre of the photograph is the location of the former door to the gasket room store.

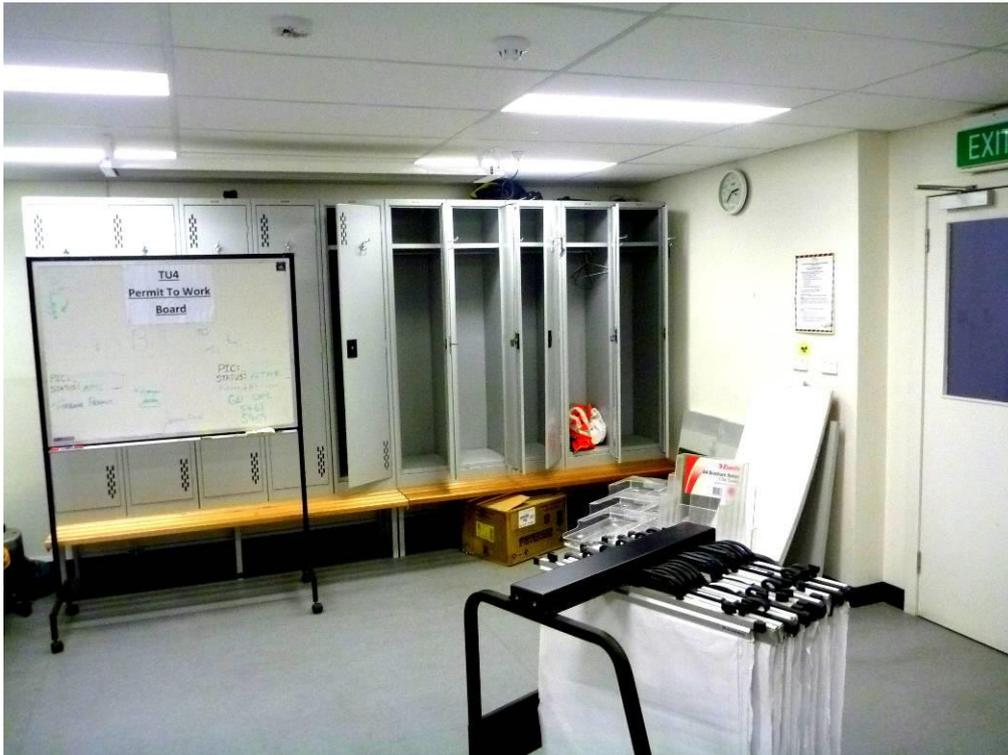
Figure D.11 View to the south showing the interior of the gasket room store after being refitted as a locker and change room.

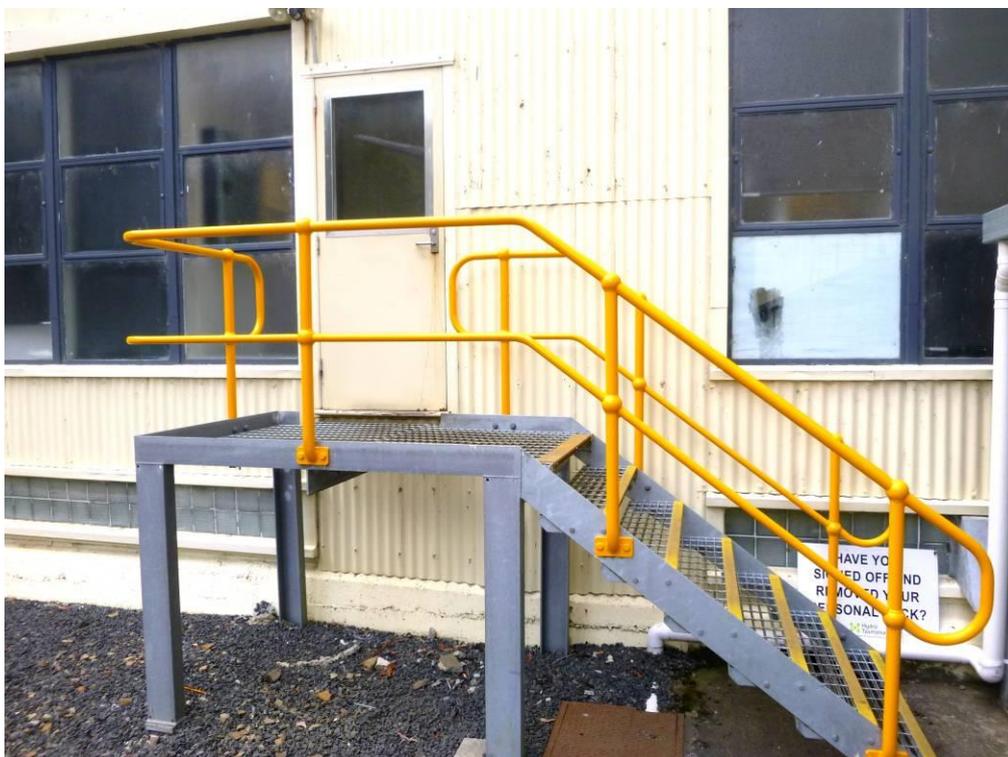
A hardboard partition has been constructed in this hallway near to the entrance from the main bay, to create a small annex near this door. A set of external stairs, which stand free of the building itself, have been constructed on the outside of this space (see Figure D.12) and a new doorway has been cut into the exterior wall. The interior has been refitted and repainted and a new water service installed.

Figure D.12 View to the southwest showing the exterior stairs and door added to the exterior of the west wing and entering into the refurbished first floor hallway.
