# Mersey-Forth Water Management Review

TECHNICAL AND SOCIAL STUDY

2013

## Land Rehabilitation at Lake Mackenzie

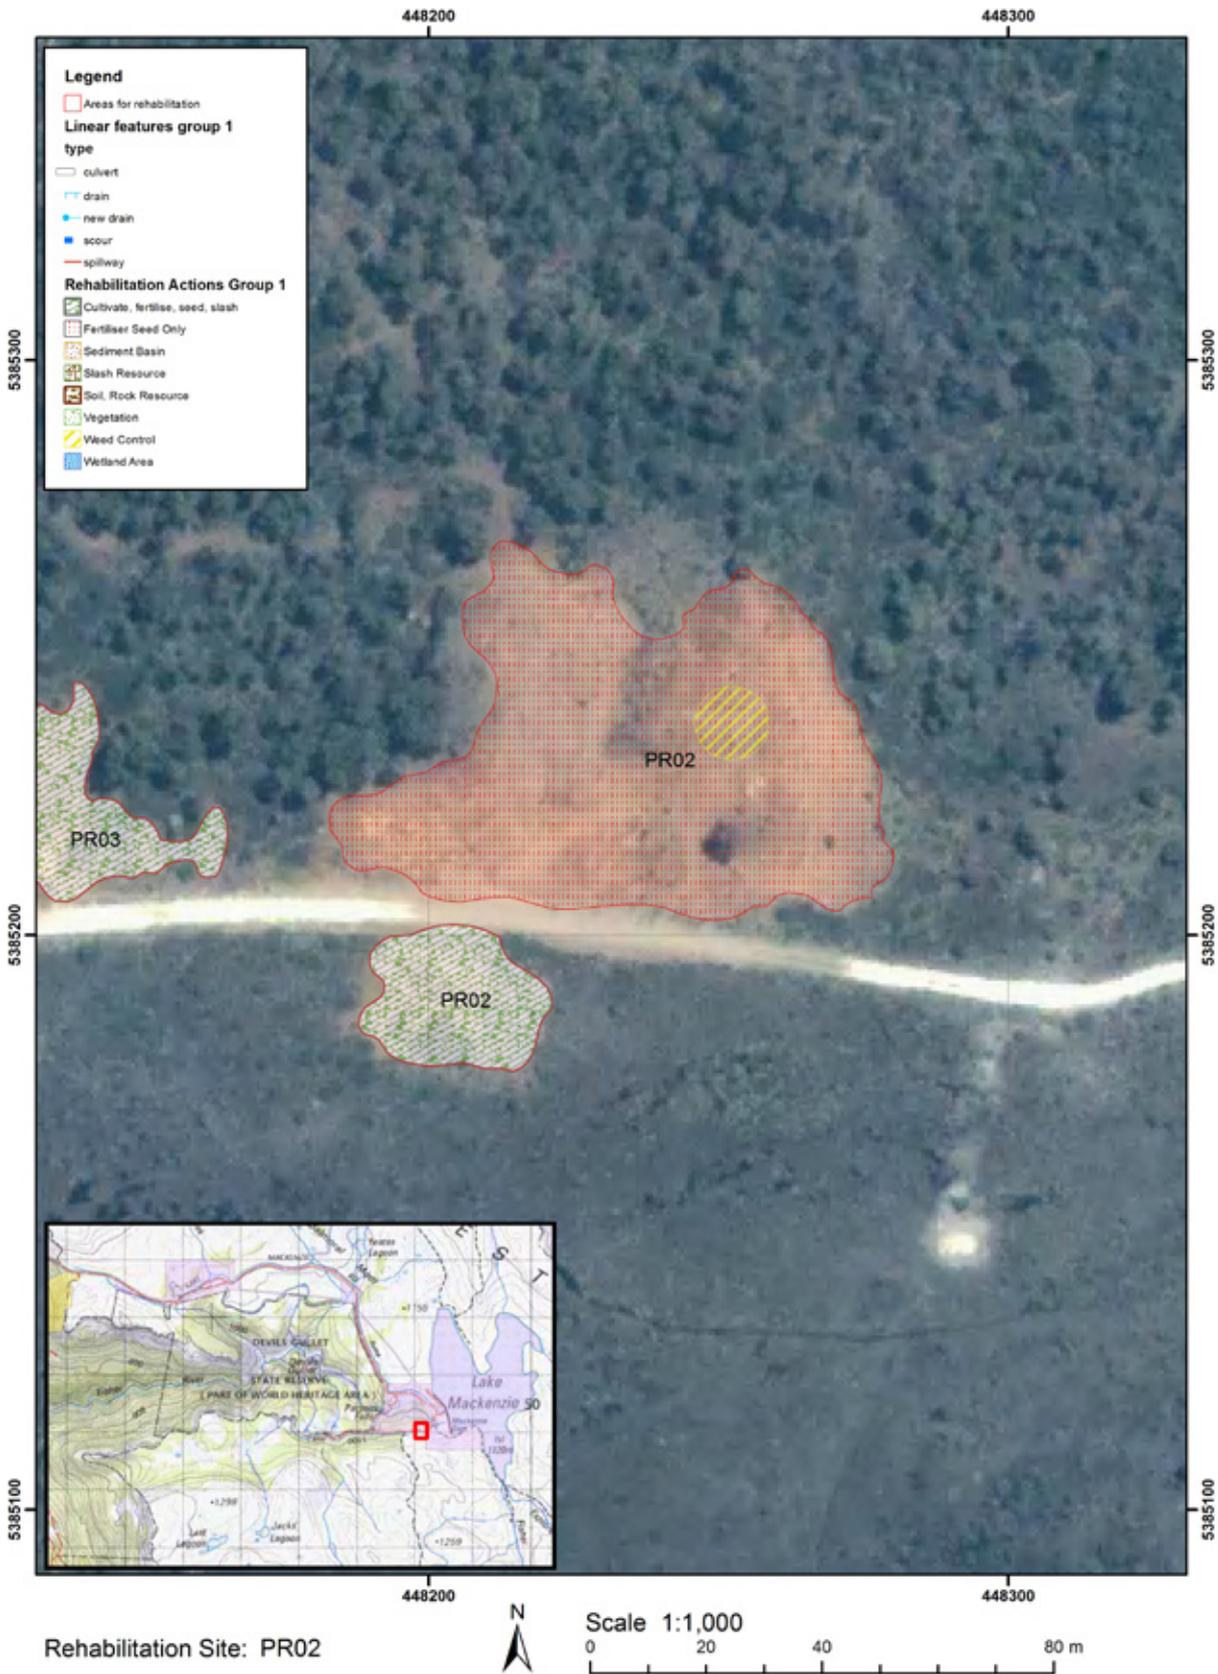
Map D.1: Rehabilitation Site PR02

Two introduced weed species were observed in the vicinity of sites for rehabilitation. Ragwort (*Senecio jacobaea*) was observed occasionally along the roadside but not within sites to be rehabilitated. Spear thistle (*Cirsium vulgare*) rosettes were observed on the northern side of the road at Parsons Road #2 site (PR02 see Map D.1 in Appendix D).
