# Annual Environmental Review Report

(Reporting Period 1<sup>st</sup> April 2019 to 31<sup>st</sup> March 2020)

## TAMAR VALLEY POWER STATION

PREPARED FOR  
AETV POWER PTY LTD

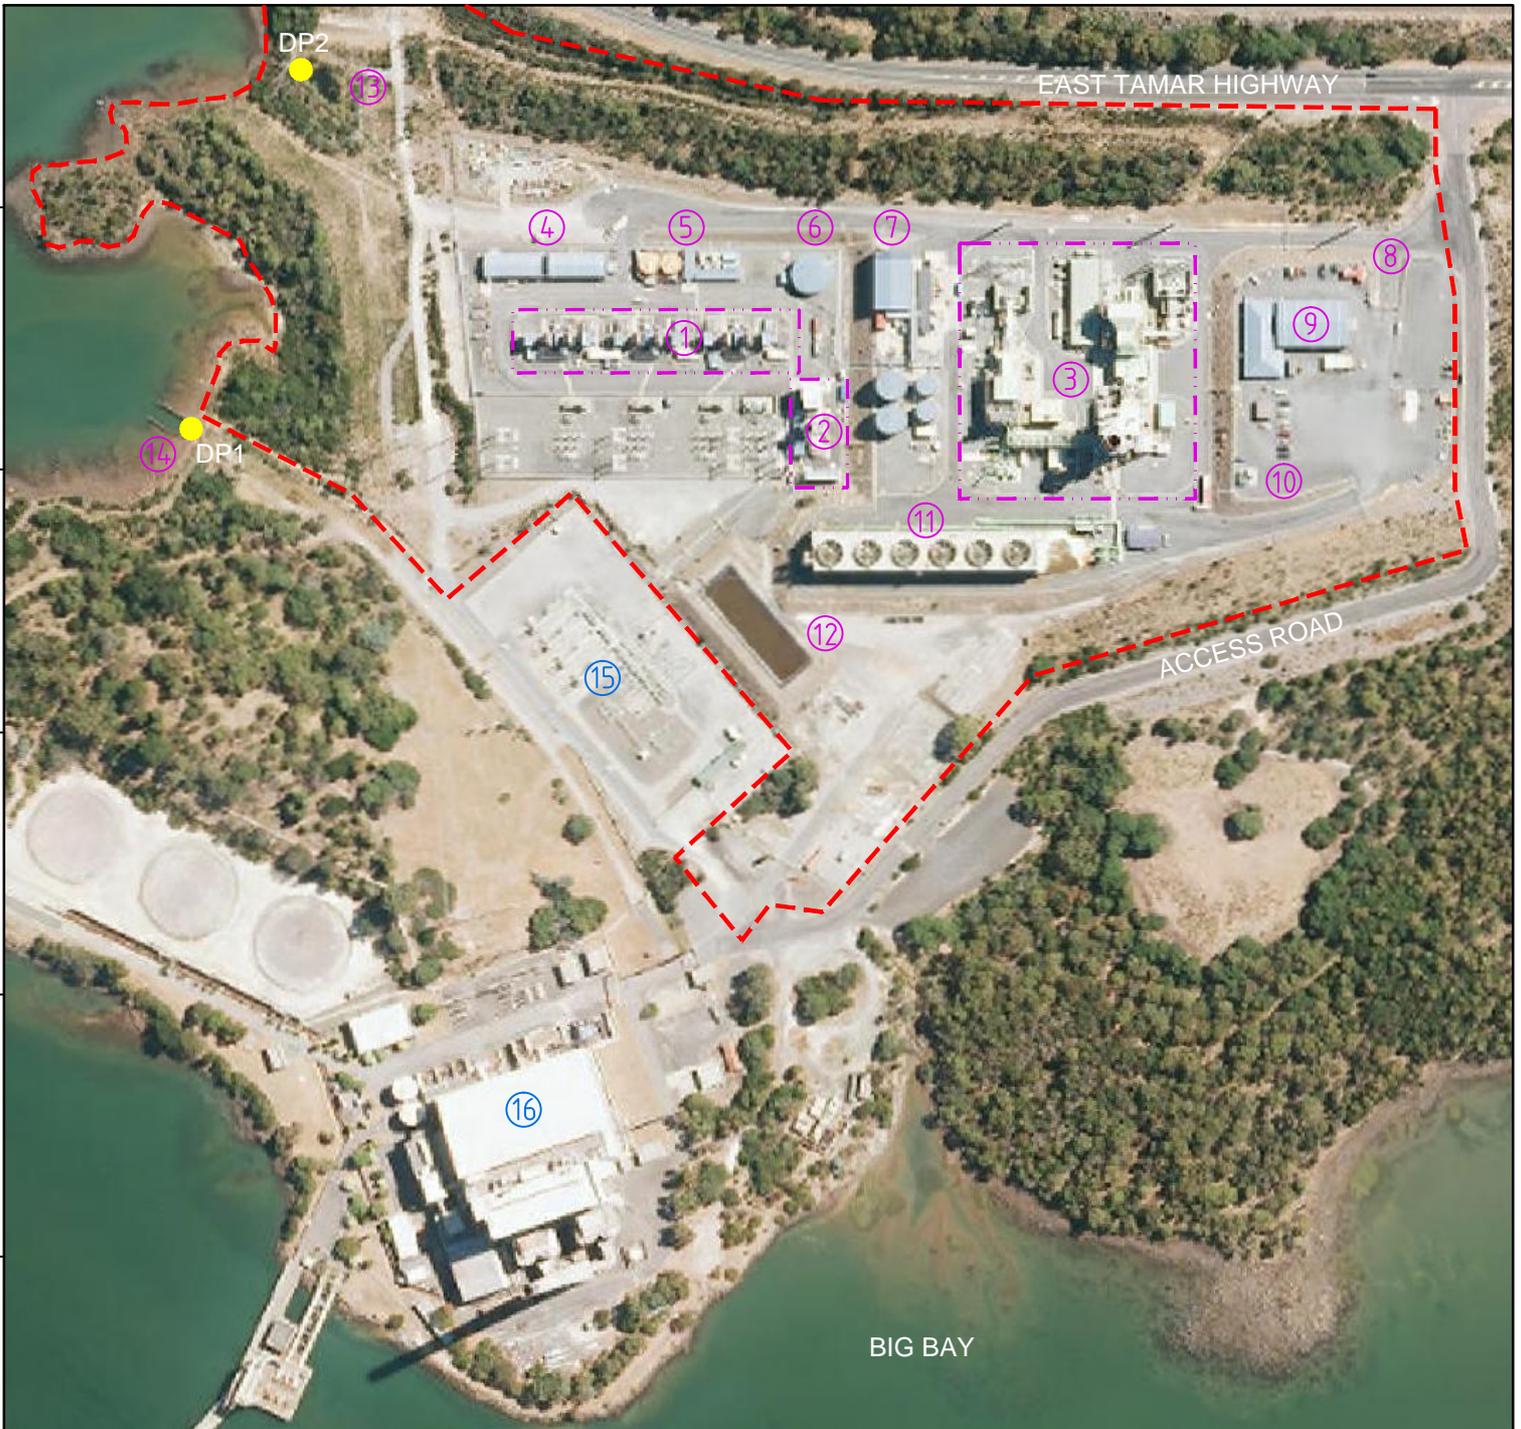
- ① PRATT & WHITNEY OPEN CYCLE GAS TURBINE (OCGT), FT8's (PEAKING PLANT)
- ② ROLLS ROYCE TRENT OPEN CYCLE GAS TURBINE (OCGT)
- ③ MITSUBISHI COMBINED CYCLE GAS TURBINE (CCGT) & HEAT RECOVERY STEAM GENERATOR (HRSG)
- ④ WORKSHOPS
- ⑤ CHEMICAL STORAGE
- ⑥ WATER STORAGE
- ⑦ WATER TREATMENT PLANT

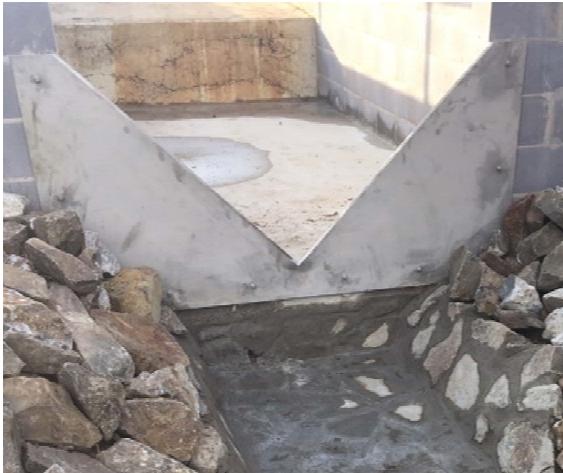
**Plate 1: V-notched weir on stormwater discharge point DP2**

- Installation of a v-notched weir to enable measurement of discharge flow (Plate 1);
- Installation of monitoring equipment with telemetry system to connect with the existing supervisory control and data acquisition (SCADA) system (Plate 2); and
- Improvements to discharge outfall channel.

Sampling stormwater from the rip rap at DP2 was difficult under low flow conditions and there was no mechanism in place for measurement of flow rate. To address this, AETV undertook improvements to the stormwater pond discharge point (DP2) during the period February to April 2020, comprising:

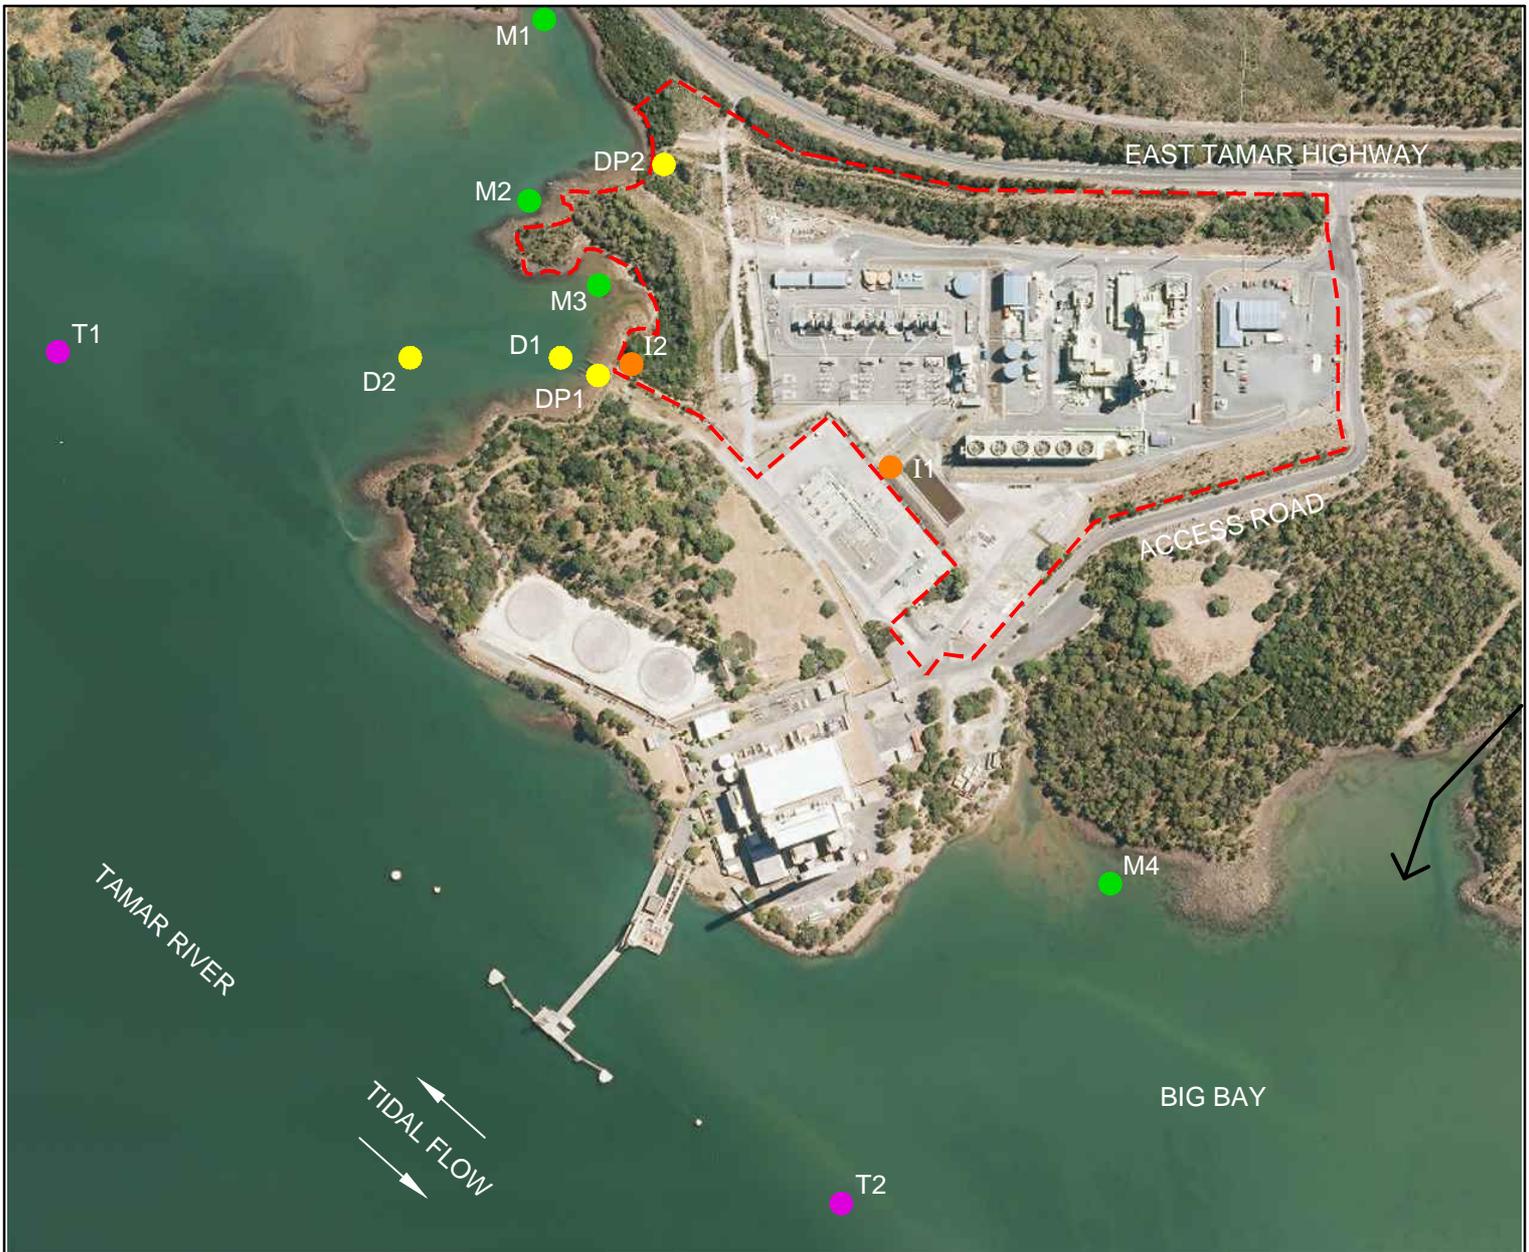
- DP ● DISCHARGE POINT WATER QUALITY MONITORING SITE
- D ● WATER QUALITY MONITORING SITES
- M ● NEAR SHORE AMBIENT WATER QUALITY
- T ● TAMAR RIVER MONITORING LOCATIONS T1 & T2 (NO LONGER REQUIRED TO BE MONITORED)
- T ● INLINE WATER QUALITY MONITORING SITES (I1 - INLINE AT WWRP, I2 - INLINE AT SUMP)
- AMBIENT DIFFUSE & POINT SOURCES OF CONTAMINATION
- - - OPERATIONAL SITE BOUNDARY

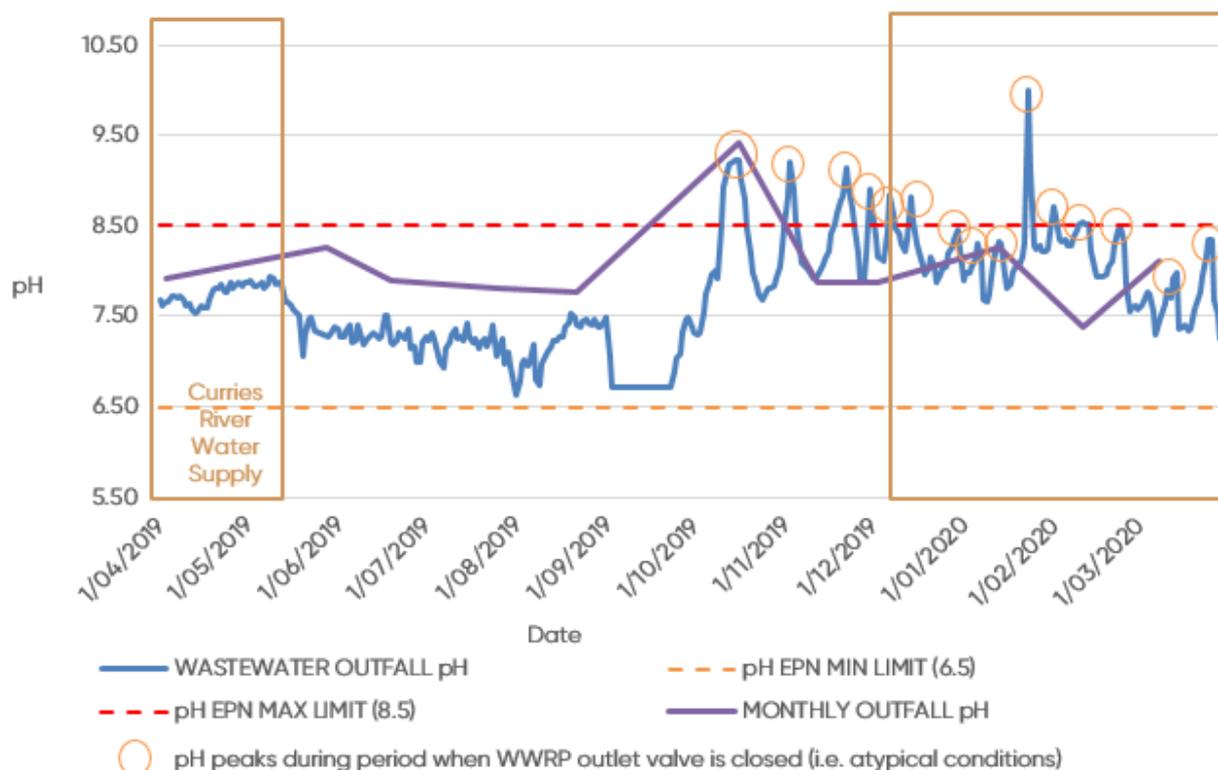
Figure 4: Comparison of daily inline and monthly outfall (DP1) pH levels

Under normal operating conditions, the following daily inline pH readings were recorded to have been outside of the EPN range of 6.5 to 8.5 pH units in the days prior to (and resulting in the need for) manual closure of the WWRP outlet valve (as summarised in Table 2):

- 10, 11 and 12 October 2019 (pH 8.93, 9.09 and 9.18 pH units respectively);
- 18 and 19 November 2019 (pH 8.52 and 8.62 pH units respectively); and
- 10 and 11 February 2020 (pH 8.52 and 8.54 pH units respectively) (alkaline pH was recorded for both daily and monthly inline pH readings on 11 February 2020).

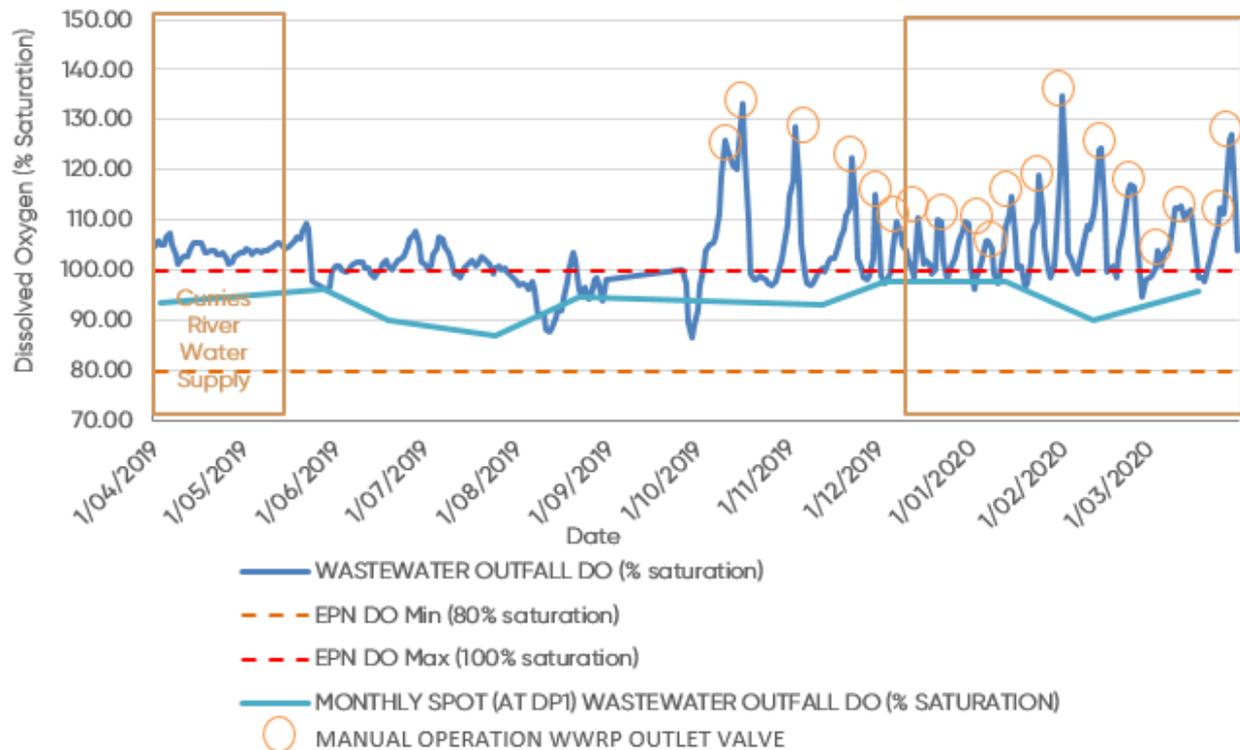
Figure 5: Daily DO inline and grab (at DP1) in wastewater discharge (% saturation)

Note that there were no values for the period 1 to 24 September 2019 shown in Figure 5, as this was when the WWRP had been drained during the maintenance shutdown.

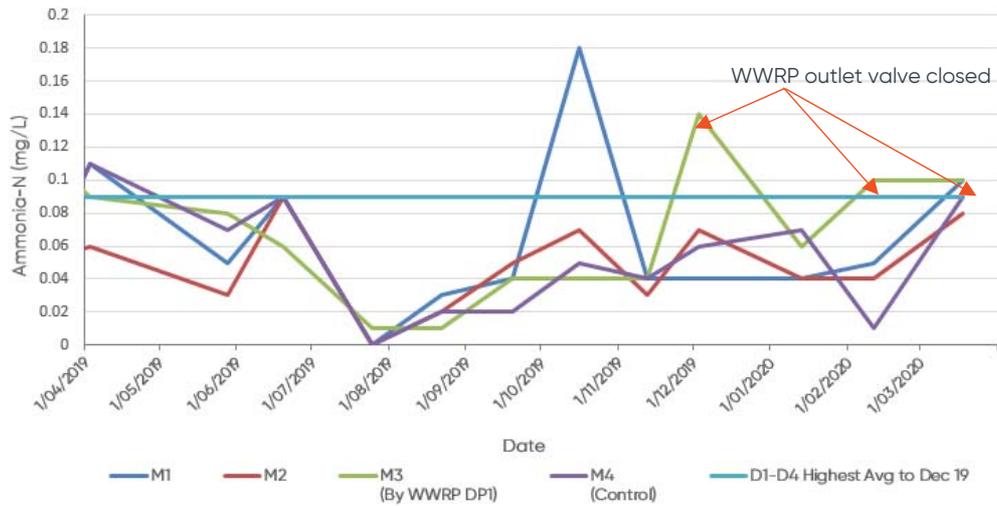
**Figure 11: Near shore ammonia-N concentrations compared to DB concentrations**

DP1 discharge WQ was compliant for ammonia-N concentrations for 11 of the 12 monthly results, with an elevated concentration (0.98 mg/L compared to EPN limit of 0.5 mg/L) recorded on 28 May 2019. In the absence of a TEER TL, the calculated average for historical DB monitoring results across all monitoring sites (D1-D4) to December 2019 was adopted for comparison. The M3 result on this occasion was still under the highest average ambient result for D1 to D4 results, so was considered not to have adversely impacted on the health of DB. A summary of NS analysis results is provided in Appendix G6.

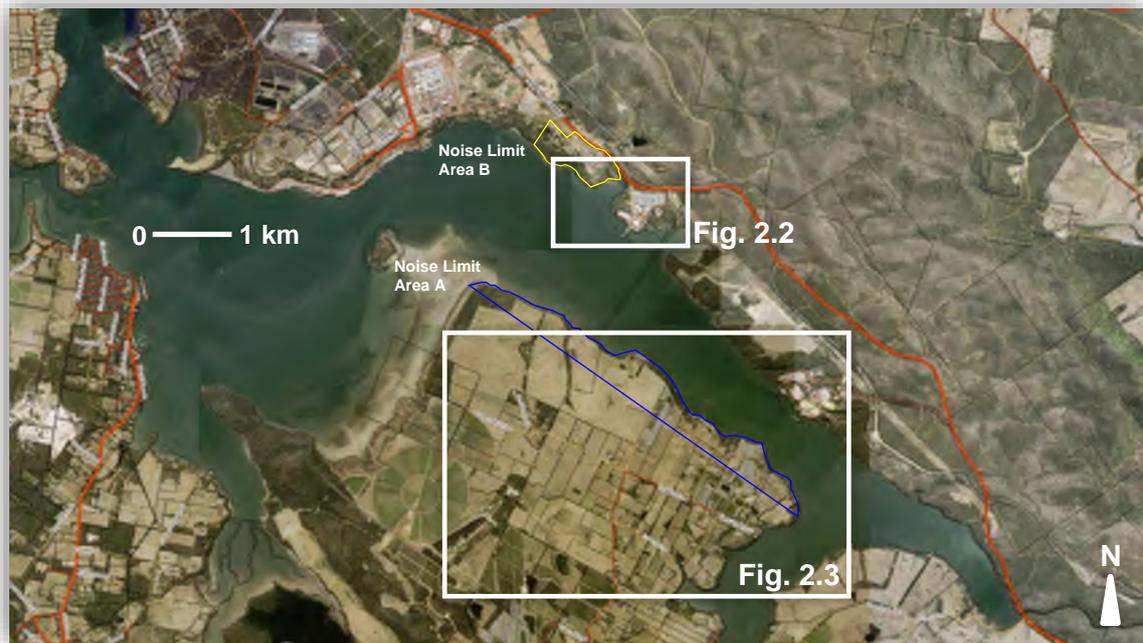
Figure 2-1: Aerial view of the TVPS and surrounds with the extent of figures 2.2 and 2.3 marked.

Table 2-1 presents the noise measurement position locations with those locations that are noise sensitive premises shaded in orange (the noise measurement positions were as utilised in previous surveys of the power station<sup>[1][2]</sup>). Figures 2-1 to 2-3 are aerial views of the power station site with the measurement positions clearly marked along with noise limit areas designated in the sites EPN.

3. For the purpose of these conditions '**Noise Limit Area A**' is defined as the area bounded by the low water mark of the Tamar River and a straight line joining Point Rapid to Middle Point (*in blue on figures 2-1 and 2-3 above*).

5. For these conditions '**Noise Limit Area B**' is defined as PID 2954828, George Town Golf Course (*in yellow on figures 2-1 and 2-2 above*).
6. If the combined level of noise from the activity and the normal ambient noise exceeds the noise levels specified above, this condition will not be considered to be breached unless the noise emissions from the activity are audible and exceed the ambient noise level by at least 5 dB(A).

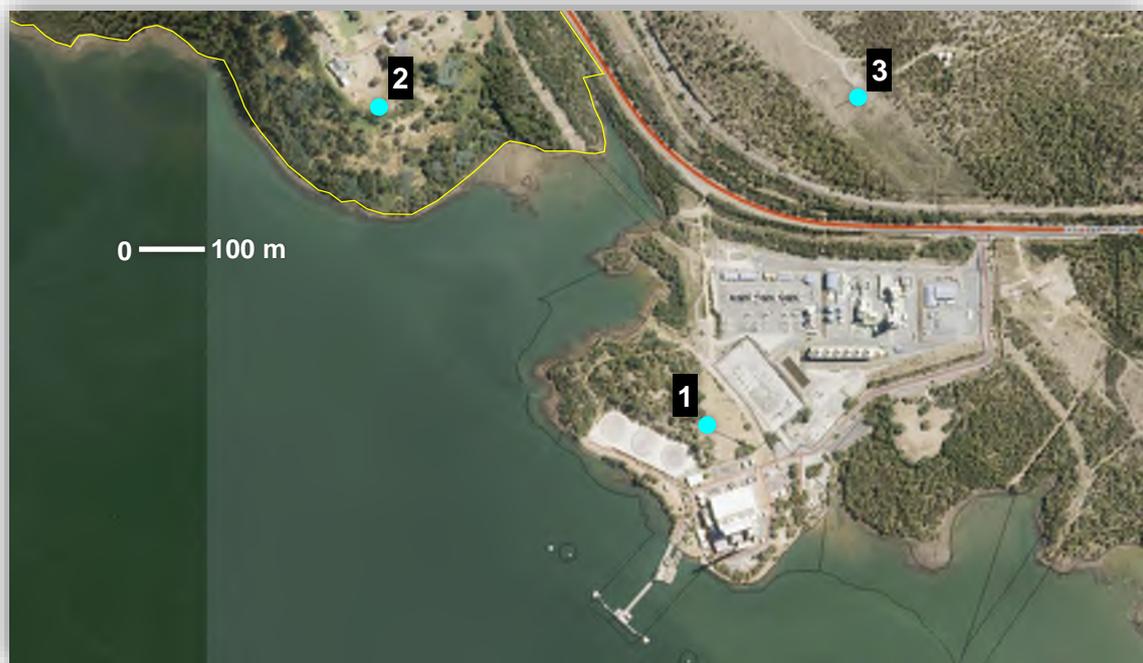
Figure 2-2: Aerial view of environmental noise survey positions 1-3.

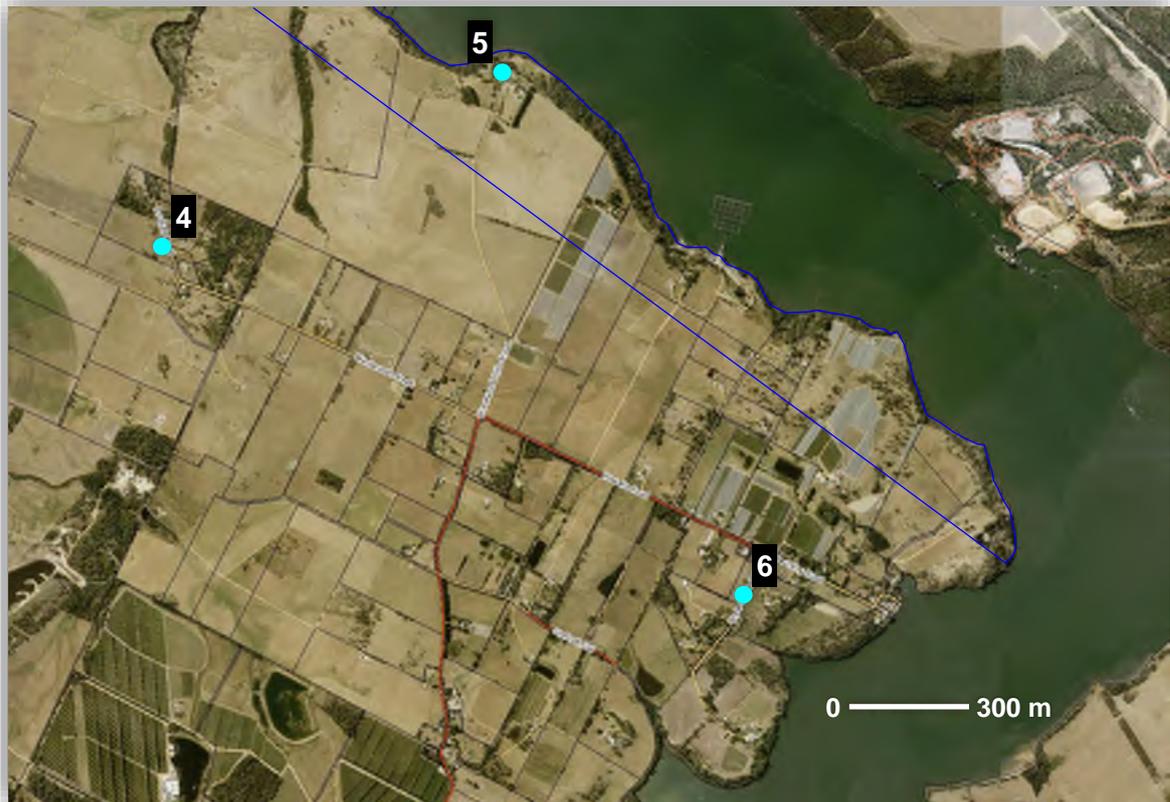
Figure 2-3: Aerial view of environmental noise survey positions 4-6.

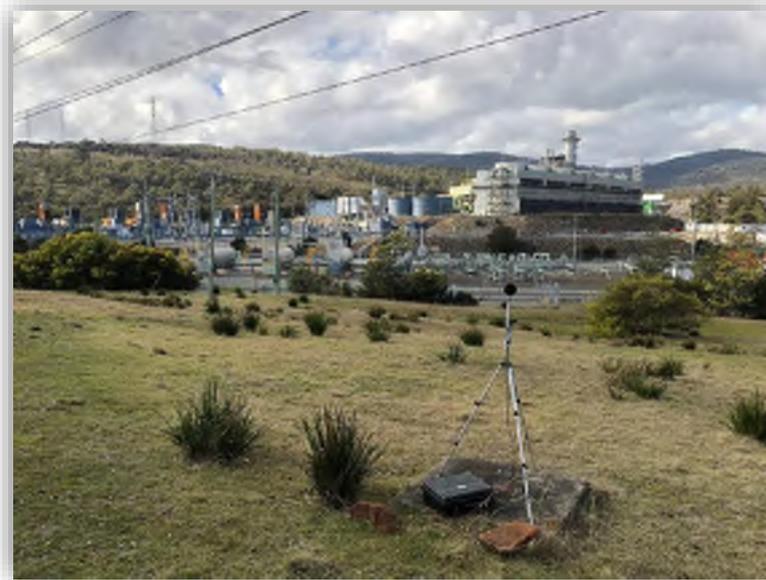
Figure 5-1: Position 1 (Archive photo).

Position 1 is near the permanent monitoring station situated within the old Bell Bay power station.

Day and evening  $L_{Aeq}$  levels were dominated by local emissions from the plant with external traffic along the East Tamar audible at times. At night, the noise environment remained relatively unchanged. A strong tone at 348 Hz was audible and measurable and originates from a gearmesh frequency within the cooling tower fan gearbox's.

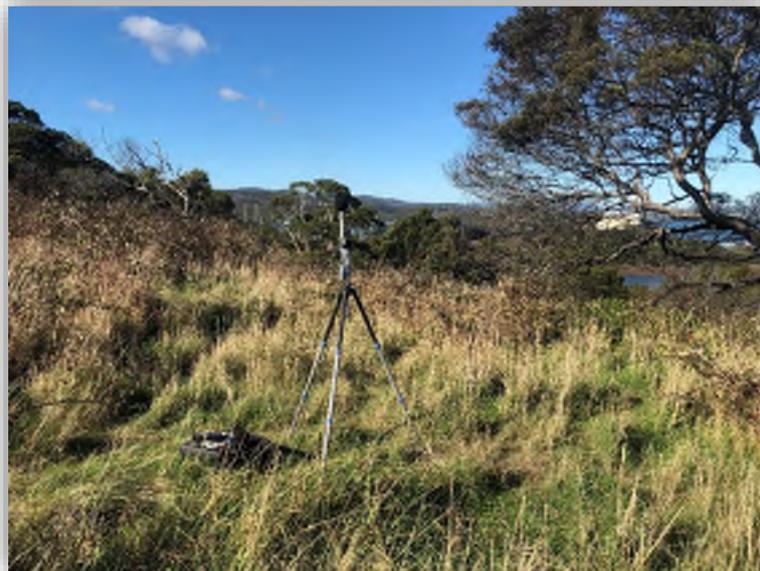
Figure 5-4: Position 2.

The day noise environment was dominated by East Tamar Hwy traffic with emissions from a chipper in Bell Bay and train transiting the nearby Bell Bay Line contributing also audible. Both broadband flow noise and tones were audible from the power station.

During the evening traffic noise remained significant while low frequency emissions from the Bell Bay industrial area contributed to background levels. At night, as traffic subsided, the TVPS controlled the noise environment with a 100 Hz tone particularly noticeable.

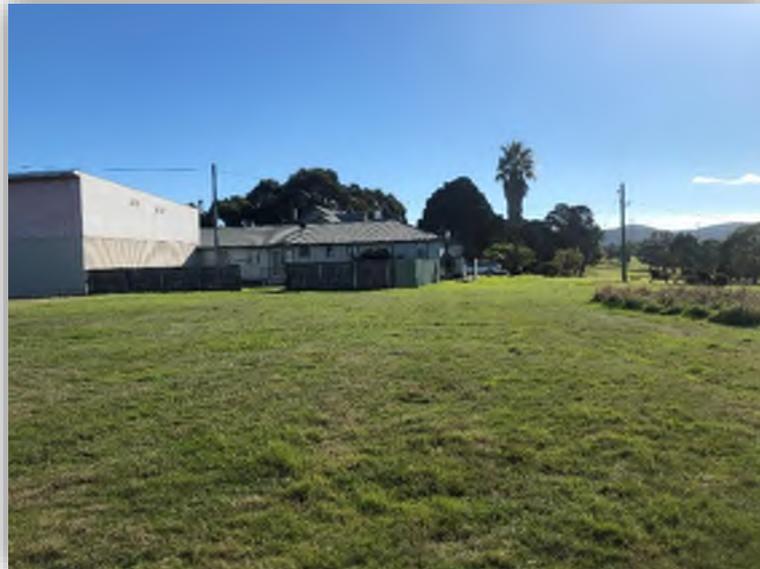
Figure 5-7: Position 2A (Along apartment boundary fence)

At this location emissions from the TVPS were dominant and controlled the noise environment with traffic along the East Tamar Highway the only audible external source. A low frequency rumble and tone could be heard along with a broadband flow noise from the cooling towers.

An additional measurement was taken at the apartment fence boundary where topographic shielding was responsible for a reduction in measured levels.

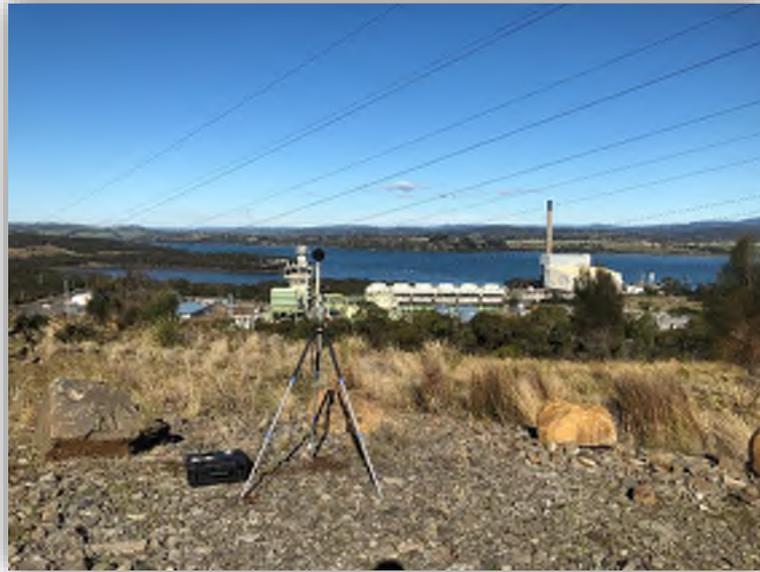
Figure 5-10: Position 3.

Position 3 is approx. 300 m north of the TVPS on elevated land overlooking the power station in the Tipogree foothills.

Noise emissions levels at this location was unchanged throughout the three measurement periods. Activity from nearby construction work was audible during the day but didn't elevate measured noise levels. Tones from the gearbox driving the cooling fans and broadband noise from the cooling towers were significant as was a low frequency rumble.

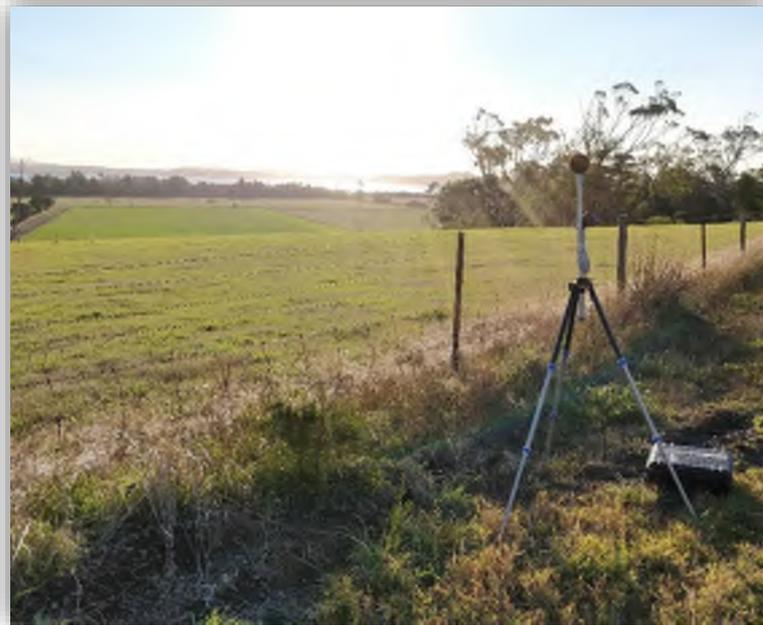
Figure 5-13: Position 4.

Day measurements were elevated by localised noise sources with a nearby domestic ploughing machine controlling the noise environment. During periods in the plougher’s absence, fan tones from the Bell Bay industrial area became noticeable while the power station remained inaudible.

During the evening and night, the power station was faintly audible with emissions from the Bell Bay industrial area dominant. Local fauna and backing alarms from the Long Reach chipping plant were also audible during the night.

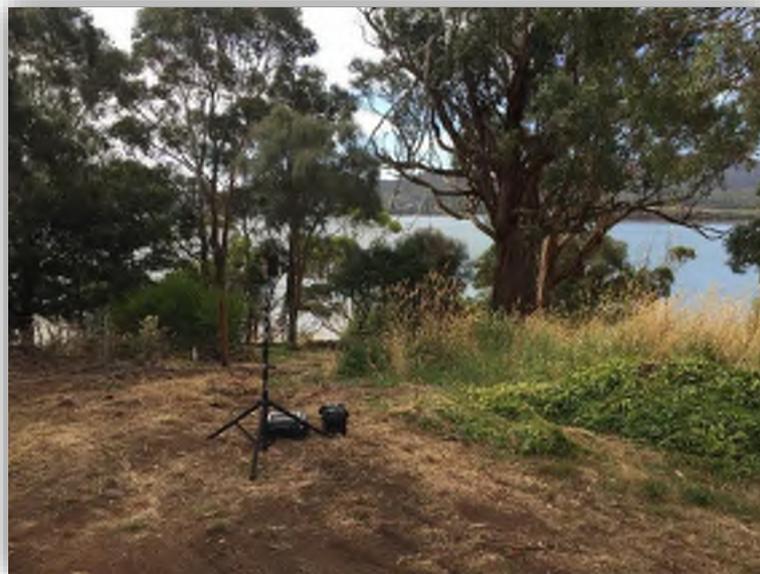
Figure 5-16: Position 5 (Archive photo).

At night nearby, sheep passing through thick foliage was noticeable while fan tones from Bell Bay and the chipper at Long Reach were also audible.

During the evening and night, an occasional low frequency roar from the TVPS became audible for short periods.

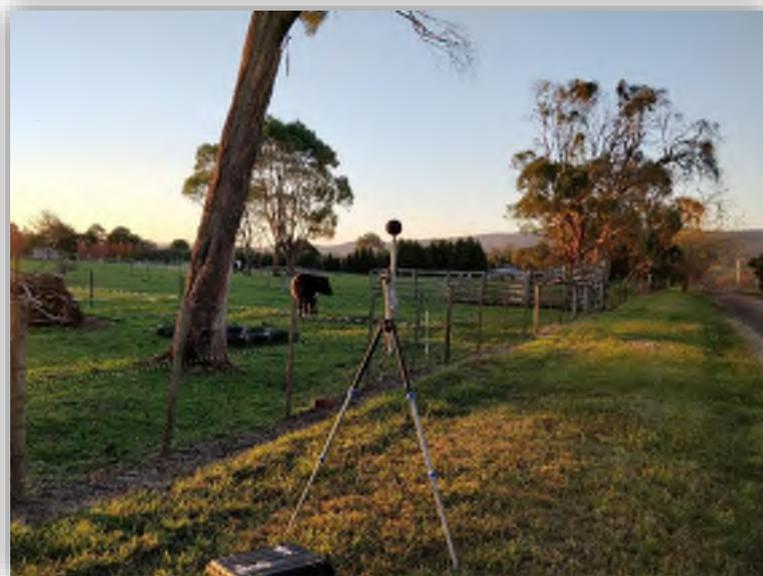
Figure 5-21: Position 6.

The noise environment during the day at this location was dominated by local noise sources including persistent chainsaw activity. In the absence of these sources, chipping operations at the Long Reach chip mill controlled background levels while the TVPS was inaudible.

During the evening and night cooling fans from the TVPS were faintly audible, however, activity from the Long Reach chip mill was dominant.
