# TARRALEAH POWER STATION

## Conservation Management Plan

Prepared by  
**Austral Archaeology Pty Ltd (David Parham) & Ian Terry**

Hydro Tasmania

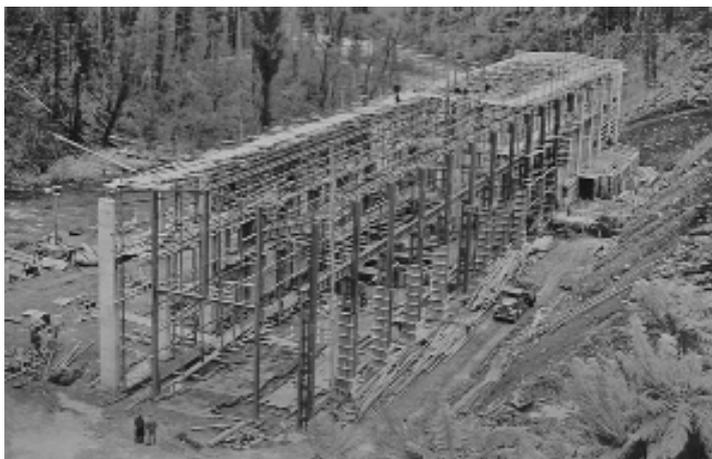
**Figure 5: c1935 view of steel framing of power station (HEC collection).**

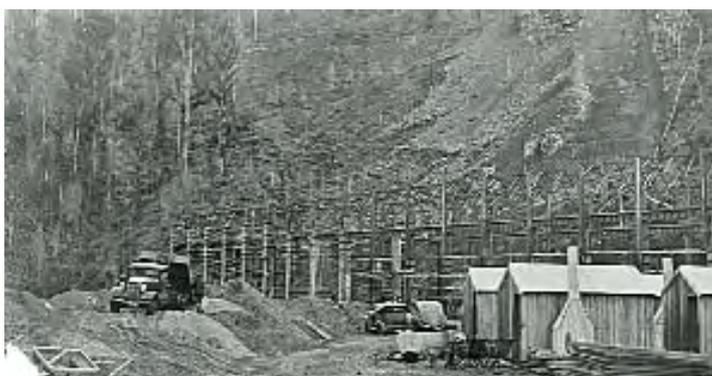
**Figure 6: c1935 view of steel frame of power station erected with hillside behind cleared for penstock and temporary vertical board huts in foreground (HEC collection).**

Photographs indicate that temporary timber buildings were built at the power station site to provide site offices and accommodation, workshops and crib rooms (Figure 6).

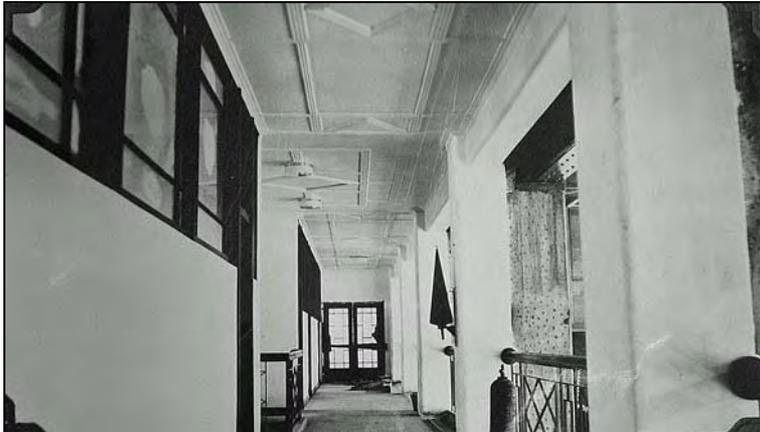
Figure 11: Open passageway outside mezzanine floor offices. Note the railings and ceiling (HEC collection).

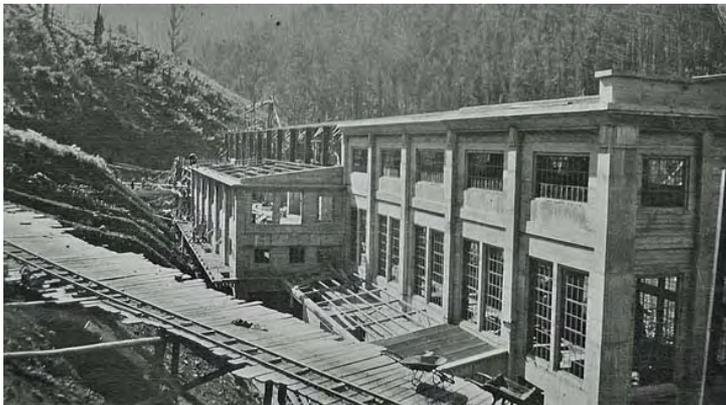
**Figure 14: c1935-36 view of rear of power station under construction showing tramway (Cyril Young Collection, AOT- NS1938/145c).**

Although much of the work was done with pick and shovel and there were few cars or trucks at Tarraleah, construction of the scheme was more mechanised than earlier schemes at Waddamana and Shannon. Nonetheless there were only eight cars and 27 trucks in the area in 1935 as well as tramways and a haulageway (Figures 13 & 14). Other construction infrastructure included a sawmill, fitting and turning shops, blacksmiths, six mechanical excavators, compressors and pumping equipment, and a steel fabrication plant where Hume Steel fabricated the steel pipes for the penstock.<sup>36</sup> By June 1936 most of the turbines, alternators, transformers and other mechanical and structural material had been received at Hobart with some of it consigned to the construction site.<sup>37</sup> Almost all of the plant was imported from European manufacturers.

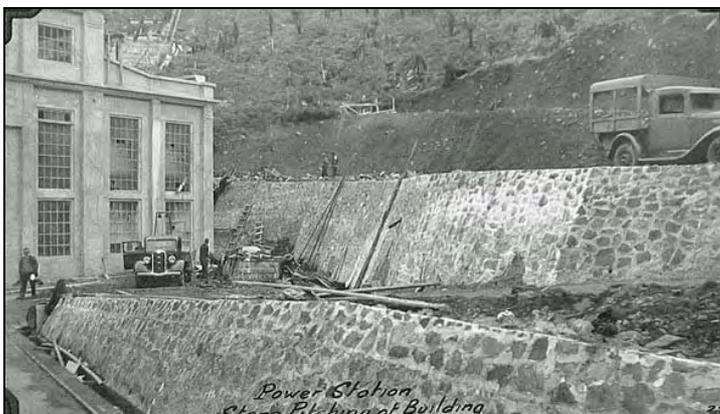
**Figure 15: Stone retaining walls built at the front of the power station. Similar walls were built along the river bank (HEC collection).**

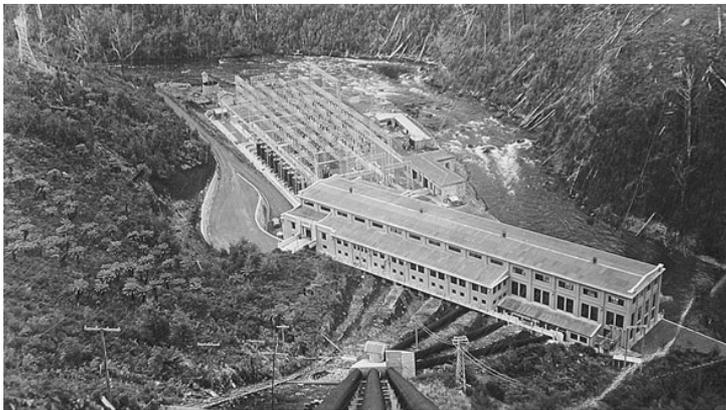
**Figure 17: View of power station and switchyard soon after opening showing penstock, excavations for three more penstocks and the workshop/store adjacent to the switchyard (HEC collection).**

A single storey workshop with blacksmiths' and carpenters' shops as well as garage and store were located adjacent to the switchyard (Figure 12). The workshop was damaged in a flood in 1939 with the blacksmith's wing washed away and rebuilt

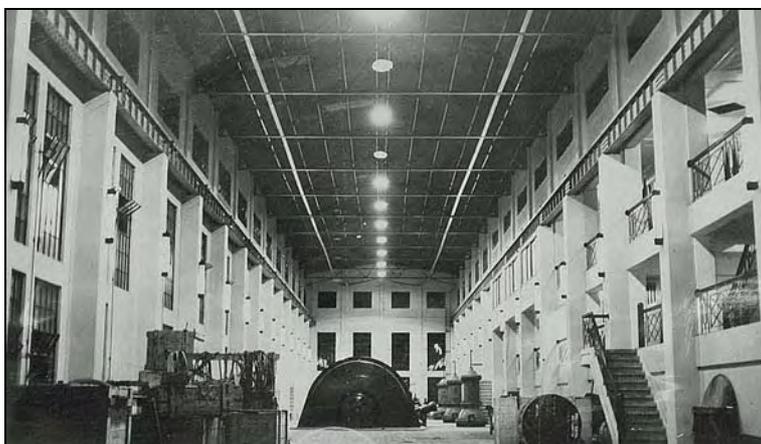
Figure 21: Interior of power station in c1938. Note railings and stairs (HEC collection).

The power station itself had a concrete floored main chamber, which initially accommodated the three generators, as well as rooms on the western side on the ground and mezzanine floors (Figures 21 & 31). On the ground floor were an auxiliary room at the southern end, with a terminal room adjacent, then battery room, a room for motor generator sets, a supervisory equipment room, a stairwell and storage space followed by a room of transformer cubicles and lastly, at the northern end, a store. A workshop was located at the north western corner of the building. Upstairs there were, from the northern end, a landing and entrance vestibule, then a series of three offices followed by toilets over the stairwell, the District Operating Superintendent's office, a Shift Engineer's office (later reduced in size and converted to a control room annex) and the large control room with windows giving out to the machines and a stairway at its southern end adjacent to a small room housing AC and DC switchboards.<sup>33</sup> There was a passageway with railings outside the mezzanine offices (Figure 4). The offices and passageway were notable for their fine Art Deco styling and parquet floor (Figures 9 - 11). Rubber mats were laid on the floor in the control room. There was a workshop at the north eastern end of the building.

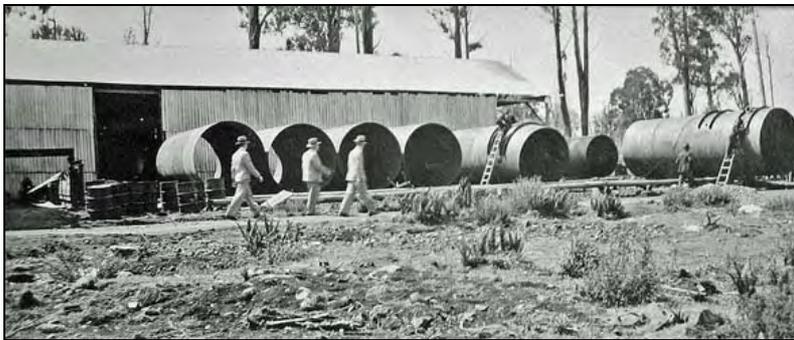
**Figure 24: Hume Steel Pty Ltd steel fabrication plant at Tarraleah in 1936-37 (Cyril Young Collection, AOT - NS1938/114).**

Concrete open canals and fluming conveyed the water from the storage pond to the forebay where it entered a steel pipeline, which was fabricated at Tarraleah by Hume Steel Company and electrically welded together in situ (Figures 24 & 25). This pipeline was 1.6 miles (2.5kms) long and 102 inches (2.6m) wide. A surge tank (145ft [44.2m] high and 18ft [5.5m] in diameter) was erected part way along the hilltop penstock (Figure 26). A valve house with three 5 foot (1.5m) valves erected at the top of the hillside penstocks regulated the flow of water from one pipeline to three

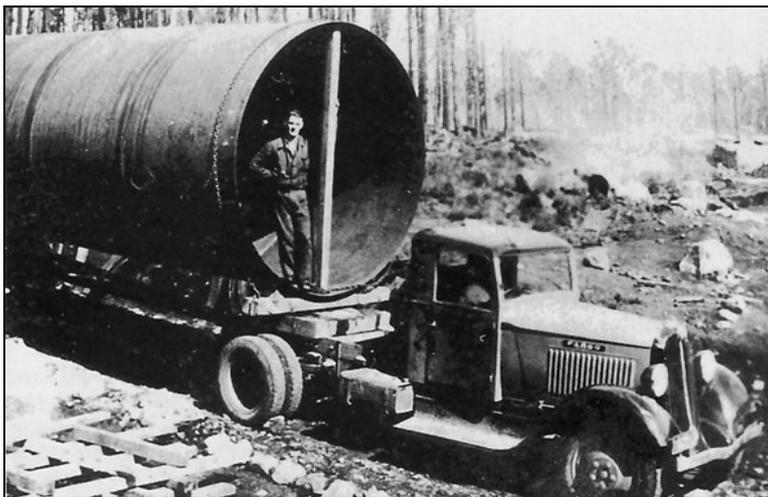
**Figure 25: Section of 102 inch pipe being transported to hilltop penstock (HEC collection, reproduced in Marwood, p. 48).**

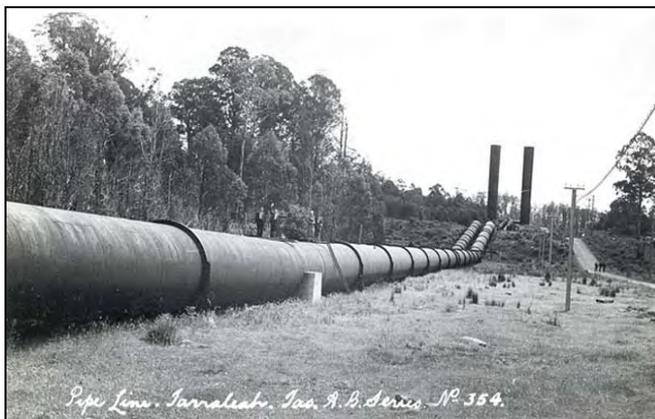
Figure 30: Pipeline and twin surge tanks in the 1940s (Tasmaniana Library postcard collection).

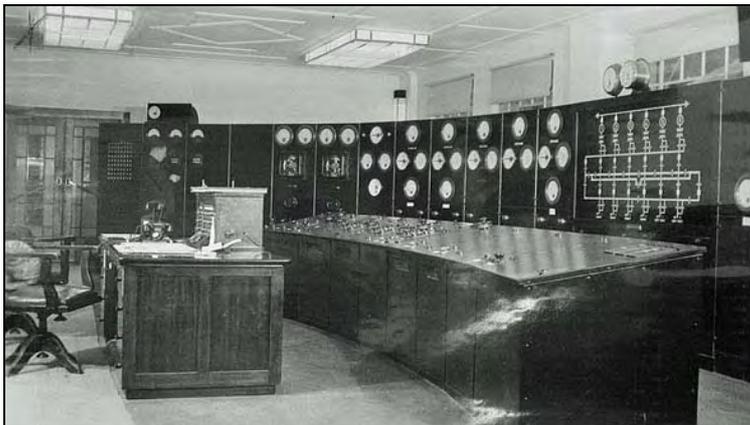
**Figure 36: Control room at Tarraleah in c1950 (HEC collection).**

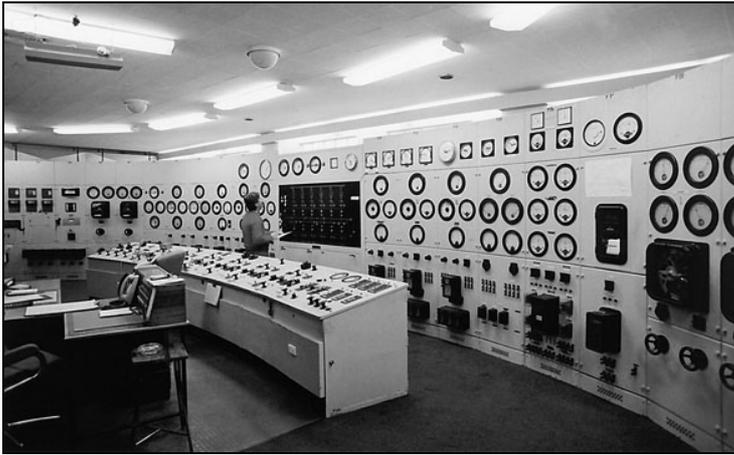
**Figure 38: Control room in the late twentieth century. Note the altered ceiling (HEC collection).**

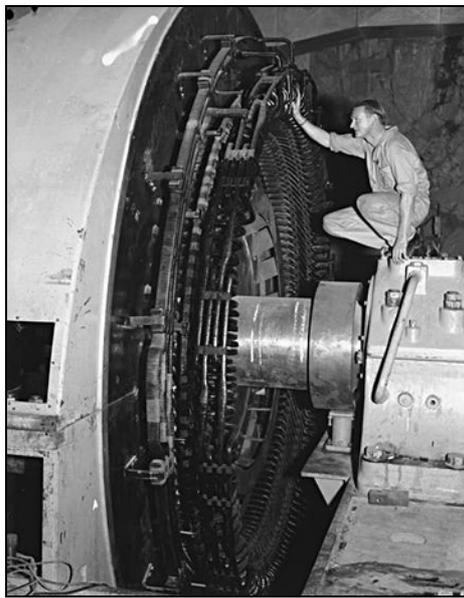
**Figure 39: Maintenance of turbine during the 1950s (Frank Hurley photograph held by NLA — <http://nla.gov.au/nla.pic-an2396718>).**

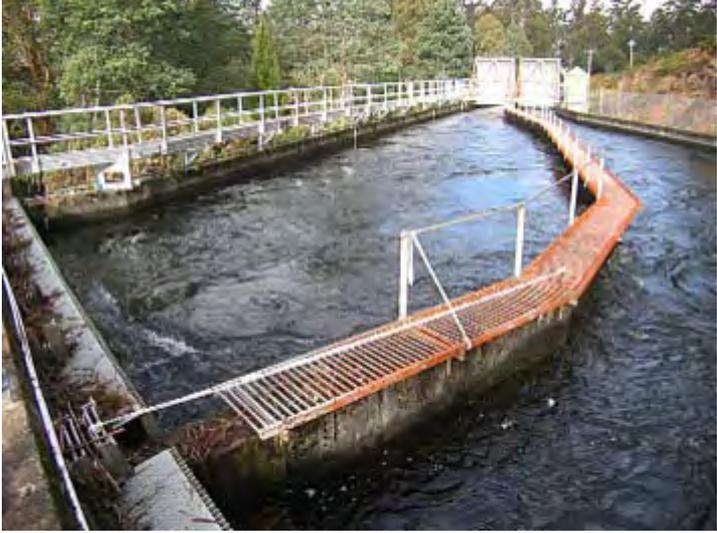
<p><b>Description</b></p> <p>The forebay is located where water coursing down the canal, at this point divided, passes through trash racks (installed in the mid 1990s<sup>105</sup>) and enters a portal that houses the two hilltop pipelines that trend eastwards <i>en route</i> to the hilltop valve house. The trash racks are serviced by an automated weed cleaner that travels along an overhead gantry. The rakes formerly used to clear obstructions lie in close proximity.</p> <p>A centrally situated gangway constitutes the original maintenance access to a pair of radial gates located approximately 20 metres south of the portal. The central gangway has been replaced by a new railed walkway which runs along the eastern side of the canal. A spillway is also located to the north-east of the radial gates. This is all part of the control mechanisms that enable the system to be incrementally shut down.</p> <p>A stack and instrumentation affixed to the headwall of the forebay allows remote monitoring of water levels.</p> <p>Adjacent to the forebay there is a vertical board building over-clad in colorbond™. The two roomed interior has a tent ceiling and is lined with ply wood. It currently houses forebay controls and has reportedly functioned as a weather station although its original purpose is unknown.<sup>106</sup></p>

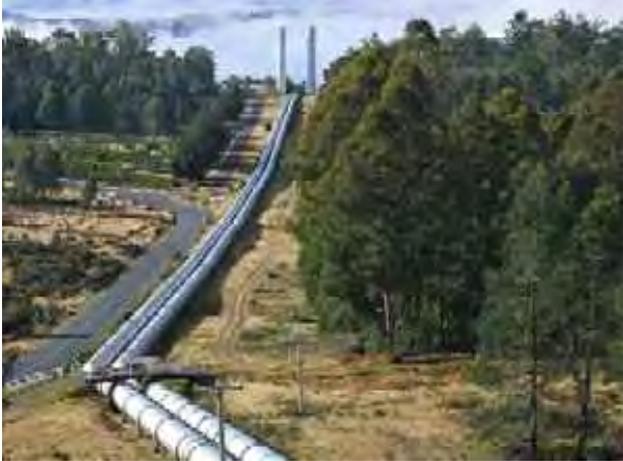
<p><b>Description</b></p> <p>Two pipelines convey water from the forebay to the hilltop valve house. These are referred to as the hilltop pipelines. The pipes, fabricated at Tarraleah and electric welded 'in situ' are 2.6m in diameter and are supported on concrete cradles and/or steel anchors on smaller concrete bases.</p> <p>For much of their extent the silver-grey painted penstocks are located parallel to the road into Tarraleah Village. Mature trees, including conifers, line the grassy verge. The southern-most penstock was part of the original 1937-38 construction whereas its counterpart closest to the road was installed in the early 1940s. Three pairs of "anti-vac" valves (manufactured by Glenfield &amp; Kennedy Ltd, Kilmarnock) are located at high points along the penstocks route. These provide a safeguard against implosion. Valves are also present at points where water is drawn to supply the village, chalet and golf course.</p> <p>A small timber bridge with a gate, timber railings and rubble abutments crosses the penstock below the forebay. The bridge is in poor condition. A second timber decked bridge with stone abutments and concrete and steel is located near the valve house.</p>

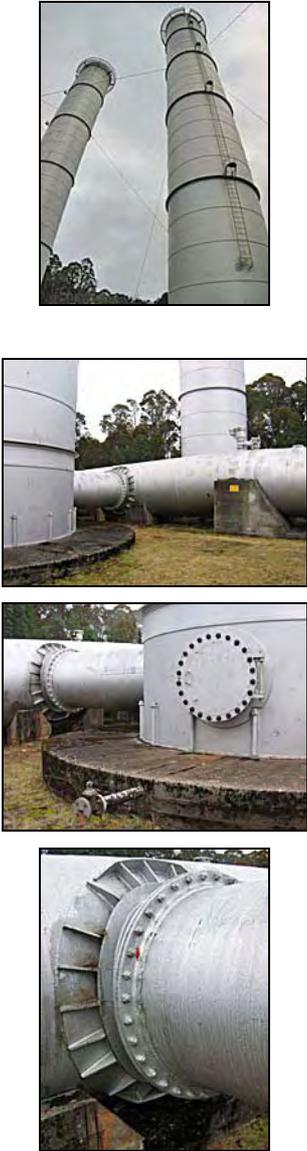
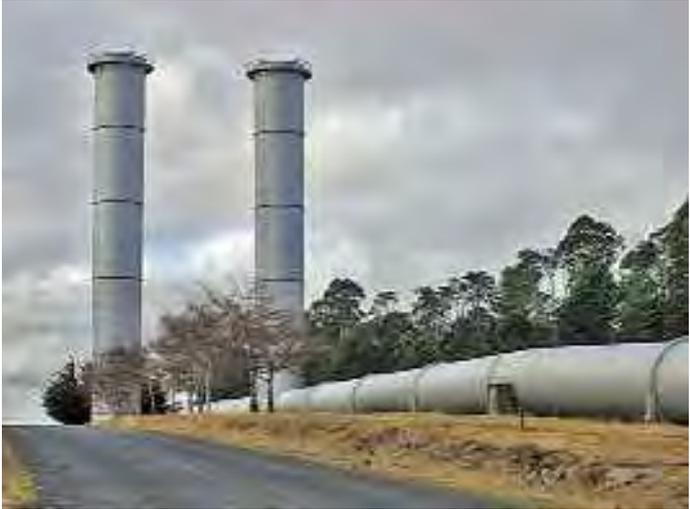
### 3.2.3 Surge Towers

<p><b>Description</b></p> <p>The two steel surge towers, fabricated in Tarraleah and welded 'in situ', are outstanding features that impart a 'gateway' status on the approach to Tarraleah from the south-east.</p> <p>The towers are 141 feet (43m) high, and 19.5 feet (5.94m) at the top tapering to 18 feet (5.49m) at the bottom. They are located on a rise adjacent to the hilltop penstocks and are seated on concrete slab foundations. There are valves and concrete supports on the adjacent pipes. Cable stays provide stability and steel ladders provide external access to their tops.</p> <p>It is unusual to find two surge towers together and their form and height is of high visual and technical significance.</p>	
<p><b>Element</b></p> <p>Setting</p> <p>Surge Towers (including concrete bases, ladders, cables, etc)</p> <p>Valves</p>	<p><b>Significance rating</b></p> <p>very high</p> <p>very high</p> <p>very high</p>

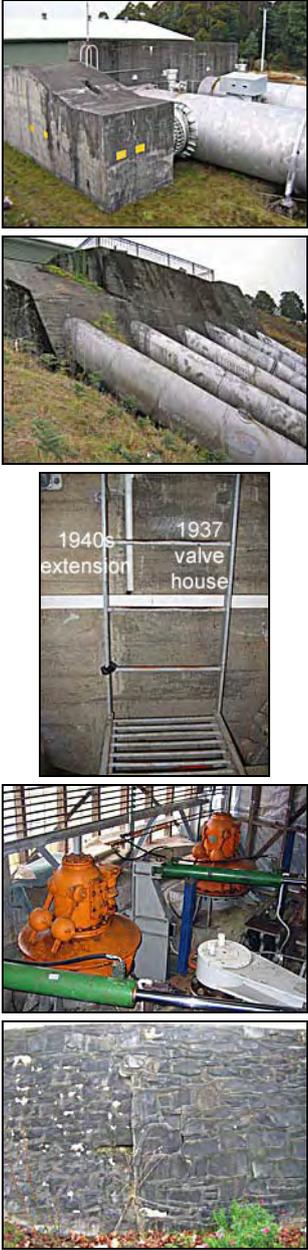
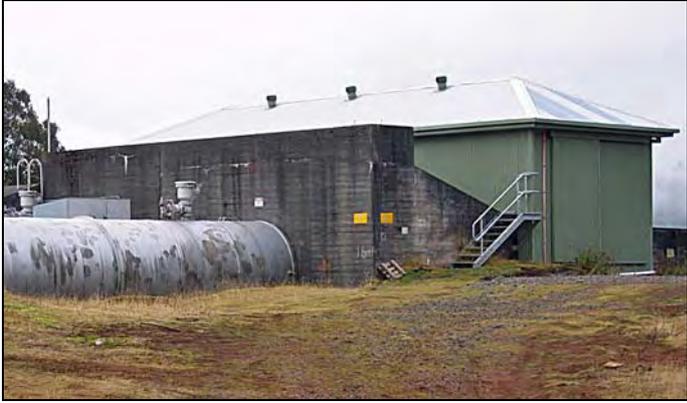
### 3.2.4 Valve House

<p><b>Description</b></p> <p>A hip roofed colorbond™ clad building, originally of timber but reclad in recent years. The building is timber framed with a concrete base and pit containing the valves. There are three roof vents. The original valve house was built to accommodate the transition from the southernmost hilltop pipeline into three hillside penstocks which fed machines 1-3 in the power station below. The valve house was doubled in size in the 1940s when hilltop pipeline number 2 was constructed along with hillside penstocks 4 and 5. Evidence of the extension of the building can be seen in the interior of the building (see annotated photo). There are remnant timber louvres and laserlite panels on the eastern side of the building.</p> <p>Both the hilltop pipelines and hillside penstocks are anchored at the building by large concrete supports. A railing has been installed at the edge of the concrete support overlooking the hillside penstock. This provides a spectacular overview of Tarraleah power station and a distant view of the hillside penstocks to Tungatinah power station. Interpretive panels are located on this platform.</p> <p>The valve house contains six original butterfly valves installed to regulate the water passing into the six hillside penstocks. Other more recent equipment has also been installed.</p> <p>A stone retaining wall in the cutting in which the valve house is situated shows various stages of construction with different levels of sophistication and workmanship.<sup>107</sup> An adjacent metal clad shed contains winches for the haulageway.</p> <p>A concrete pad south of the valve house indicates the site of the former Tarraleah village switchyard.</p>

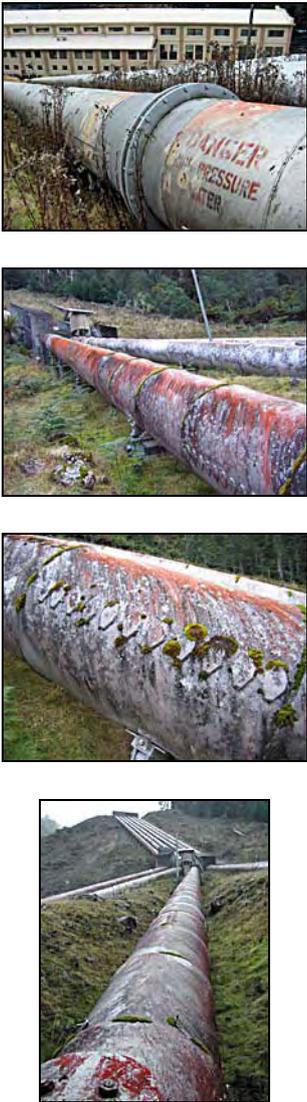
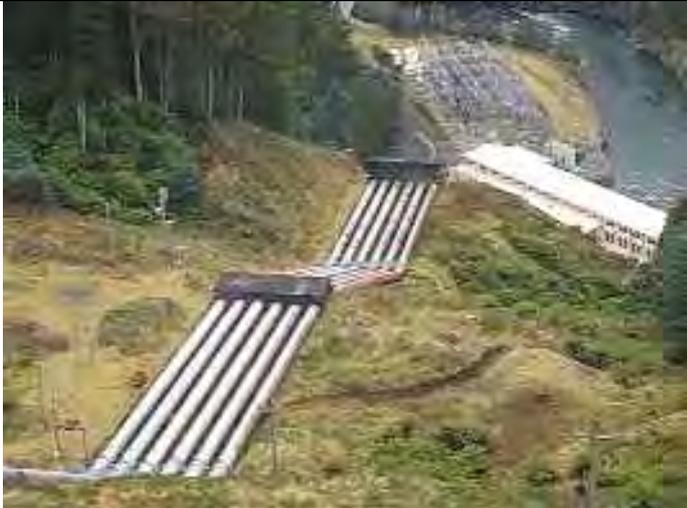
<p><b>Description</b></p> <p>Six steel penstocks drop from the hilltop valve house to the power station. The pipes taper in diameter from 5 feet (1.52m) at the top to 4 feet (1.22m) at the power station. At each break in slope they pass through concrete thrust boxes. Steel and concrete anchors secure the pipes at intervals.</p> <p>On approach to the power station the pipes are set within cuttings. They enter the building through inlet valves at the rear. The pipes were fabricated in Tarraleah and electric welded in situ. They were installed in three stages coinciding with the commissioning of machines (refer to s2.0 for a detailed explanation of the sequence of construction).</p> <p>The penstocks are a highly visible feature of the immediate landscape with a viewing platform adjacent to the hilltop valve house providing a spectacular overview of their precarious position on the hillside above the power station. They are a key feature in the landscape and, with the Tungatinah penstocks across the valley, form an industrial landscape of very high significance.</p> <p>Technically they were the largest penstocks fabricated in Tasmania to that time.</p>

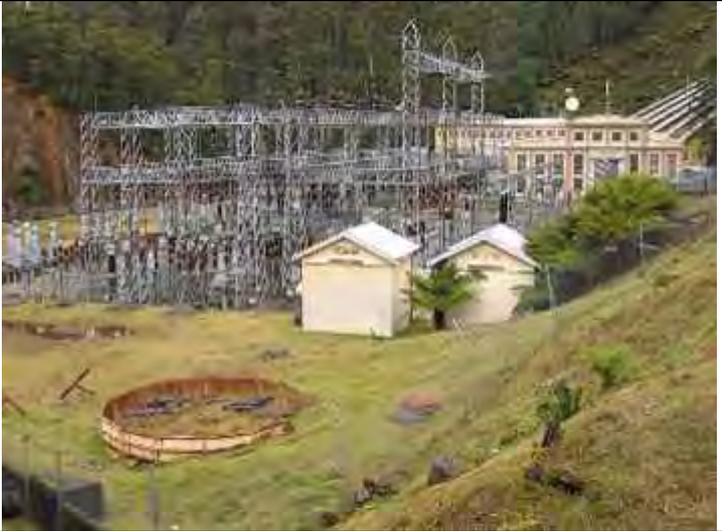
<p><b>Description</b></p> <p>The original 1937-38 switchyard. A substantial portion of the original infrastructure was removed and a new switchyard installed adjacent to the power station in the 1990s.</p> <p>The original switchyard is located on a levelled terrace north of the power station between the internal access road and the Nive River. It is contained within a locked enclosure surrounded by a wire mesh fence and a stone and concrete retaining wall with tree ferns growing out of it. This also retains the road above.</p> <p>The switchyard is integral to the setting of the power station.</p> <p>It contains original switching infrastructure, including some original transformers and circuit breakers, a remnant tramway with small bogey, two small concrete buildings (original function unknown) and a third concrete structure, which provides access to the underground cable tunnel. The latter is fitted with metal racks and carries cables from the generators in the power station machine room to the switchyard. In places the camouflage paint applied during World War 2 remains visible.</p>

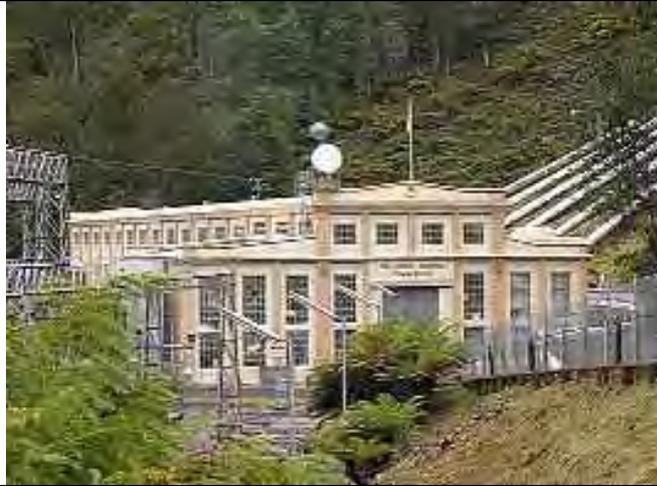
### 3.2.8 Power Station

The Tarraleah Power Station is a concrete walled building with stripped classical design elements, banks of steel framed windows, and a formal entry for both visitors and to the loading dock. It has a gabled corrugated iron roof (which replaces the original corrugated asbestos cement roof). The pedestrian entry is marked by an Art Deco style projecting bay and bridge. Metal and glass Art Deco style ornamental lights are located around the entrances and the sides of the building. The power station's facades are divided into bays featuring pilasters and stepped parapets, corbelled ledges, concrete hoods, string courses, small paned windows, and circular entry columns. A redundant pelton wheel is displayed near the entrance bridge.

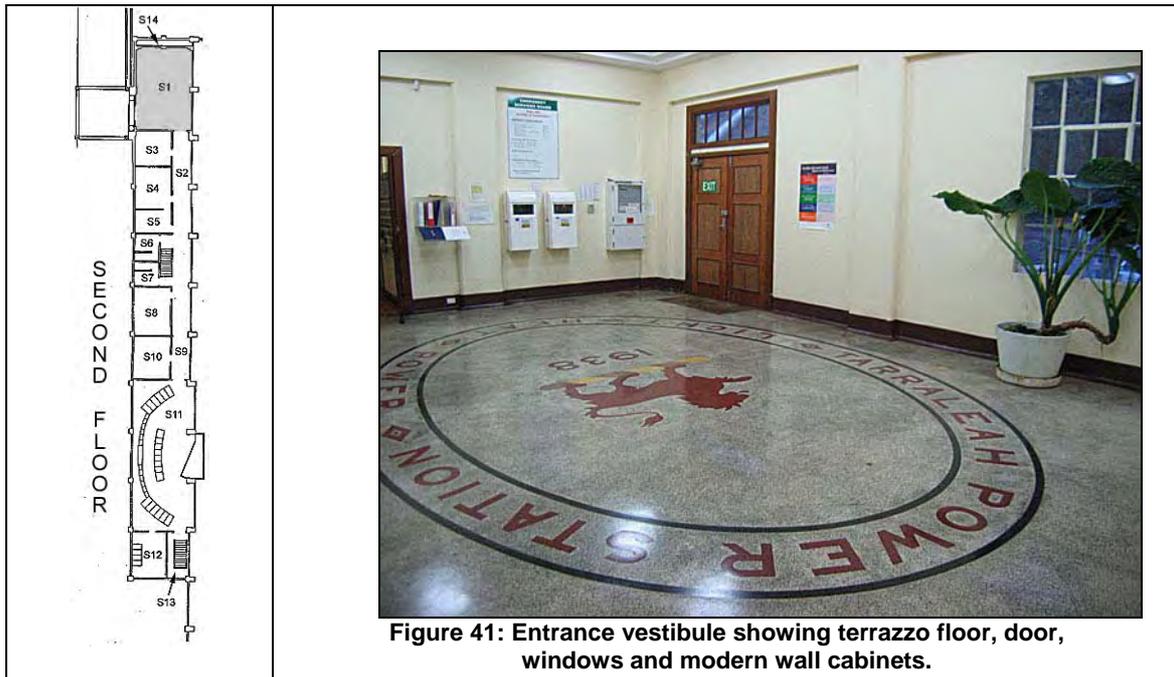
Figure 41: Entrance vestibule showing terrazzo floor, door, windows and modern wall cabinets.

The entrance vestibule is a large formal space dominated by a fine terrazzo floor with a large circular motif featuring the Tasmanian heraldic lion above the station opening date, 1938, surrounded by a circle of text reading 'Tarraleah Power Station, Light, Heat, Power'. The space also features two large memorial stained glass windows in the northern wall commemorating the opening of the power station in 1938 and the labour of the men who worked to design and construct the development. These windows are backlit with lights accessed via S14. A plaque on the eastern wall also commemorates the opening of the power station.

The internal door to the second floor passageway (S2), the external door, and their architraves, are of stained Tasmanian oak. The entrance features three panelled double doors with ply panels and modern door furniture. A six paned stained timber framed fanlight with clear glass surmounts the door. The double swing doors to S2 feature glass infill with central panes of clear 1/4inch bevelled polished plate glass and surrounding panes of *Belgian stippolite*. Antique bronze finished kick plates and diagonal aligned handles complete the doors. A window located on the western wall has a painted metal frame and eight large panes, the central four being a side-opening casement. Window furniture is original.

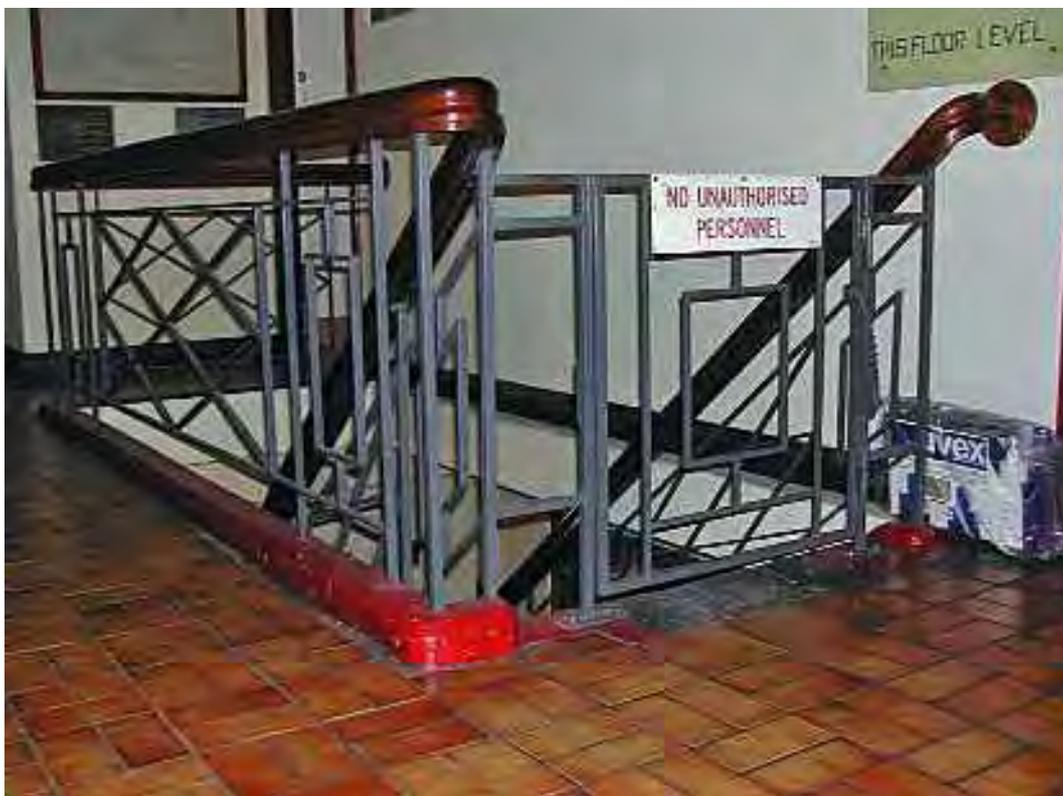
Figure 45: Central stairwell to first and ground floors showing late twentieth century tiled flooring and Art Deco painted welded steel balusters and gate, and varnished timber railing.

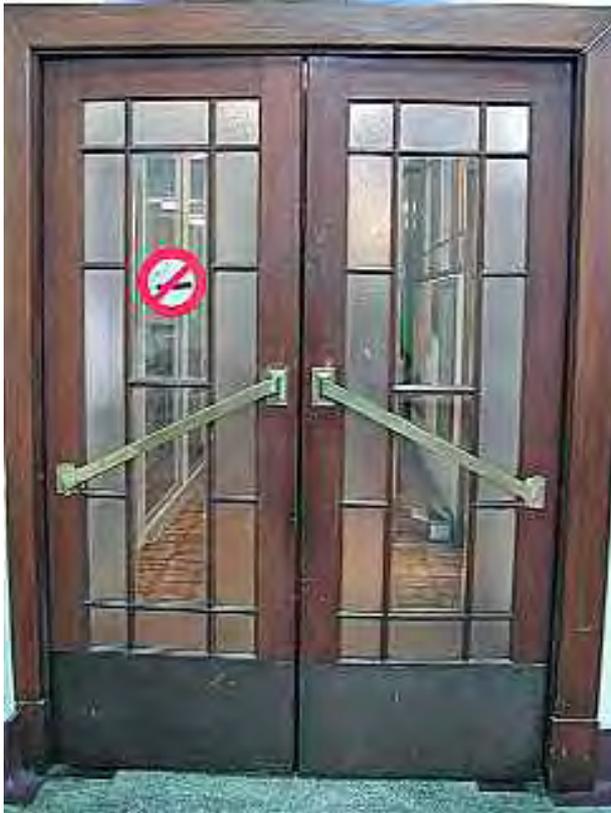
**Figure 46: View of door between S1 and S2 showing timber and brass detailing, and both the plain and stipplite glass panels. Apart from the No Smoking sticker this door is identical to the door between S2 and S9.**

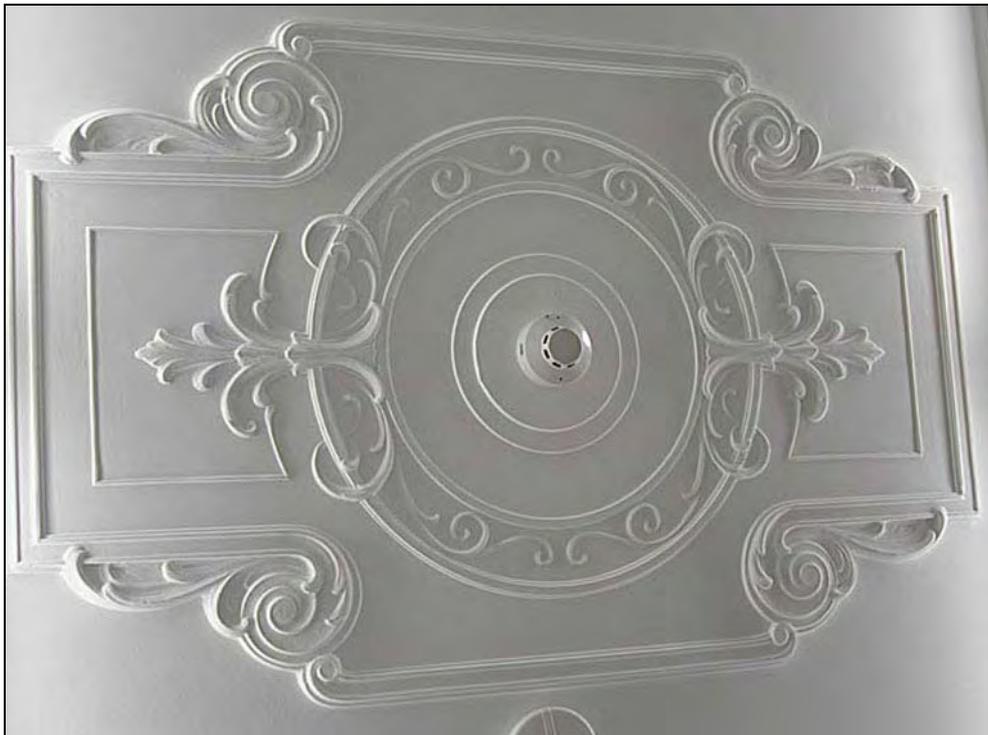
**Figure 48: Ornate ceiling rose in team leader’s office. Compare with figure 9 showing the ceiling decorations throughout the rest of the second floor spaces.**

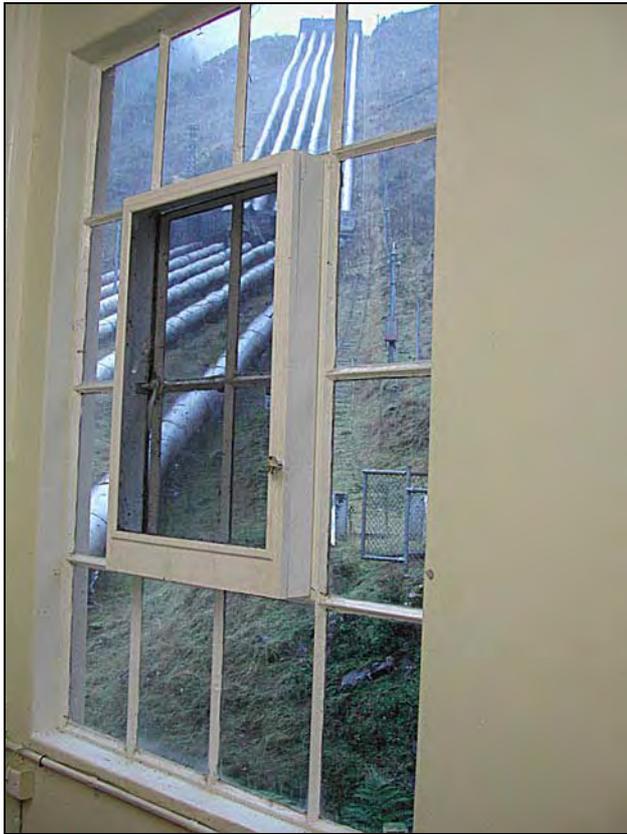
**Figure 49: External window in team leader’s office showing the centrally located opening casement and retro fitted timber framed insect screen. This window arrangement, with variation to the numbers of panes, is typical throughout the building.**

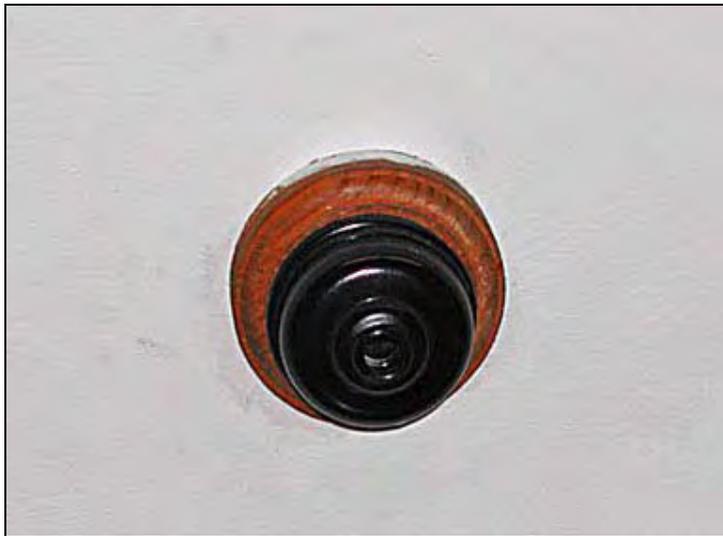
**Figure 52: Original timber and bakelite light fitting on ceiling of S4. This type of fitting is now rare inside the building.**

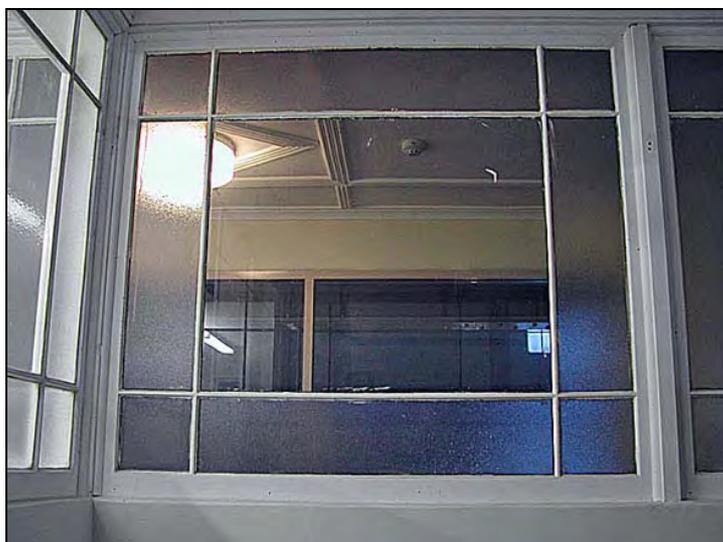
**Figure 53: Internal window between S4 and passageway showing drawn glass central pane surrounded by *Belgian stippolite* perimeter panes. Note also the window to S3, the ceiling detail of the passageway and the smoke detector. The window arrangement is typical of the second floor internal windows throughout unless otherwise noted.**

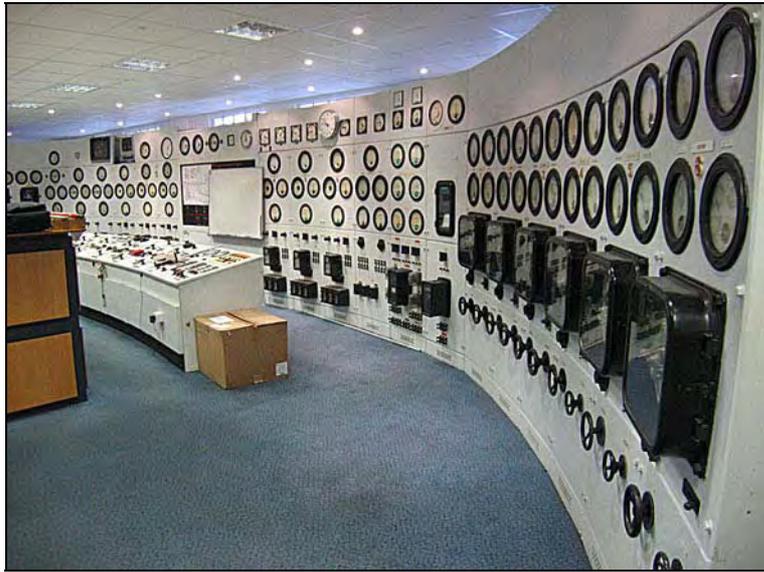
**Figure 63: Main control panel in Tarraleah control room, with the original bench board in front and c1980s console to the left. Much of the instrumentation is now redundant.**

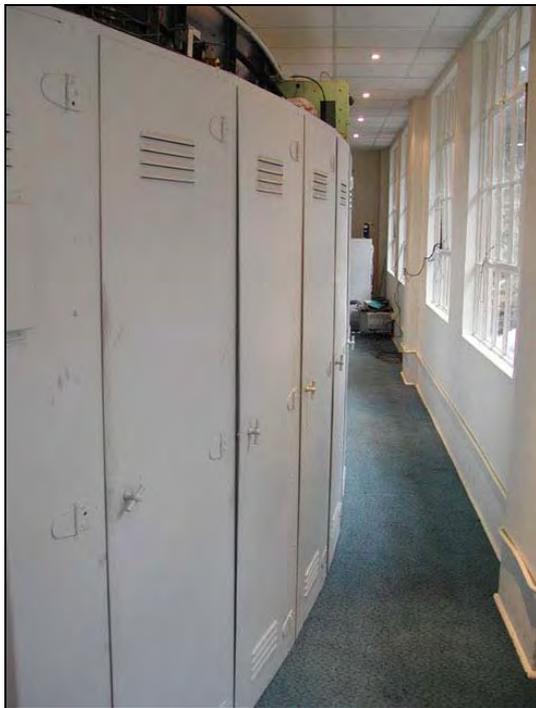
**Figure 64: Rear of control cabinet showing metal doors with original handles to access electronic circuitry in the board. Note the windows in the external wall.**

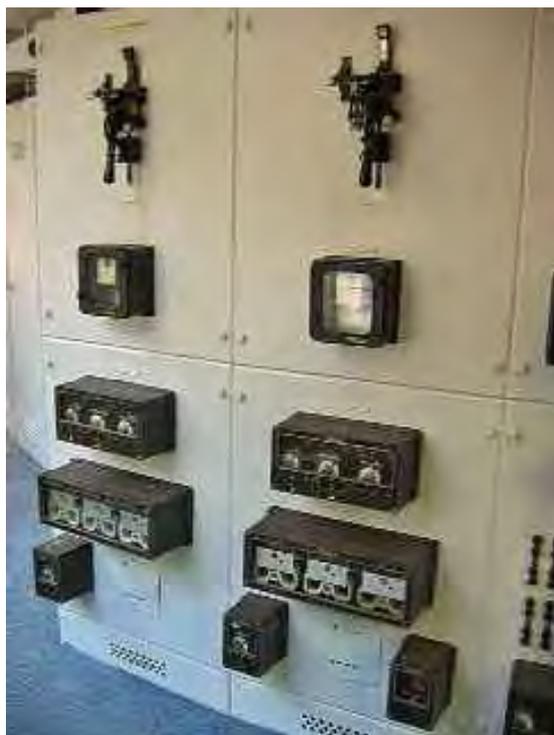
**Figure 66: Relays and controls for the auxiliary generators. This is part of the only fully intact original generator system in the power station.**

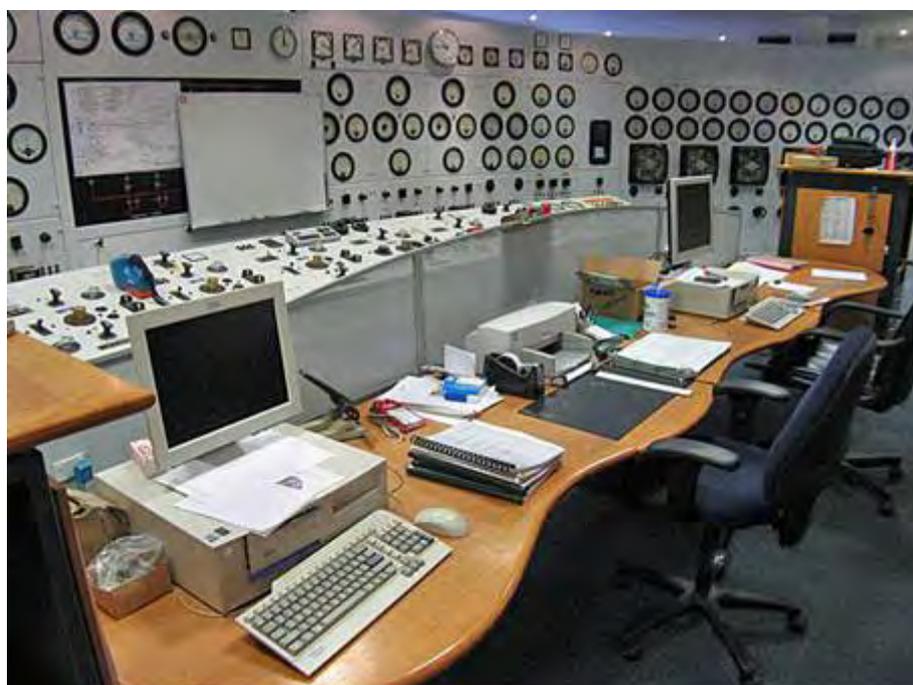
**Figure 67: View of control room showing various stages in control technology including the 1937 control panel, the control bench board and the modern and office desk and computers.**

A large room that has been altered over time to adapt to changing work conditions and power station control requirements. The room has rendered coke breeze block interior walls, carpeted concrete floor and acoustic tile clad ceiling (possibly concealing original Art Deco plaster work). Modern lights are downlights and lights concealed in "eggcrate" fittings concealed in the ceiling.

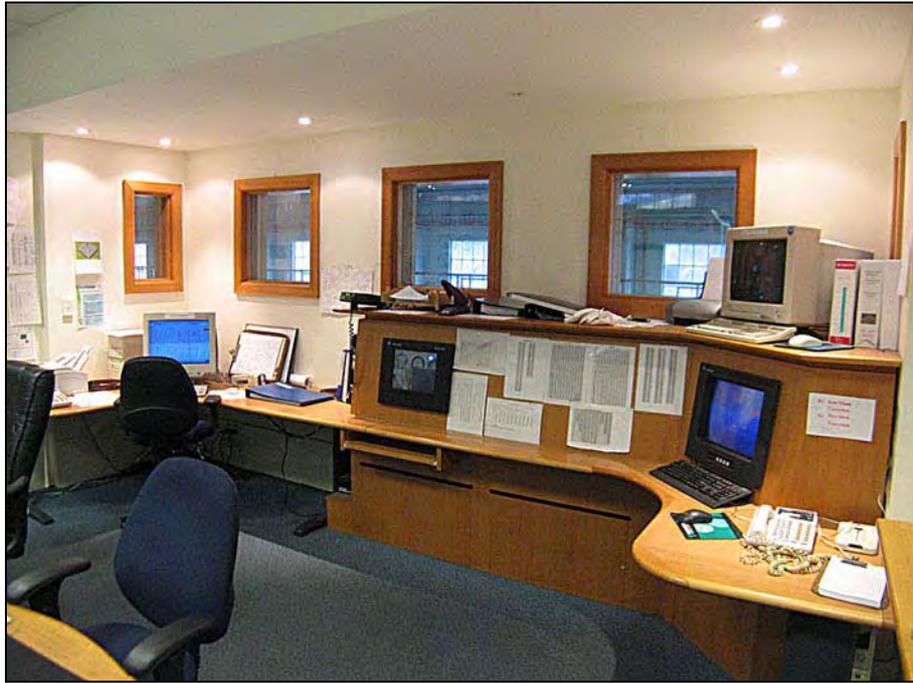
**Figure 68: c1974-75 addition to the control room showing the bay cantilevered over the machine room, and its timber framed windows and computer console.**

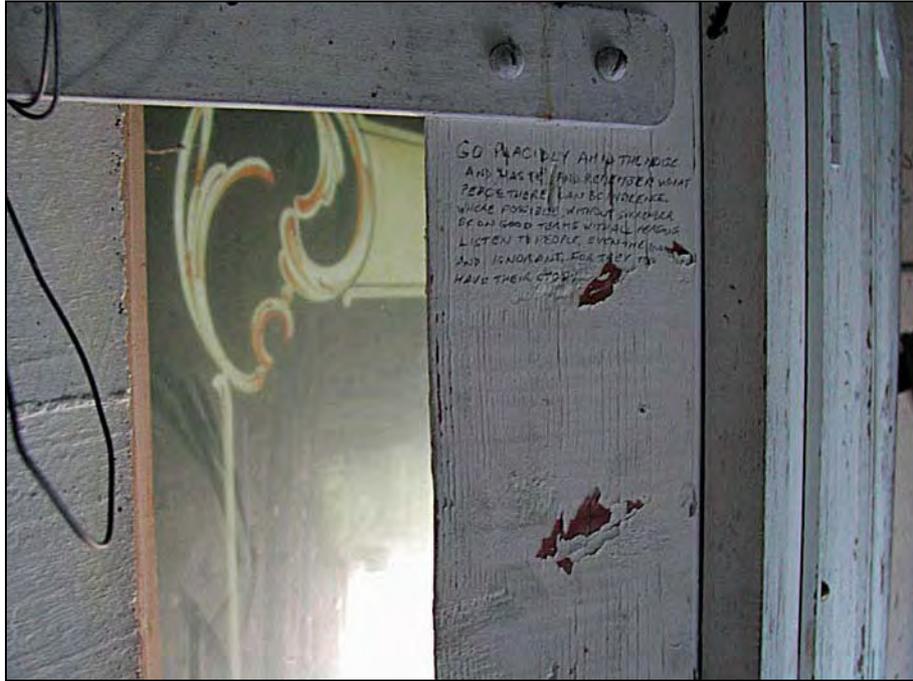
**Figure 73: Detail of screen, fixings, graffiti and memorial stained glass windows. Note evidence of formwork used in the construction of the concrete walls.**

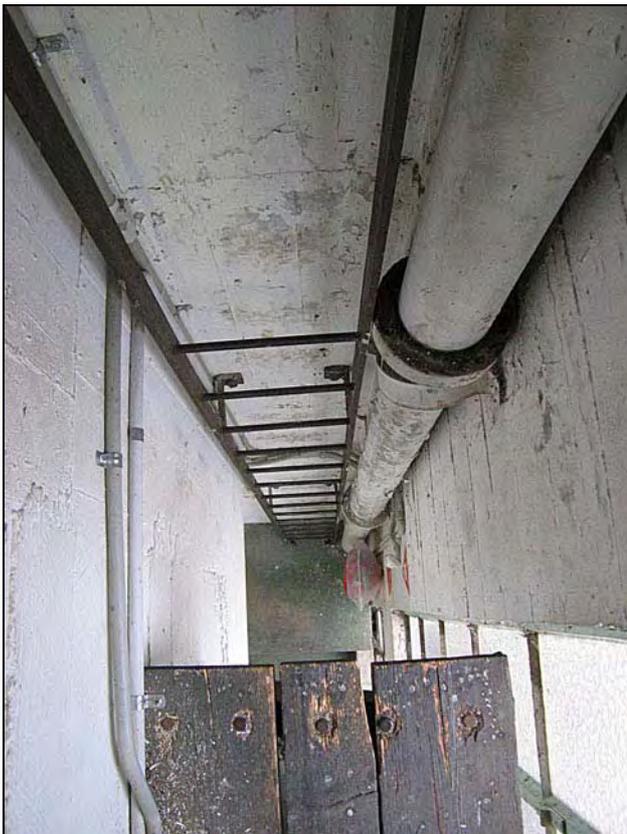
**Figure 74: Wall mounted iron ladder used to access maintenance space behind memorial stained glass windows. Note the downpipe, the timber plank flooring and the evidence of formwork erected when pouring concrete for the building.**

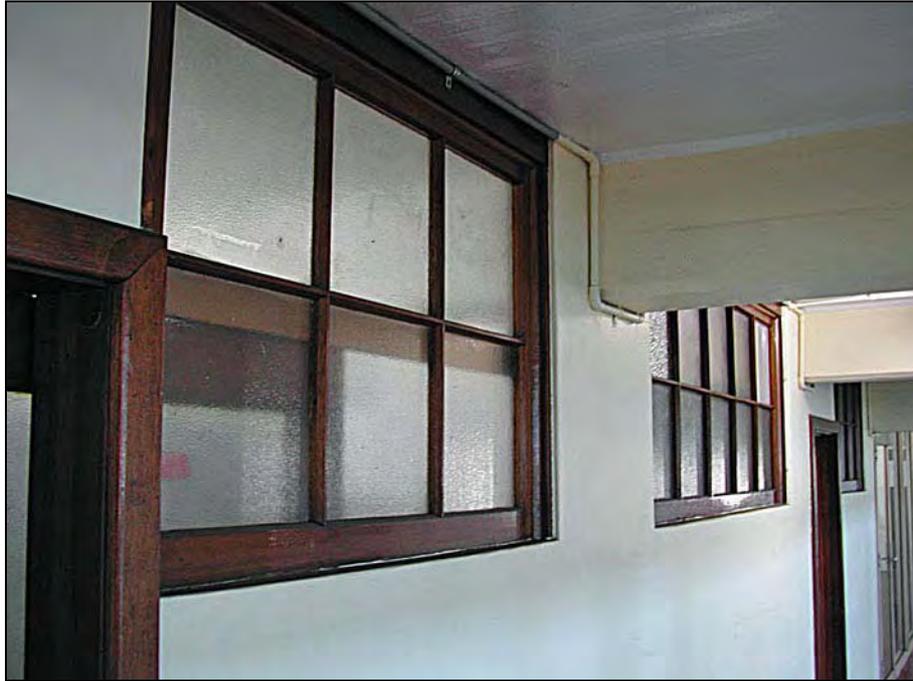
**Figure 78: Detail of internal windows to S19 & S20 from the first floor passage. Note the concrete beams and electrical conduits.**

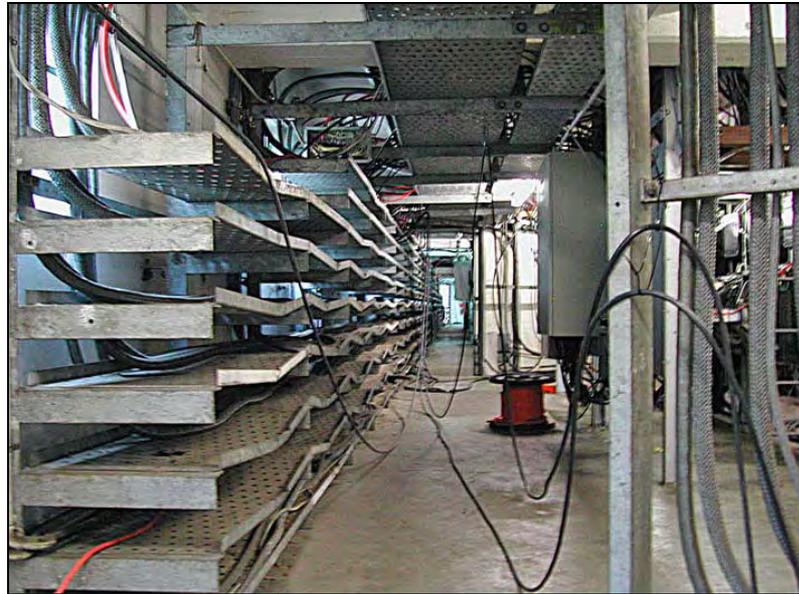
**Figure 79: View of former terminal room showing shelves of cables leading to and along the length of the control cable duct.**

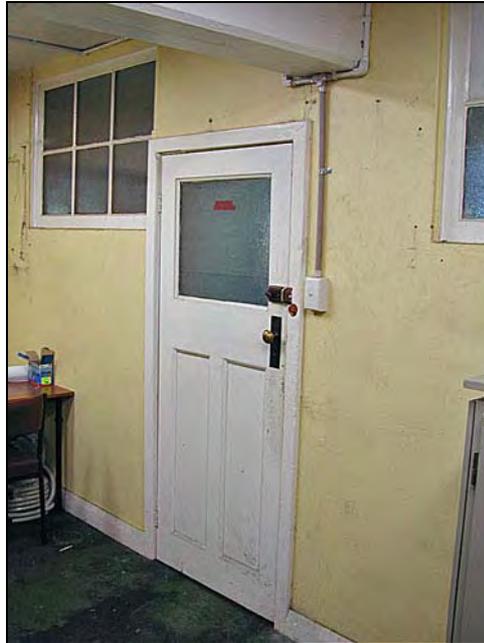
**Figure 82: View of room showing painted internal timber work, standard first floor door, modern light switch and conduits and the building's structural framing expressed in the ceiling. This is typical of the utilitarian spaces of the first floor.**

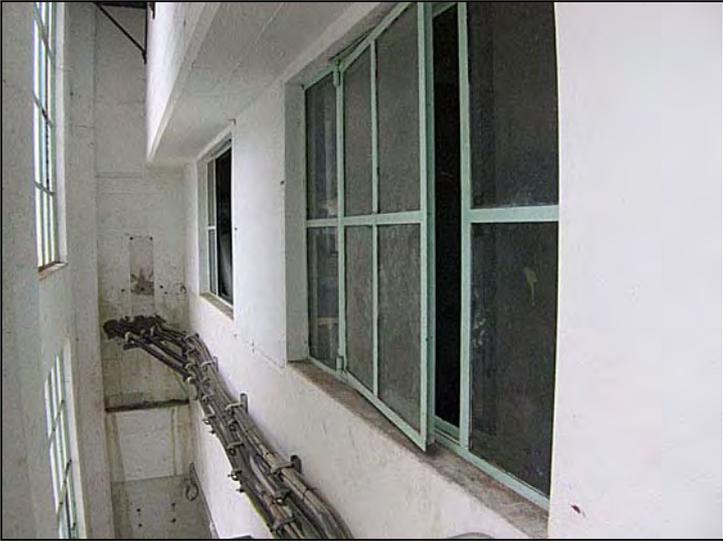
<p><b>Figure 88: View of northern stairwell showing windows to store room and external windows as well as cabling along internal wall.</b></p>
<p><b>Description</b>  A narrow utilitarian space with concrete stairs between the first floor and the machine floor. There are windows to the store room (S24) and metal-framed multi-paned windows on the building's northern external wall. Metal rod winders at stair level enable the upper windows to be opened and closed as needed. The windows are a dominant feature of the space. There is a steel modern fuse box and a large cluster of electrical cabling fixed to the space's south wall.</p>	
<p><b>Element</b>  Space configuration  Walls  Windows to S23 and outside  Window furniture, including winders  Stairs  Fuse box and cabling  Electrical lights, fittings and fluorescent lights</p>	<p><b>Significance rating</b>  very high  very high  very high  very high  very high  low  low</p>

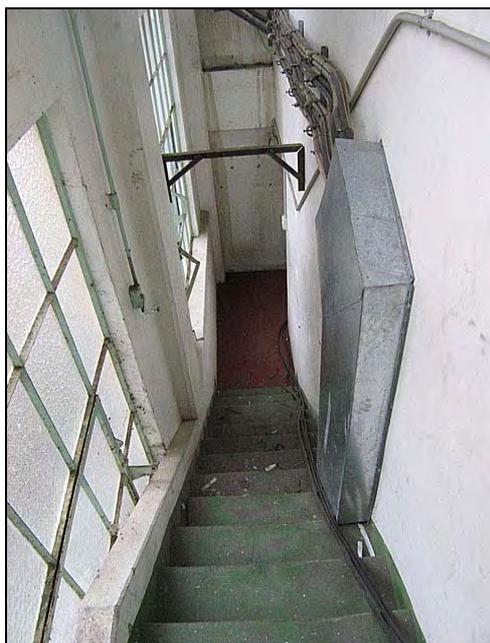
**Figure 89: View of stairs, fuse box, cabling and windows with original window furniture including high window winding mechanisms.**
