# TARRALEAH POWER STATION

## Conservation Management Plan

Prepared by  
**Austral Archaeology Pty Ltd (David Parham) & Ian Terry**

Hydro Tasmania

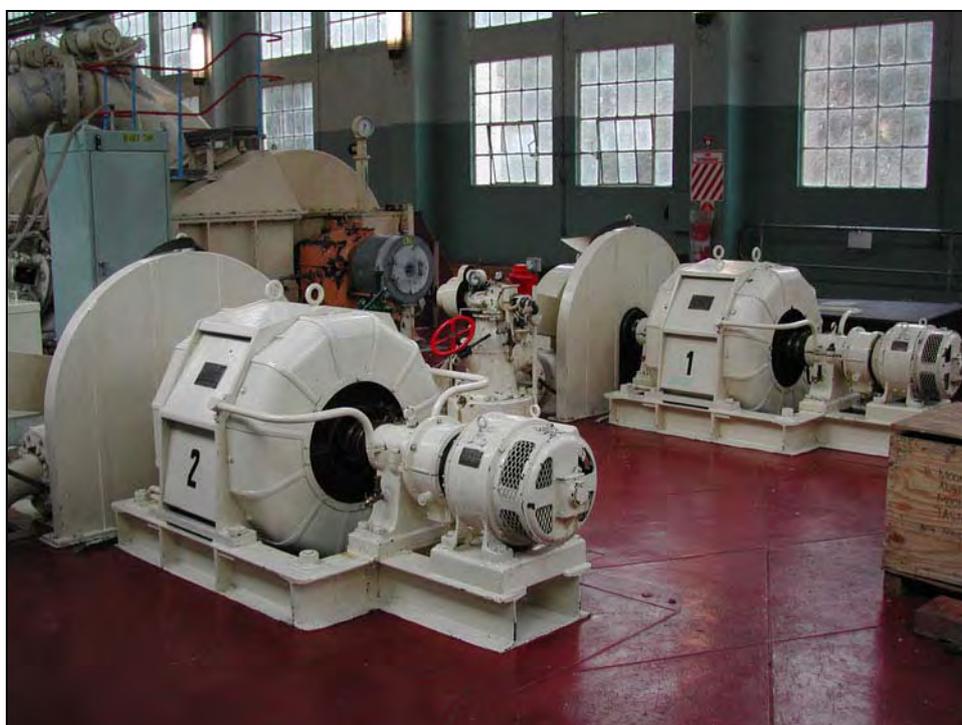
Figure 95: View of auxiliary (or 'house supply') generators 1 & 2. Exciters and turbines pictured.

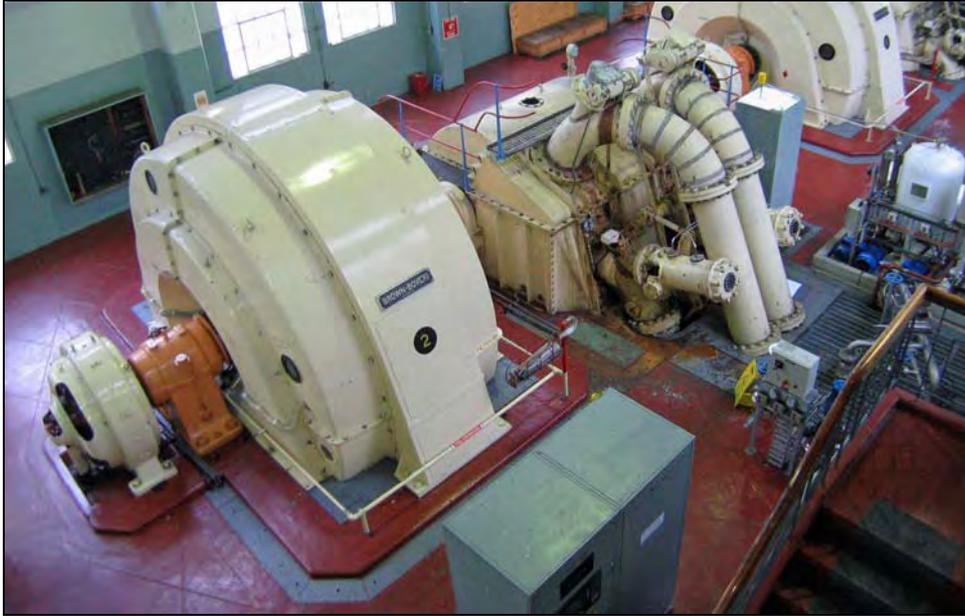
**Figure 97: Overview of Boving & Co machine #2. Picture from L; Exciter, alternator, turbine & spears.**
