Hydro Tasmania

SAFETY OR ENVIRONMENT BRIEF

Incident notification

Brief Number (YYMMDD)	251016	Date Issued	16 October 2025
SAP Number (if applicable)	N/A (Principal Contractor controlled workplace)	Approved By	Head of WHS
Action Required?	Yes

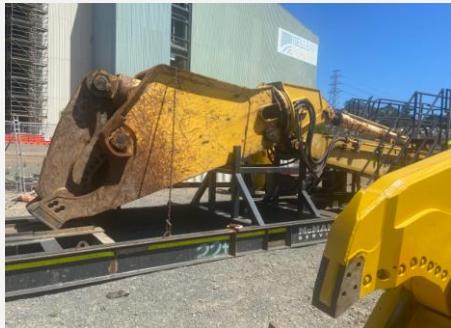
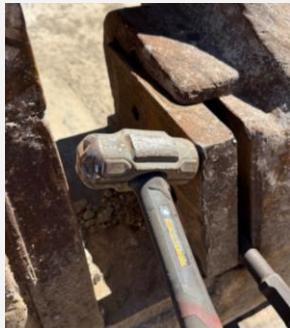
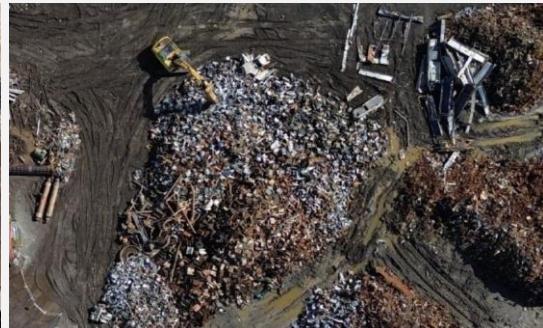
On 15 October a Principal Contractor was removing a guide blade from a shear jaw on a demolition site. A hammer was used to hit the edge of the guide blade during this task. This impact caused a metal shard from the blade to dislodge and become a projectile. This metal shard struck a worker and caused an injury to their hip area resulting in bleeding that required hospital treatment.

- Your task risk assessments should consider:
 - Hazards unique to the tools and equipment being used
 - Condition of tools and equipment being used
 - Specific methods and techniques applied which may include using force or energy
 - The potential for fragments to release due to the use of force (exclusion zones/PPE?)
