# Hydro Tasmania

## SAFETY OR ENVIRONMENT BRIEF

### Water release into spiral case

Brief Number (YYMMDD)	251205	Date Issued	5 December 2025
SAP Number (if applicable)	85009	Approved By	Head of WHS
Action Required?	Yes

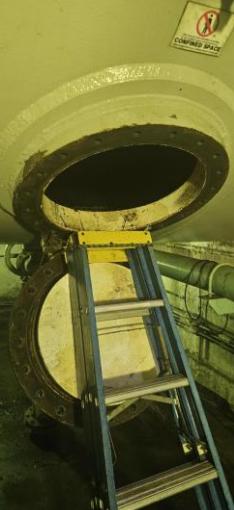
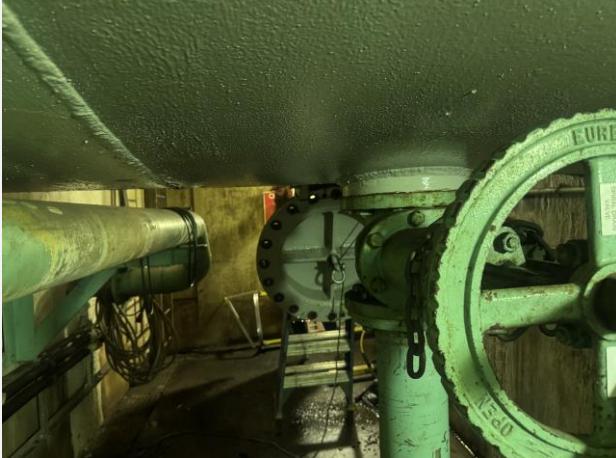
Spiral Case Access	Drain valve and access hatch location

During servicing of the intake still well, the drain valves were opened to remove water. This resulted in water entering the penstock, flowing into the spiral case, and exiting through the spiral case access hatch.

The spiral case was considered an active work area; however, no personnel were inside at the time of the water release. **Note** - The still well drain valves are not typically isolated to provide safe access into the spiral case.

An investigation is underway, and a Safety Alert will be issued once the investigation is complete. In the meantime, please discuss this incident with your teams, consider any risks that may apply to your work, and remain vigilant around isolation practices and coordinating different work activities.
