Lake Mackenzie lunettes restoration plan

Prepared by Anita Wild

Wild Ecology Pty Ltd

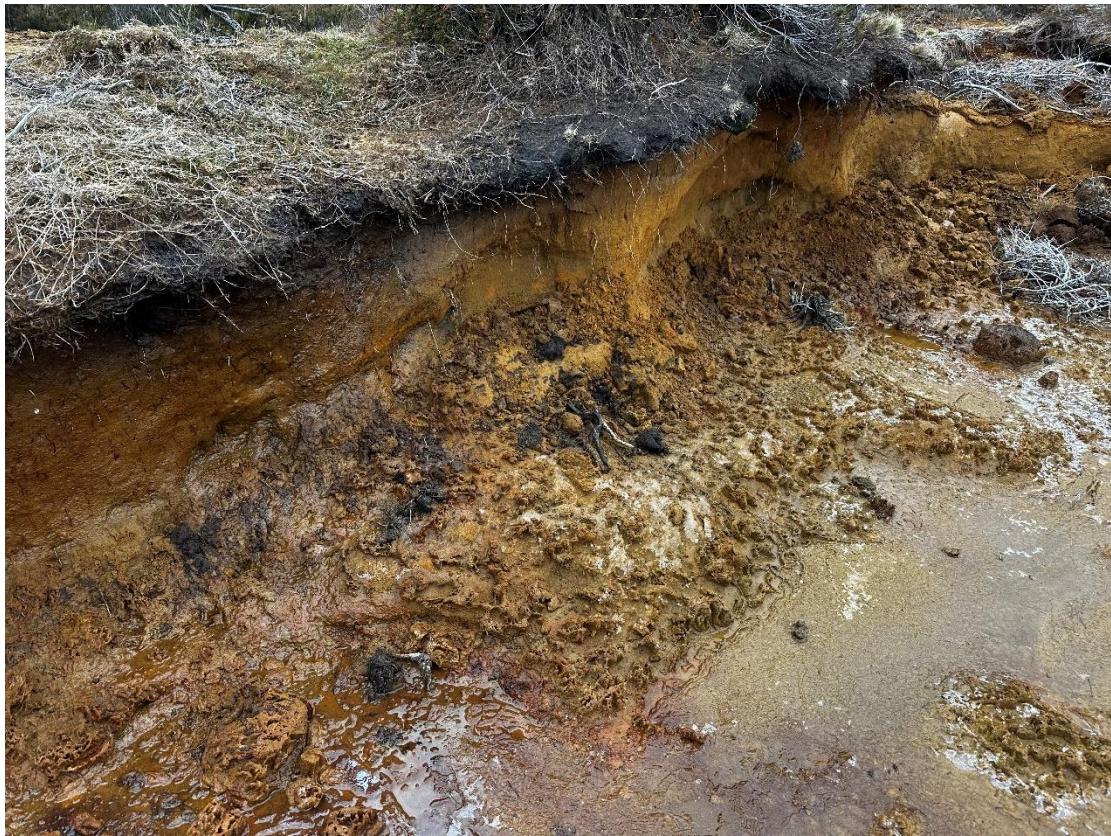
Figure 1 Frost heave erosion on the toe of the fore dune escarpment

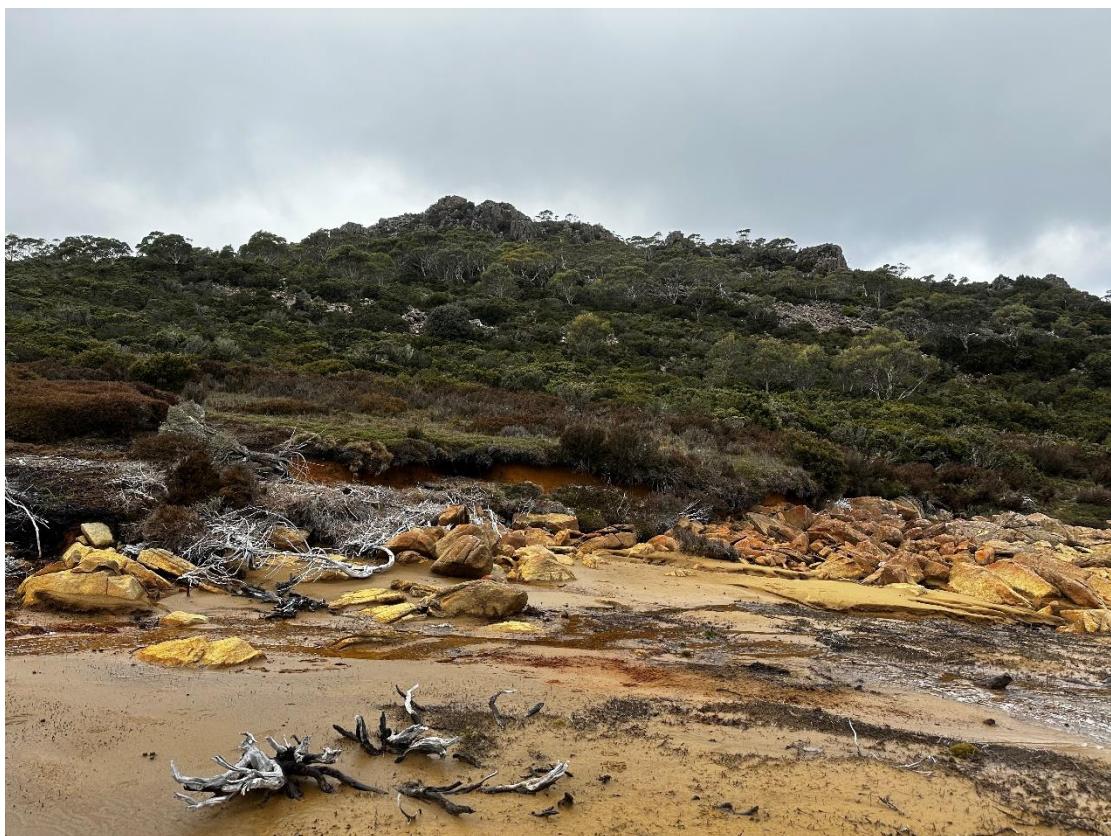
Figure 2 Lightly-armoured shoreline susceptible to wave action, possibly amplified by ramping of wave energy.

Subsequent monitoring using three-dimensional laser scanning at AH 11828 as demonstrated that active erosion of the area is still occurring, and that restoration works could result in a reduction of artefact re-location due to ongoing deflation of the dune areas from wave action. These patterns of wave erosion correspond to periods of high-water levels and the relatively higher spring winds that will result in long wind fetch from the full lake (Figure 3). Additional field observations in 2023 indicate that erosion processes also include frost heave and seepage erosion of the toe of the dunes (Figure 1) and that even the lightly armoured shoreline displays wave action impacts (Figure 2) and gully erosion of drainage channels (survey data).

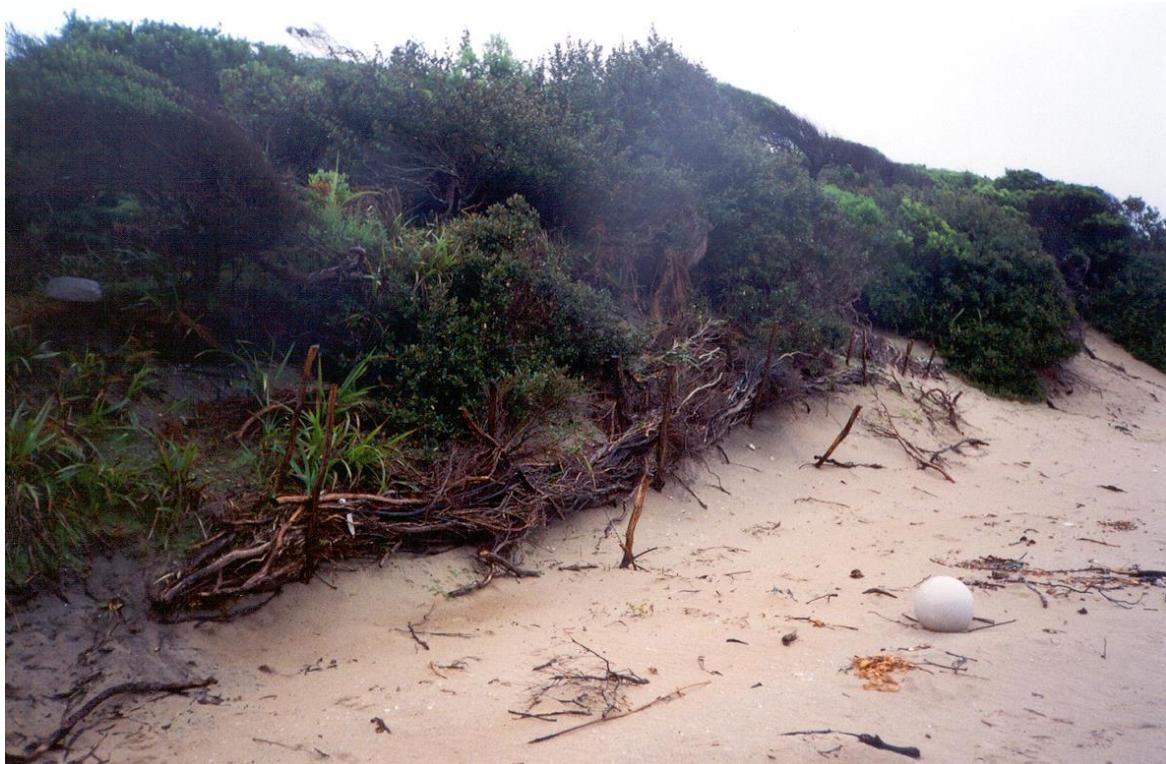
Figure 9 Vertical scrub fence protecting a coastal dune from further impacts on Tasmania's west coast (Photograph: Caleb Pedder)

Restoration activities on, and near, the lunettes should aim to reduce the erosive energy of waves on the dune faces seepage erosion and frost heave and potential solifluction on the dune toes and gully erosion of drainage lines on the outwash area. Restoration treatments will incorporate three techniques: tea tree fencing between 1-1.5m out from the (existing) dune face to reduce wave action (Figure 9 and Figure 10), potentially small coir logs on the dune face to reduce seepage erosion and frost heave (Figure 11, although see discussion below) and small rolled coir weirs to reduce gully erosion and the formation of head cuts (Figure 12).

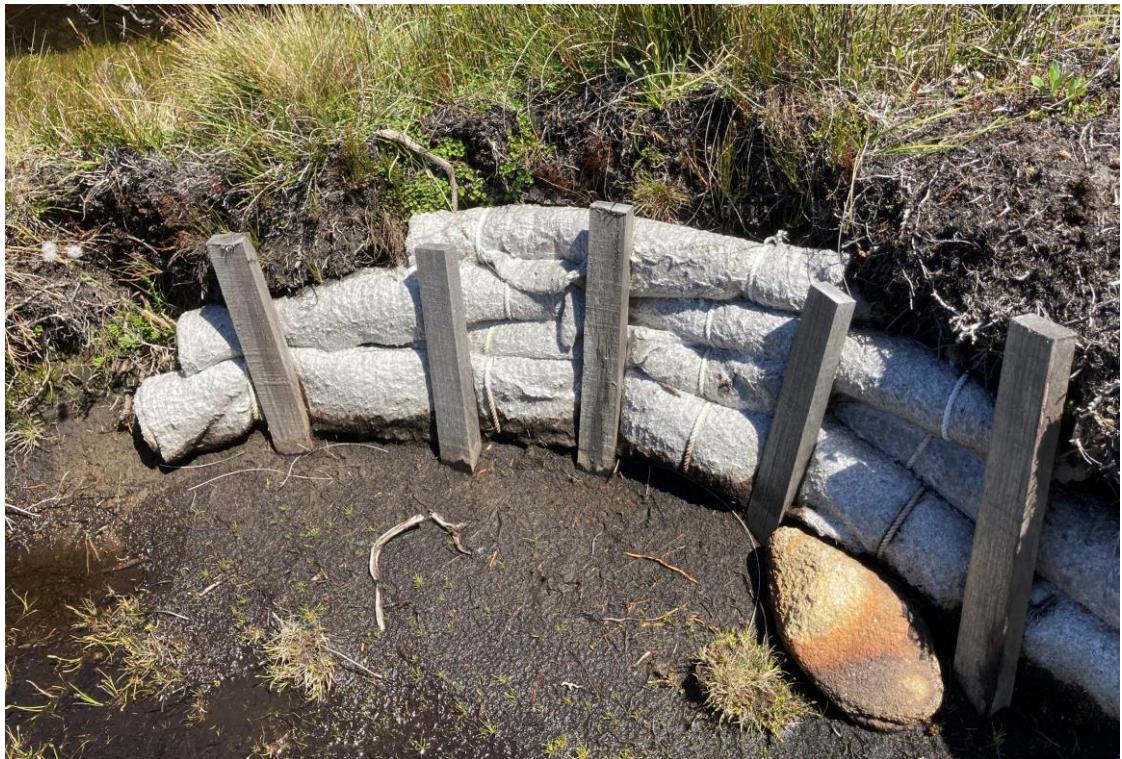
Figure 11 Small coir logs reducing frost heave and supporting a deflated pool at Pine Marsh Bay, Lake Mackenzie

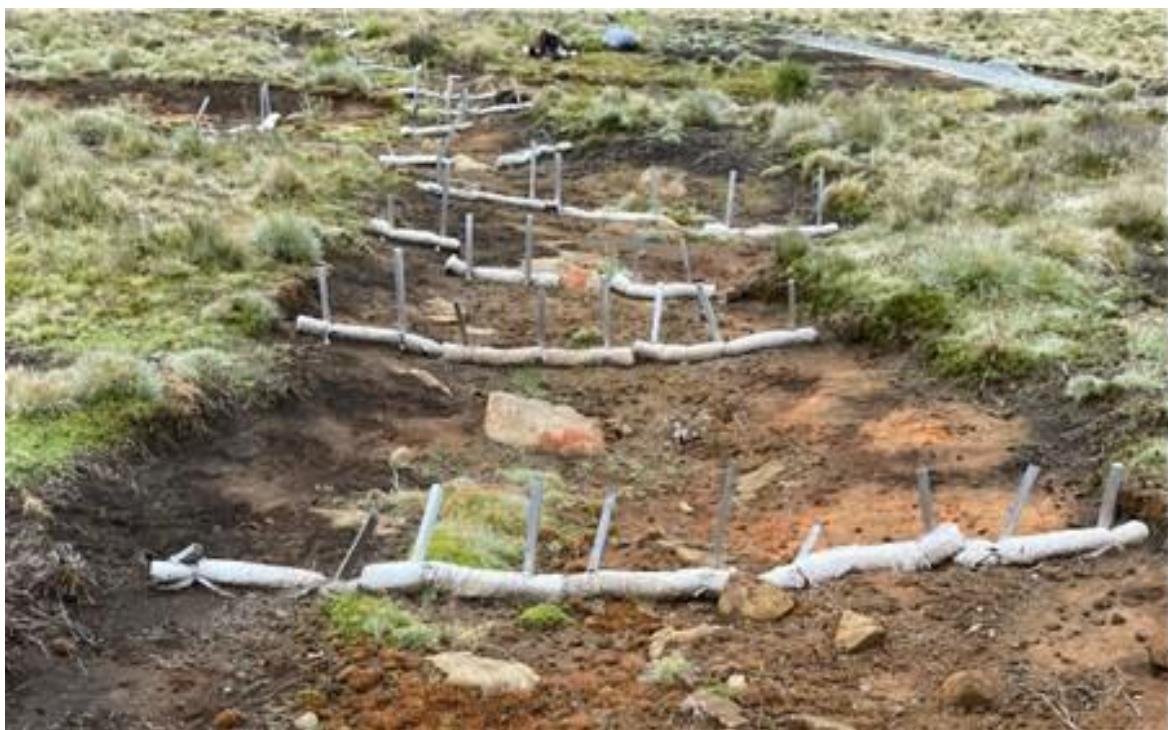
Figure 12 Small coir logs acting as weirs to slow overland flow in area of gully erosion at Ritters Plain, Lake Mackenzie. This is the proposed treatment for the gully erosion on the lake bed adjacent to the dunes.

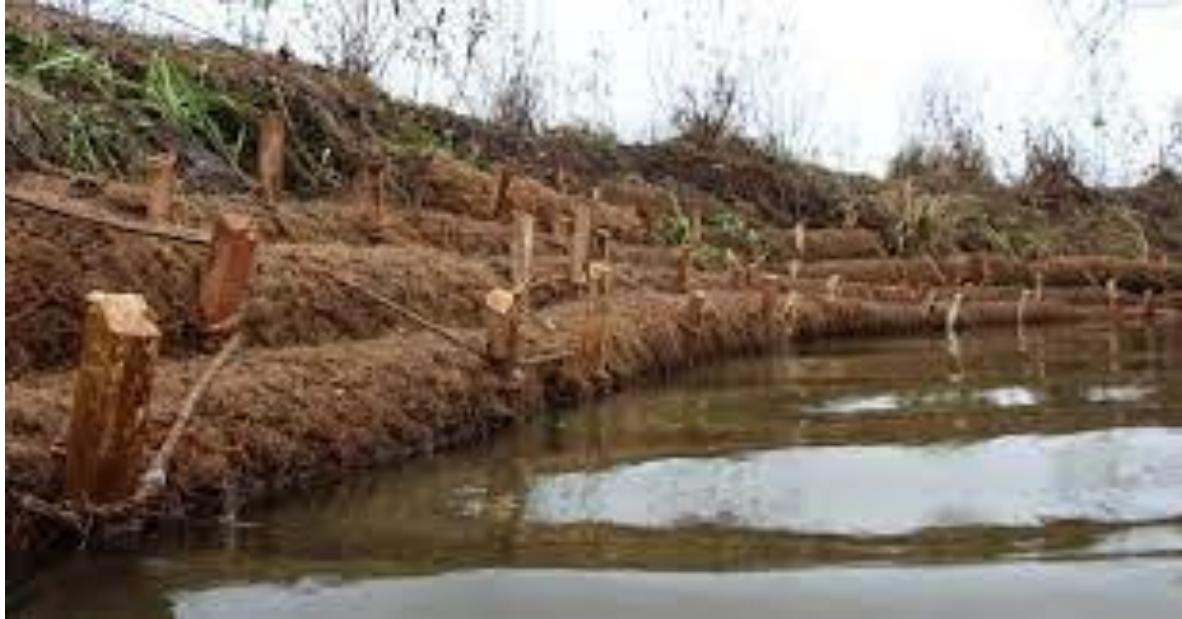
Figure 13 Large pre-formed coir logs that should be considered for the dune face at Lake Mackenzie

Due to the high intensity and erosive potential of the waves from the long wind-fetch distance at Lake Mackenzie, it is likely that heavy-duty coir logs would perform better on the dune toes. These logs are used extensively in coastal areas, including those with wave action and should be considered in this treatment, therefore costs are also included in this plan and it is recommended that an engineering assessment is done prior to installation.

Due to the high wave energy action, it is recommended that robust and larger pre-made coir logs are considered for the dune toe treatment. This treatment should increase the longevity of the treatments and reduce the risk of remobilisation of 'logs' due to wave action.
