Tungatinah Power Station Conservation Management Plan Review

Final Report prepared for Hydro Tasmania

AT0221

17 January 2018

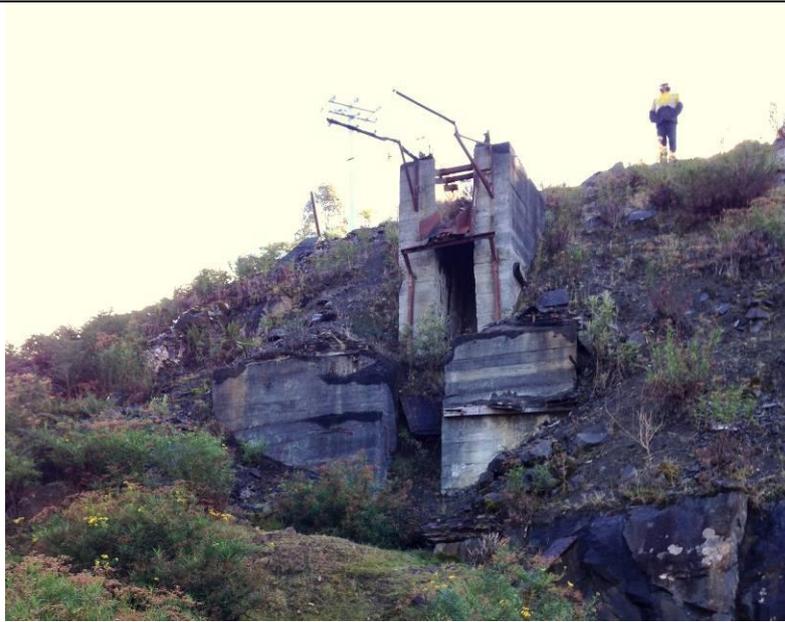
View to the northwest showing the batching plant and/or crusher footings

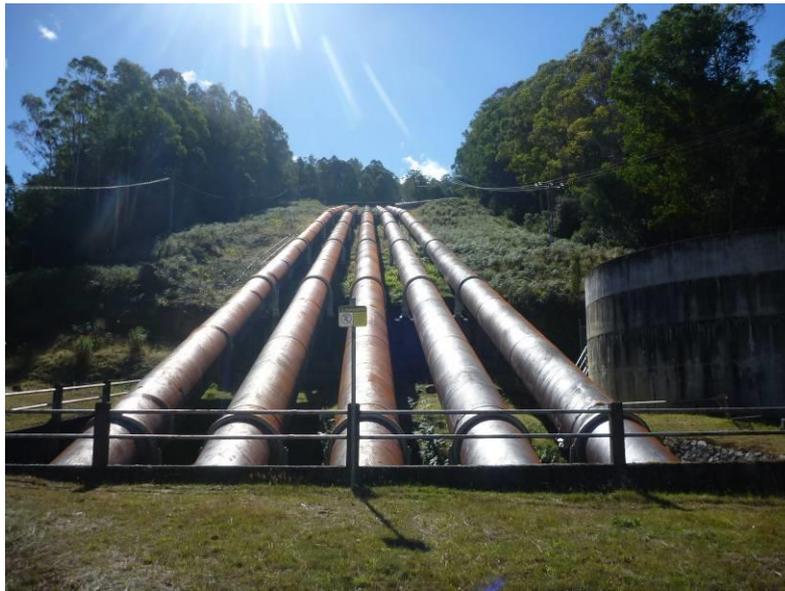
View to the north showing the penstocks (& cooling water tank)

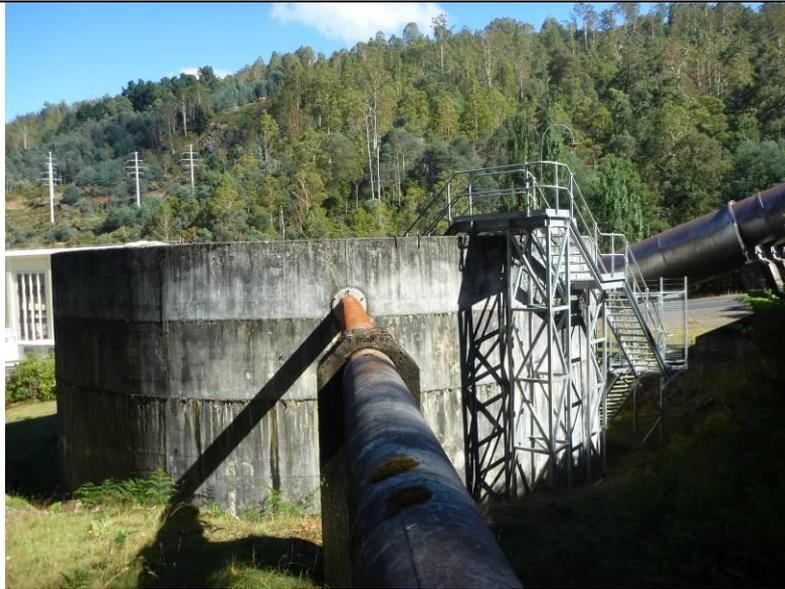
View to the west showing the cooling tank.

A weir and tank to supply cooling water to the power station is located across the road to the north of the power station. The trash rack at the weir appears to have been replaced and the old trash rack is located in the undergrowth to the north of the nearby clearing.

Update 2017 –New stairs and an additional platform have been added to the top of the stairs already attached to the northern face of the cooling tank. The conifers noted during the original investigation were still present.

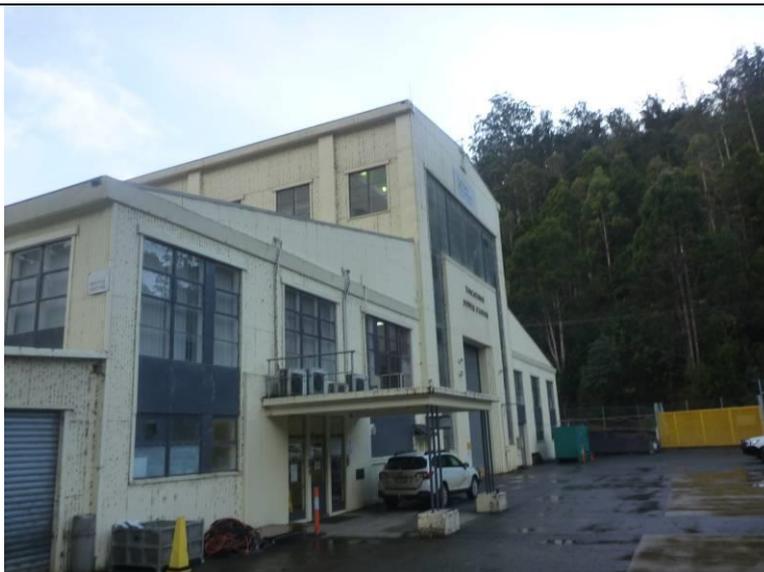
View to the north showing the entrance to the Tungatinah Power Station

Update 2017 – As was noted by Jackman¹²¹ a roof access ladder has been installed onto the back, northwestern face, of the main bay of the building intended to connect to a rooftop walkway, and ventilation fans have been installed in the roof at the northwestern end of the main bay. Two large Hydro Tas signs have been installed on the external southeastern and northeastern faces of the main bay close to the roof line.

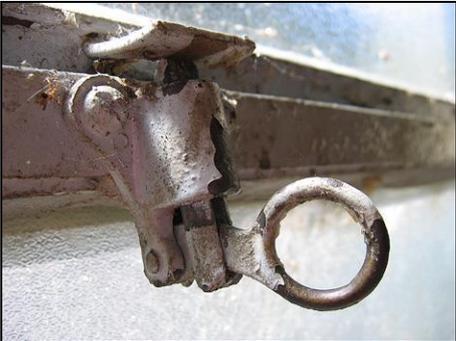
| Image | Description |
|---|---|
| | <p>Typical window lock, Gasket Room (S16). These locks should be retained and conserved in working order.</p> |

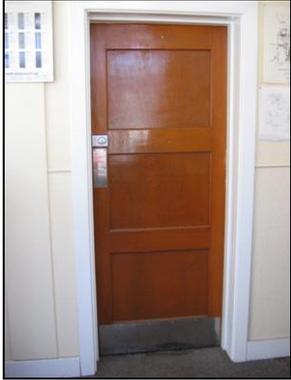
| Image | Description |
|---|---|
| | <p>Typical internal door — note chrome kick plate and finger plate (S32). Note also modern lock.</p> |

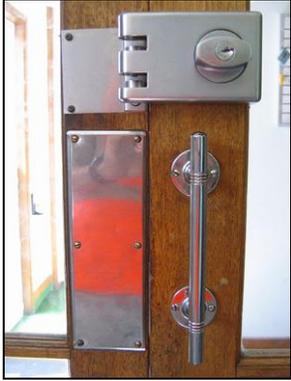
| Image | Description |
|---|---|
| | <p>Typical door furniture — original chrome handle and fingerplate, and modern lock (S31). This type of door handle and fingerplate should be retained and conserved where they occur. The modern lock is intrusive.</p> |

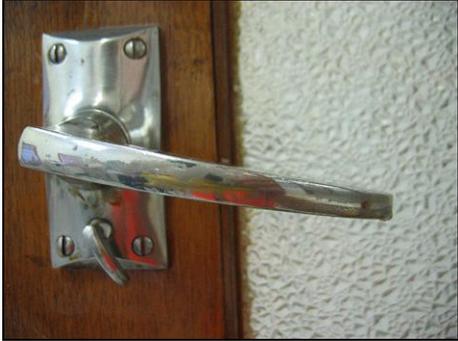
| Image | Description |
|---|---|
| | <p>Typical office door handle with snib lock (S28). This type of door handle should be retained and conserved where they survive.</p> |

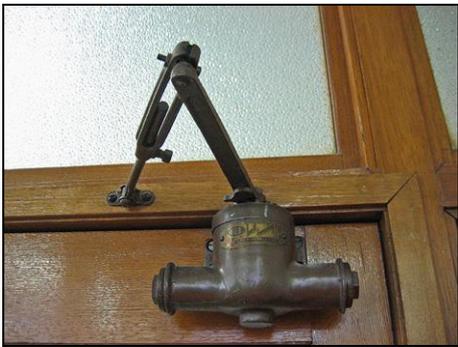
| Image | Description |
|---|---|
| | <p>Typical brass door closer in power station (S31). This type of door closer is the most common throughout the power station and should be retained and conserved.</p> |
