Basslink Review Report 2006-12
Gordon River Basslink Monitoring Program
The Appendices

May 2013

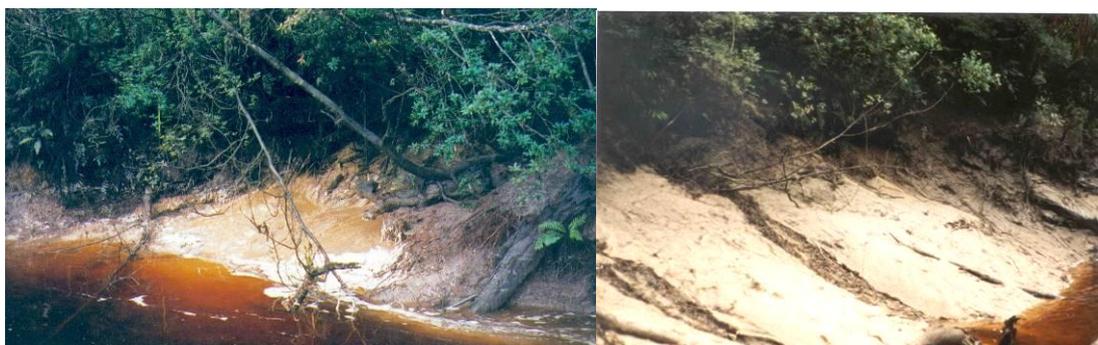
Seepage-induced erosion occurs episodically, generally following prolonged periods of three-turbine power station usage and appears to be exacerbated by extended high rainfall following power station shut-down. Spatially, the process occurs discontinuously on sandy alluvial banks, with large variations over distances of only several metres. The removal of tea tree and other vegetation from the riparian zone through scour is believed to be a significant trigger for the initiation of seepage processes. Zone 2 is particularly susceptible to this process due to the prevalence of sandy alluvial banks and large water level fluctuations.

Figure 2.13: Active seepage erosion (water and sediment exiting bank) following power station shut-down (left) leads to sediment flows (right) on alluvial banks in zone 2.

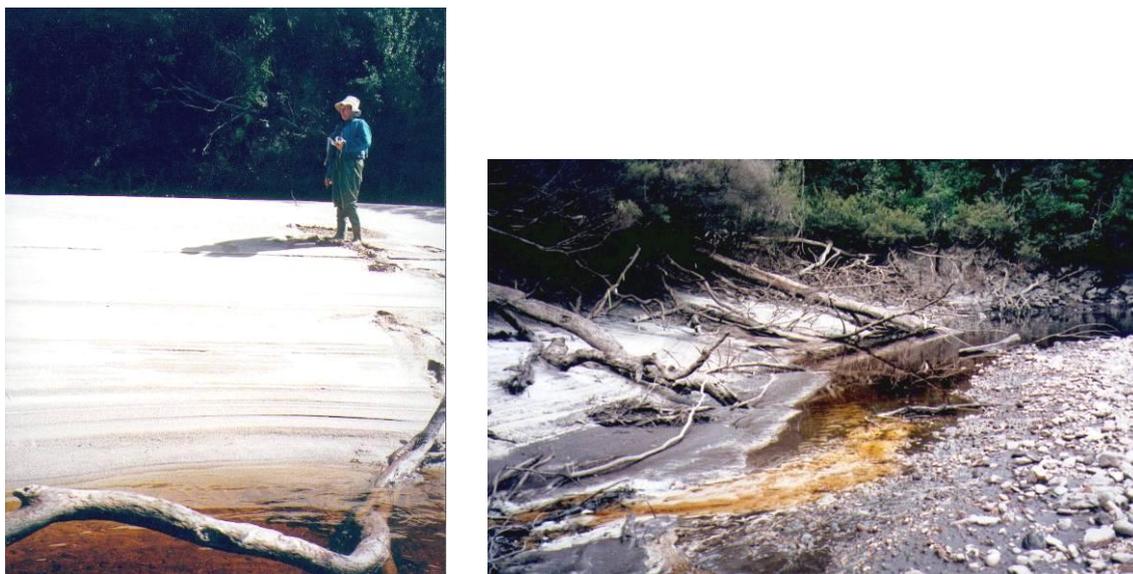
In addition to a decrease in sediment delivery to the middle Gordon River, the decoupling of flow and sediment delivery from the tributaries has also decreased the deposition of organic matter and sediment on the banks and bed of the river. Because a power station shut-down rarely coincides with the falling limb of natural storm events in the catchment, the middle Gordon has largely become a sediment throughput zone for tributary derived fine-grained material (Figure B.14).

Figure 2.14: Comparison of alluvial banks immediately following power station shut-down (left) with no mud or organic matter on bank toe, and following an extended shut-down (right) when muds have accumulated due to unregulated flow events originating in tributary streams.

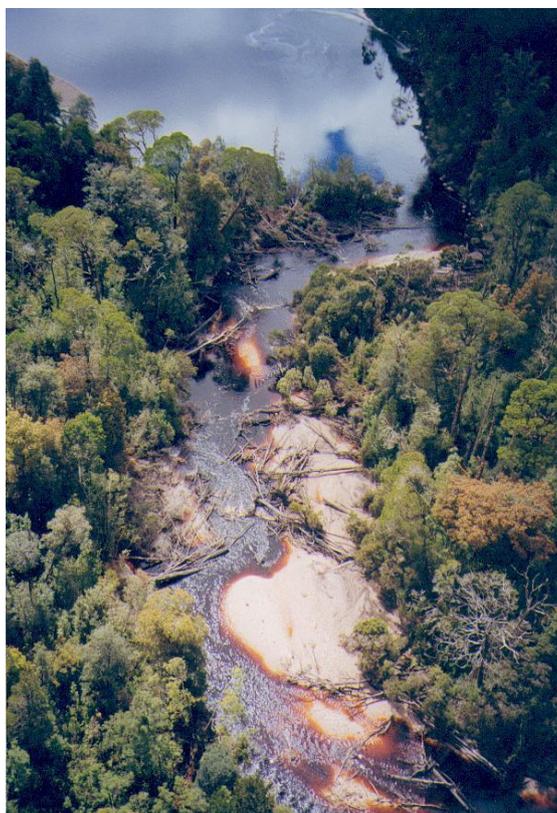
The decoupling of flow and sediment supply in the Gordon River compared to the tributaries also affects the lower reaches of tributaries, especially upstream of the Denison confluence. During periods of low natural flow and high power station discharge, water from the Gordon River inundates the mouths of tributaries up to the power station-controlled high water level. This has led to seepage erosion occurring in the lower reaches of creeks and tributaries, causing channel widening. Additionally, tributary floods combined with power station shut-downs create large water surface slopes with great erosive energy. The mouth of the Albert River is a prime example of this, widening by up to 30 m near the confluence with the Gordon since the establishment of the power scheme. Widening in alluvial reaches near the mouth of the Orange River and small creeks in zone 2 has been estimated at 10-20 m based on aerial photo analysis. Figure B.15 shows the conditions at the mouth of the Albert River.

Figure 2.15: Aerial view of mouth of Albert River showing channel widening. The confluence of the Albert and Gordon Rivers is towards top of the photo. Tree fall is associated with seepage erosion and scour.

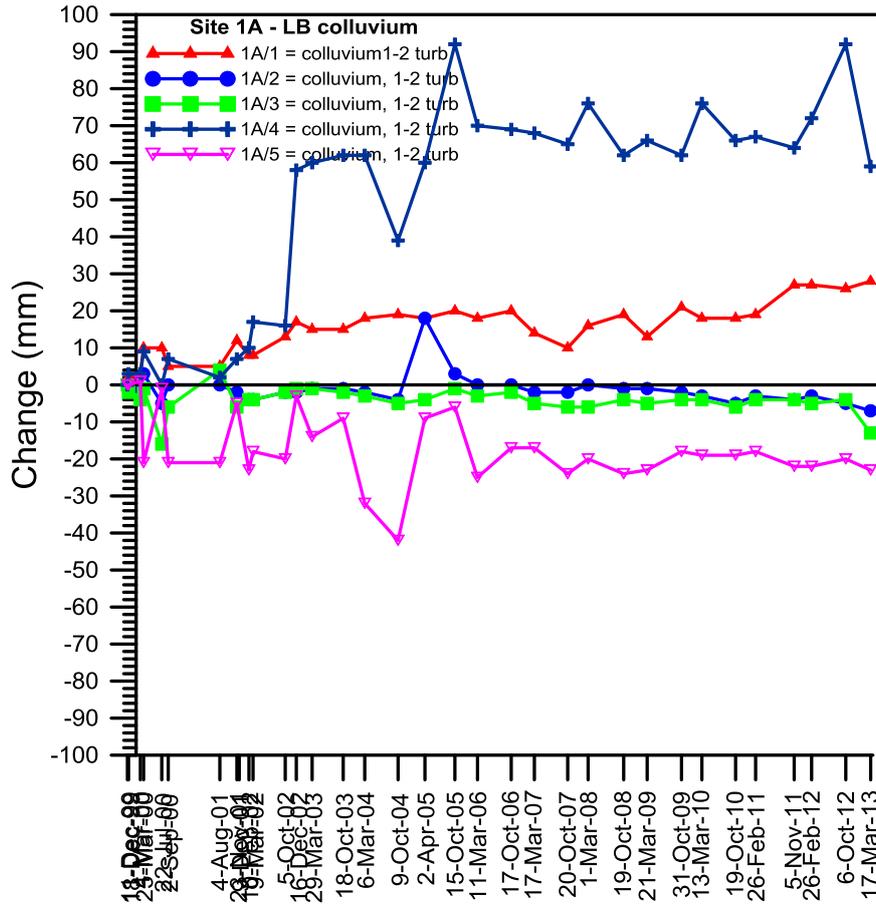
Pins in general have recorded no / little change or erosion. This is consistent with lack of seepage processes observed at site. The pin (pipe) 1A/3b has shown the largest erosional change. The sudden increase in erosion in October 2006 and February 2011 is associated with rupture, slumping and erosion of the local root-mat.

Figure 4.3: Erosion pin results from site 1A (pins 1-5).

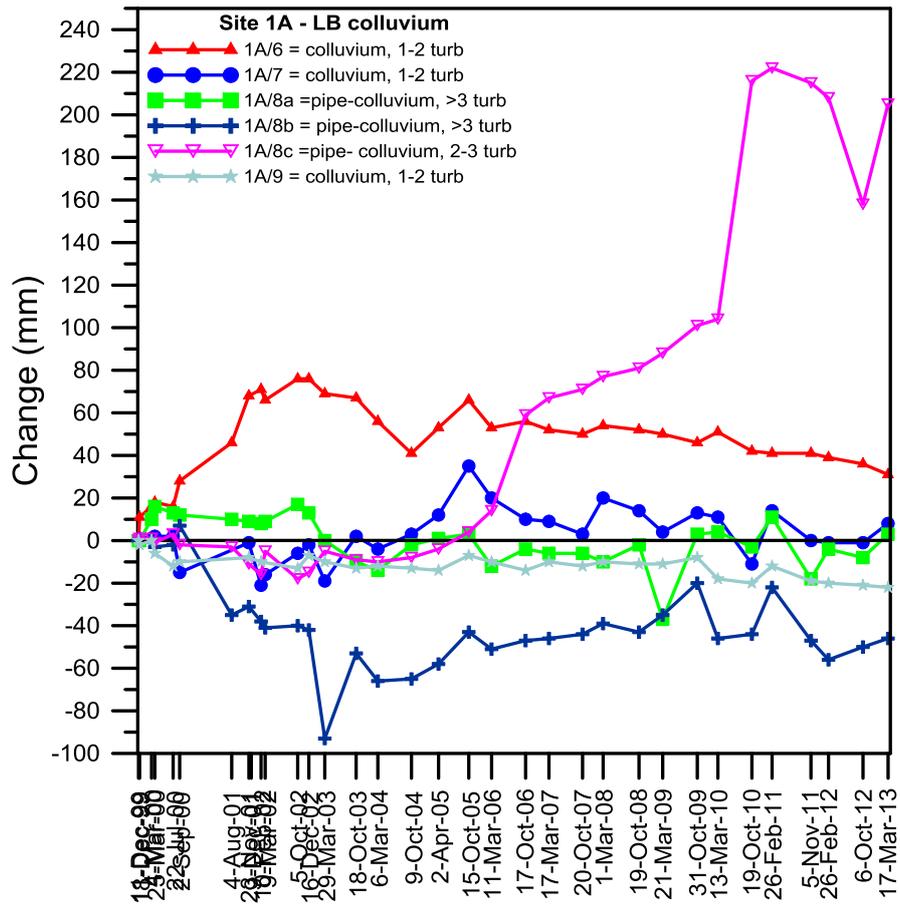
Figure 4.4: Erosion pin results from site 1A (pins 6-9).

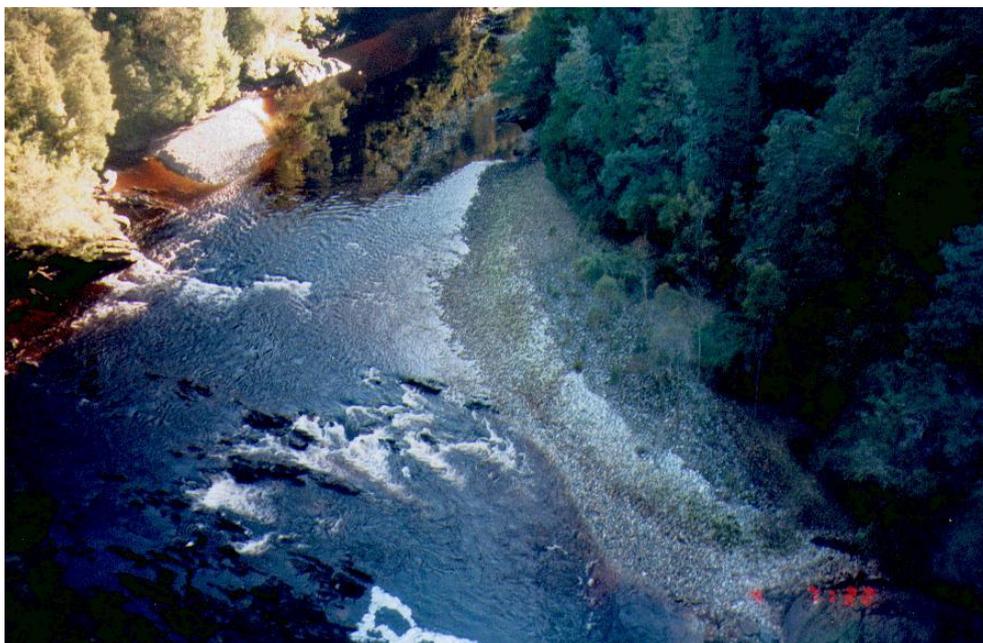
Erosional processes: Scour is the dominant process observed on the bank face, but erosion pin site appears to be protected from main flow due to position and presence of cobble bar. The right bank of the river has been scoured to bedrock. Pins and scour chains installed near base of bank have recorded scour over Basslink monitoring and vegetation and degraded root-mat have crept downslope. No evidence of seepage erosion has been observed at the site. A large Huon pine tree has progressively 'rolled' downslope over the duration of monitoring and branches are now on the ground. In March 2013, a large tree 'break' was observed on site, with the trunk snapping in the 1 to 2 turbine bank level – probably due to prolonged saturation.

Figure 4.7: View looking upstream of erosion pin site 1A, on left bank (right of picture) behind cobble bar.

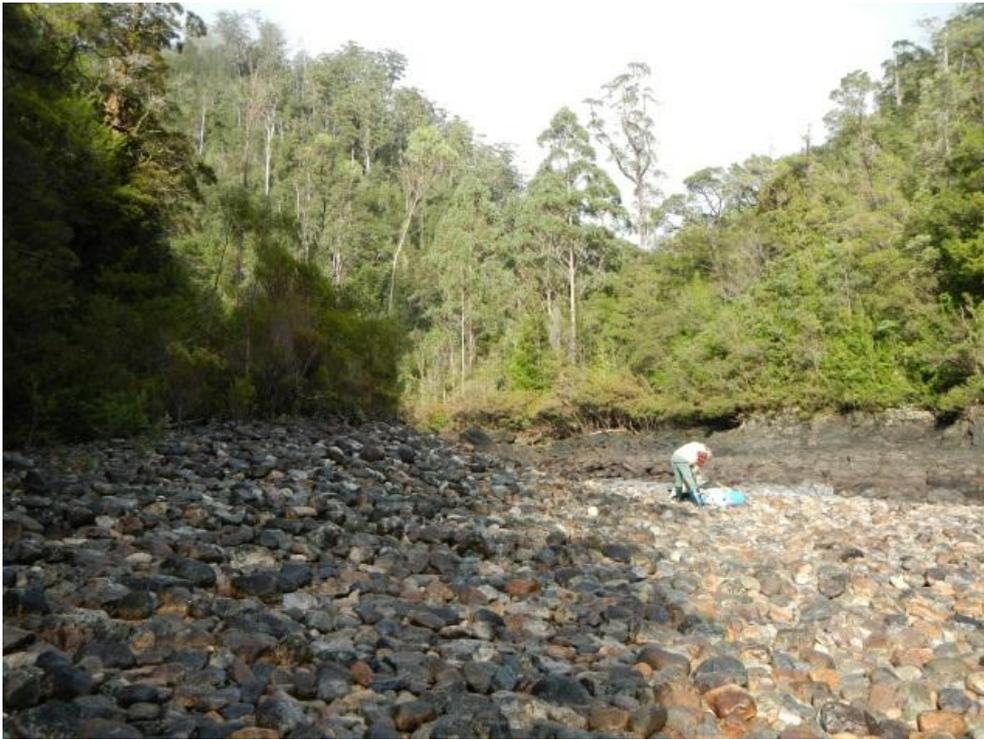
Figure 4.8: Site 1A Feb 2013 - view facing downstream of cobble bar in front of site 1A which is on left bank behind the bar.

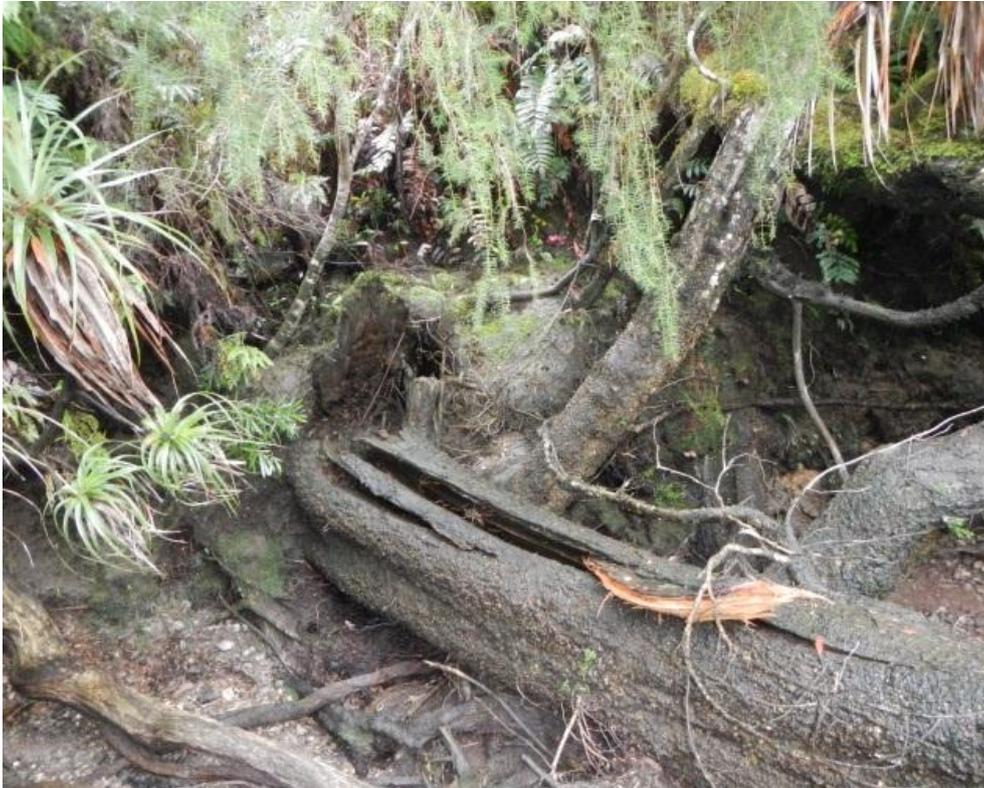
Figure 4.9: Site 1A February 2013 – Section of colluvial bank showing recent tree break. Photo is typical of site with vegetation overhanging colluvium.

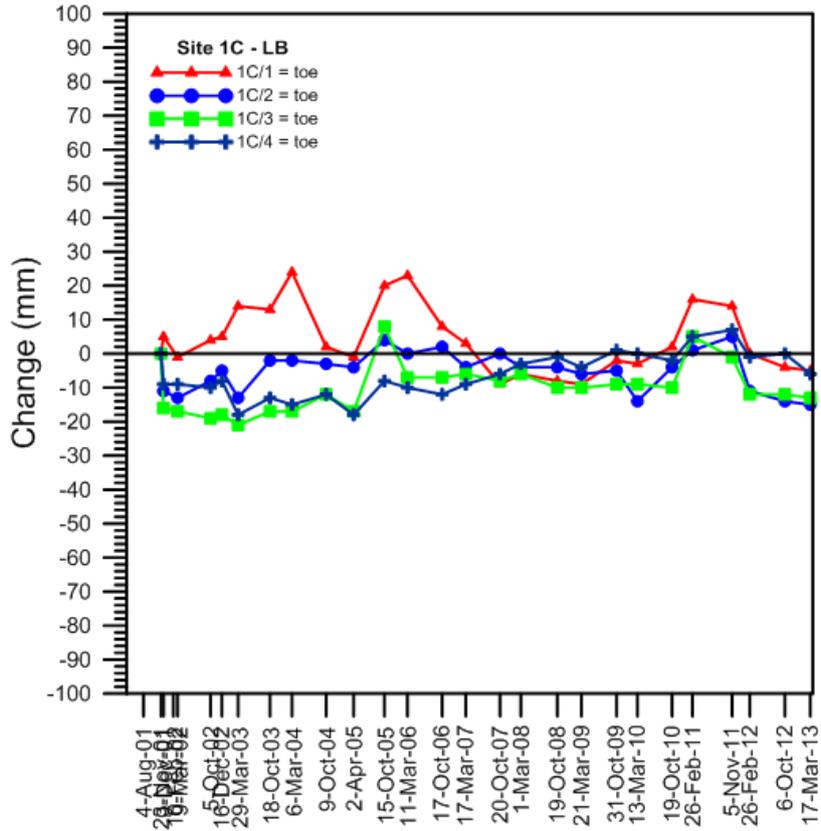
Erosional Processes: Scour is the dominant erosional process at the site. The bank appears to have a dynamic equilibrium with the regulated flow-regime prior to the commencement of Basslink monitoring, as there has been little change recorded at the site over the 10-year monitoring period.

Figure 4.16: Erosion pin results from site 1C.

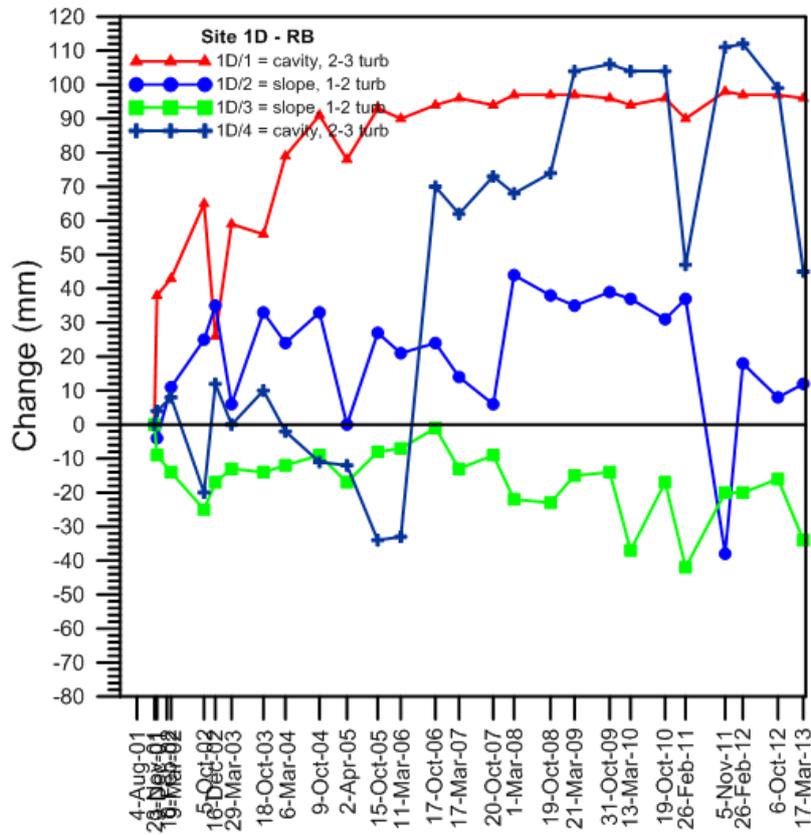
Erosional processes: The cavities initially recorded scour, but have shown little change over the last 5 years. The bank slopes have recorded variable changes. Field observations include slumping of the overlying root-mat, similar to that observed at the sites 1A and 1B.

Figure 4.21: Erosion pin results.

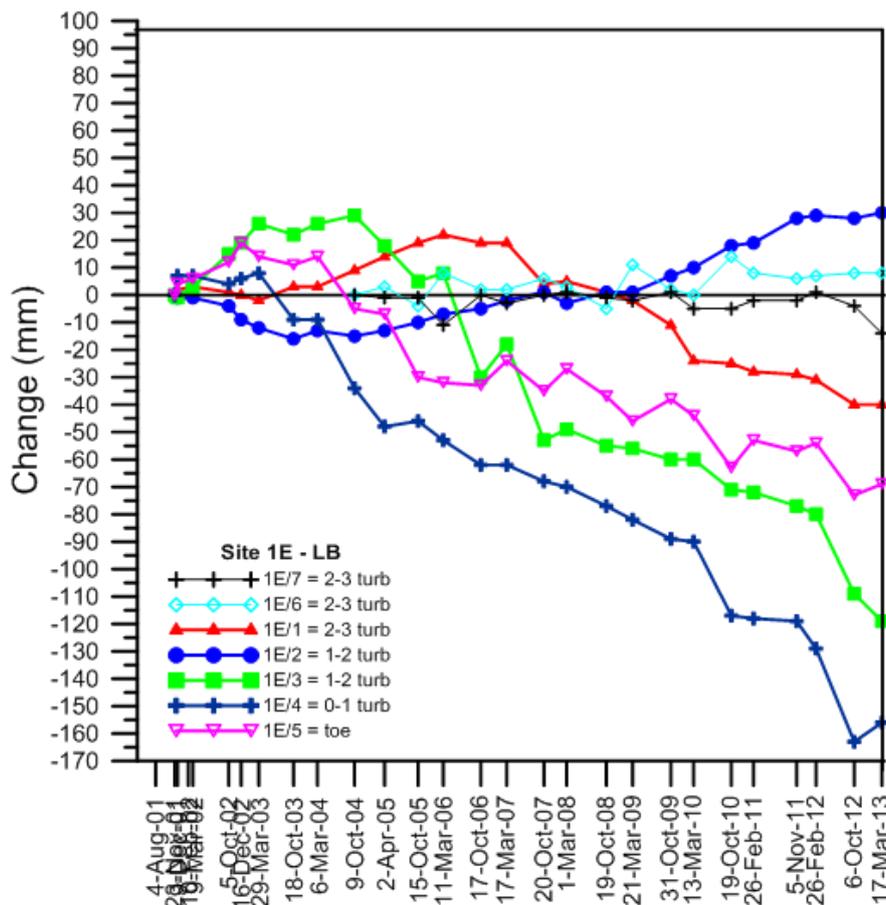
Erosional Processes: The dominant erosional processes on this bank are scour of the tea tree root-mat, followed by seepage processes leading to a reduction in slope of the exposed sands. Some of this flattening may be attributed to the introduction of the environmental flow which results in the original ‘bank toe’ being continuously inundated (except during Basslink monitoring). No sediment flows have been observed on the bank.

Figure 4.27: Erosion pin results from site 1E.

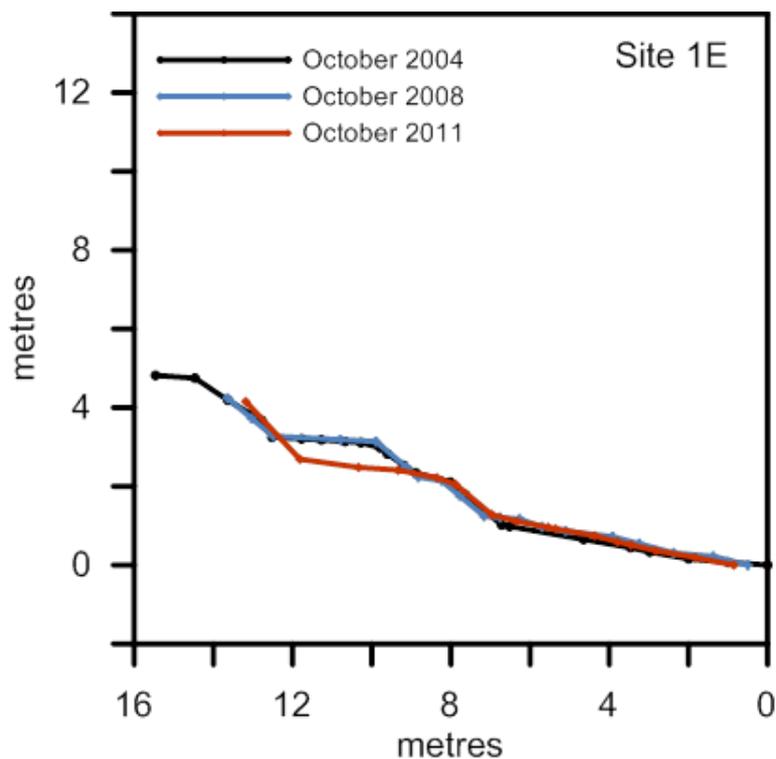
Figure 4.28: Bank profiles of site 1E. Erosion pins do not record scour, suggesting 2011 profile is not in exact same location.

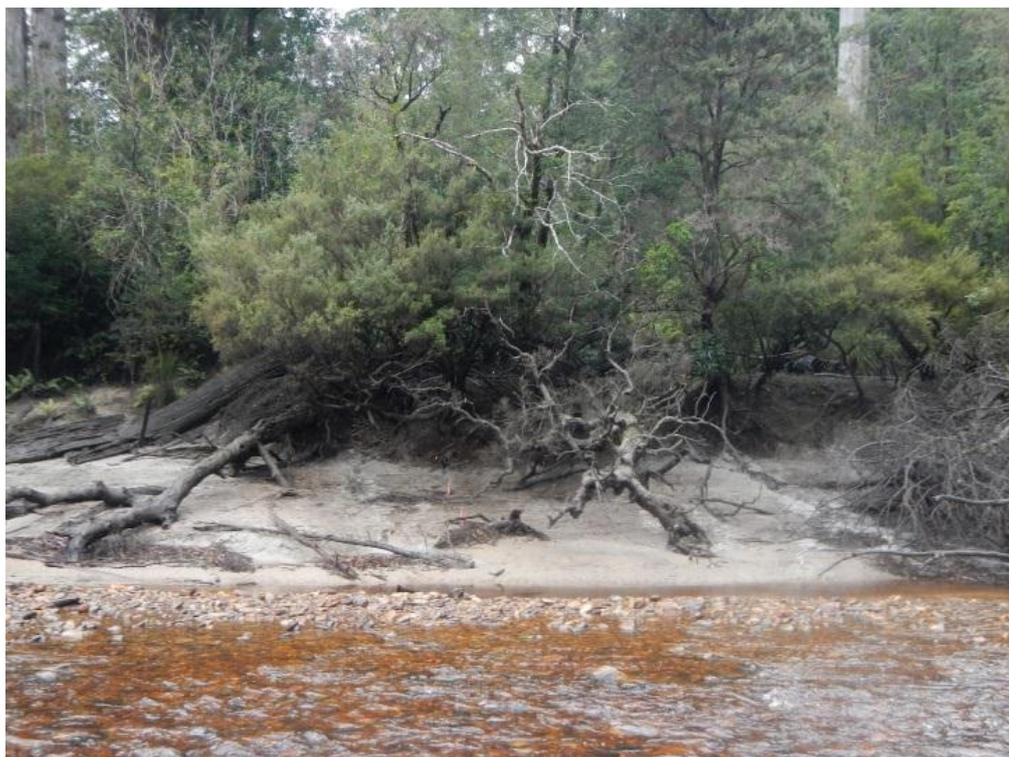
Figure 4.34: Site 1E February 2013 - Erosion pin profile is directly below tree-fall in centre-right of photo. New profile has been installed upstream (left in photo).

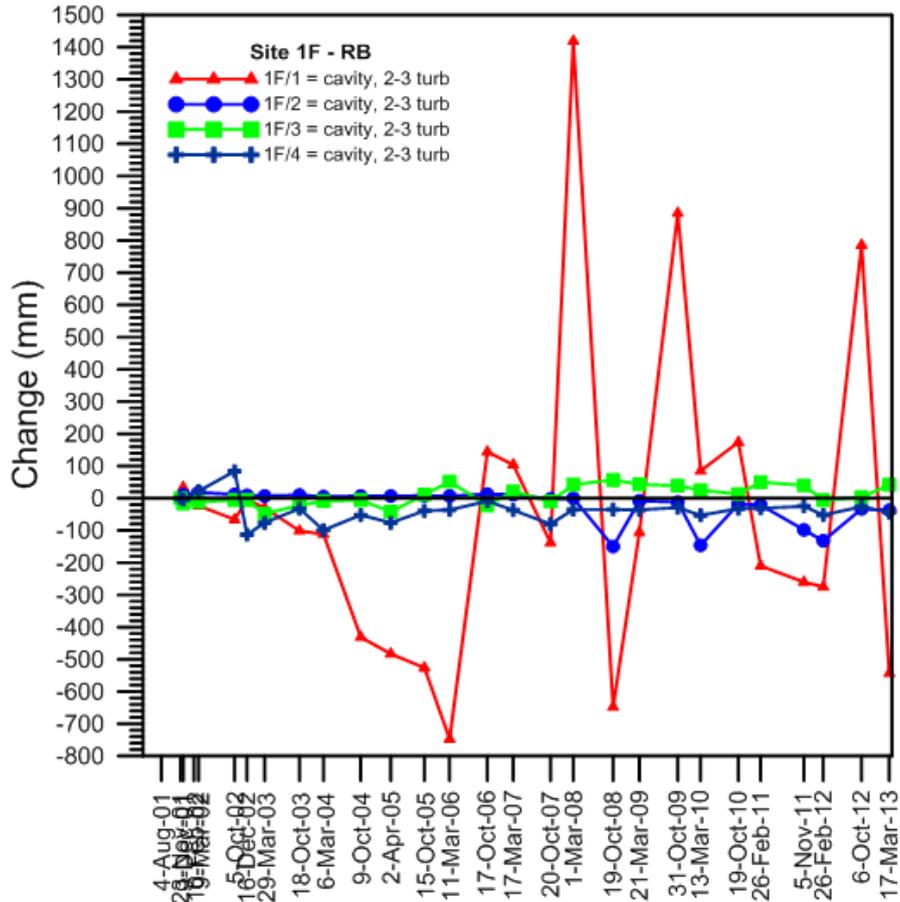
Erosional Processes: Similar to the other colluvial sites, the predominant process is the slumping and erosion of the overlying root mat. Little sand and no sediment flows have been observed at the site for the past few years.

Figure 4.35: Erosion pin results from site 1F (pins 1-4).

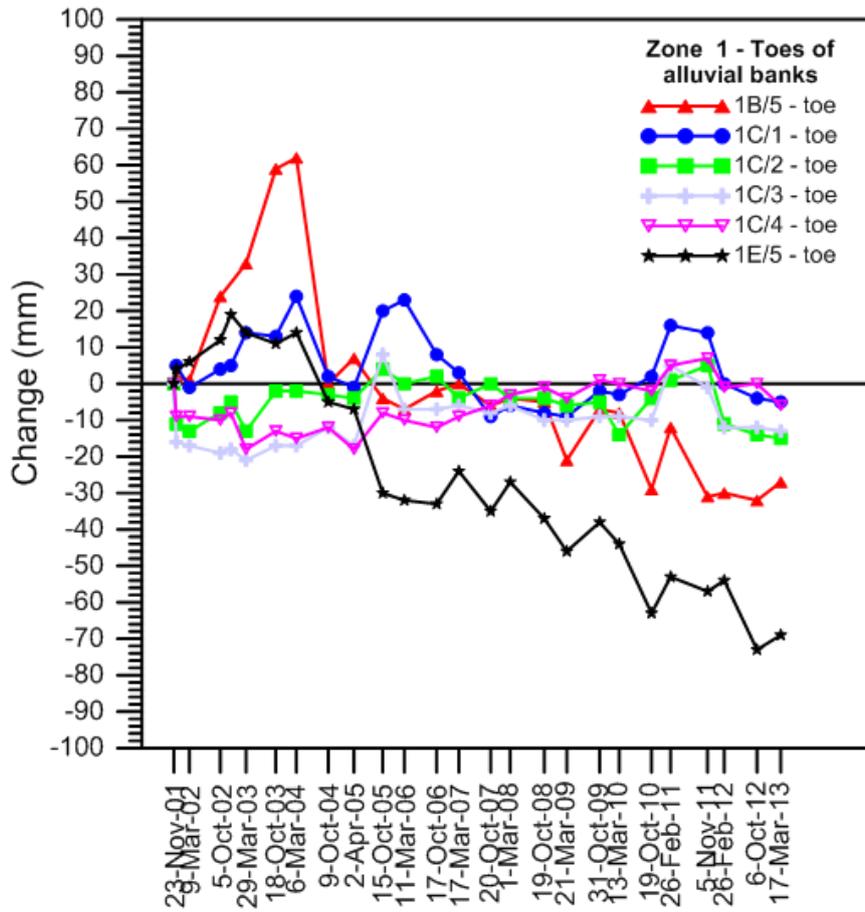
Figure 4.43: Erosion pin results from bank toes in zone 1.

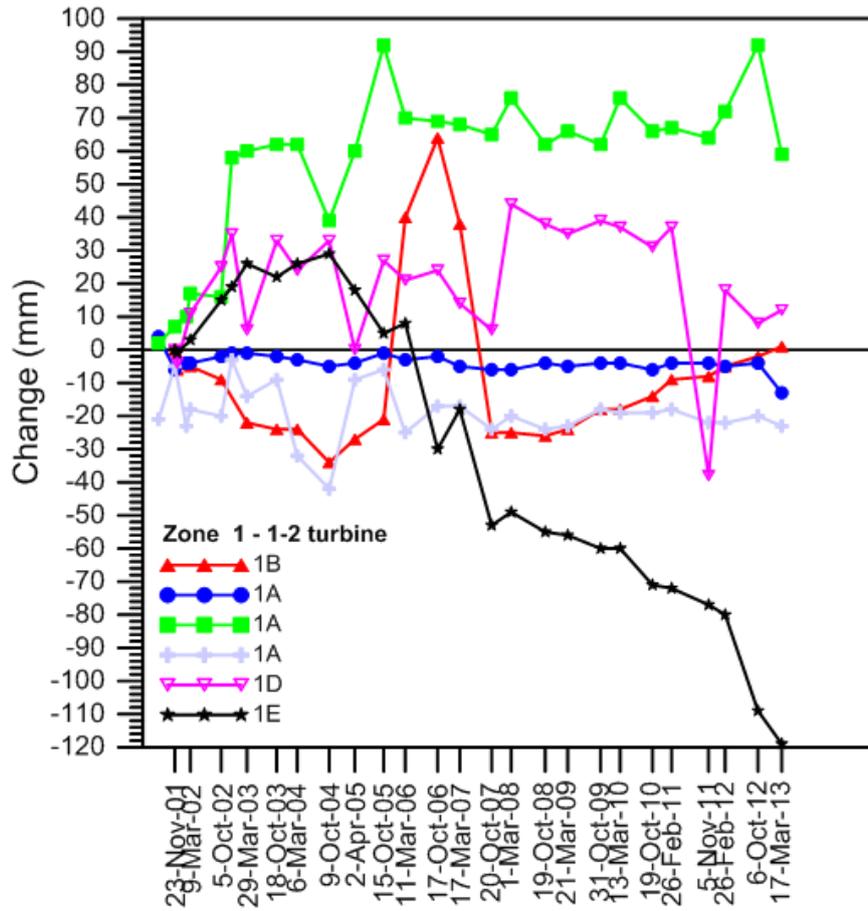
Figure 4.44: Erosion pin results from pins in 1-2 turbine bank level in zone 1.

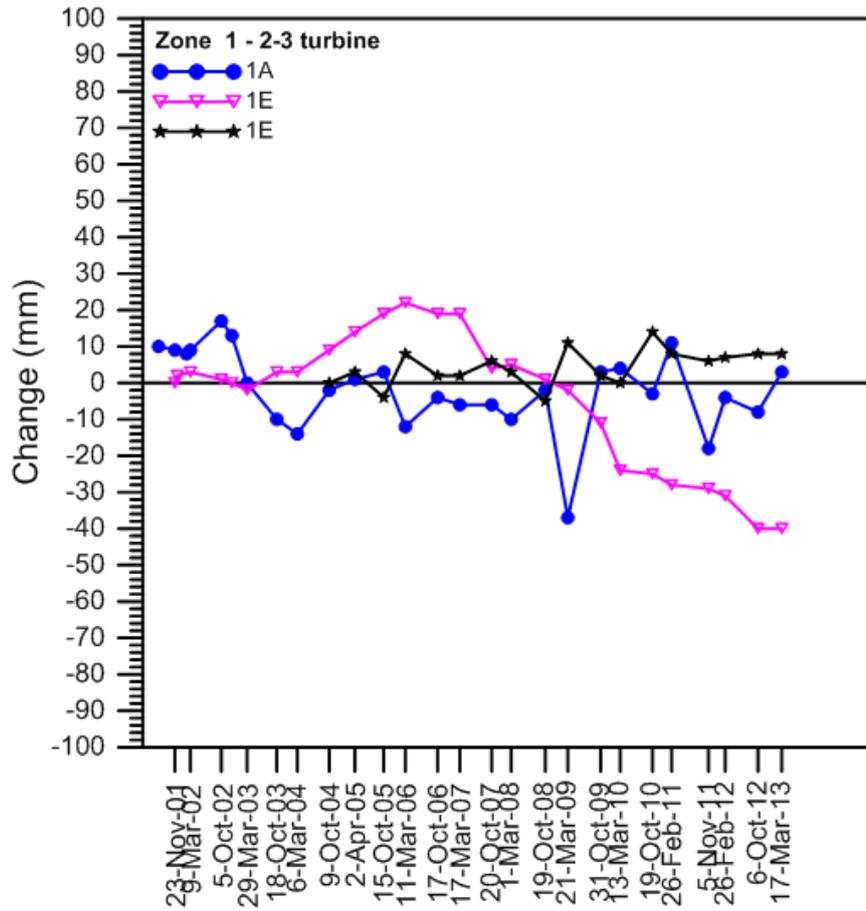
Figure 4.45: Erosion pin results from pins in 2-3 turbine bank level in zone 1.

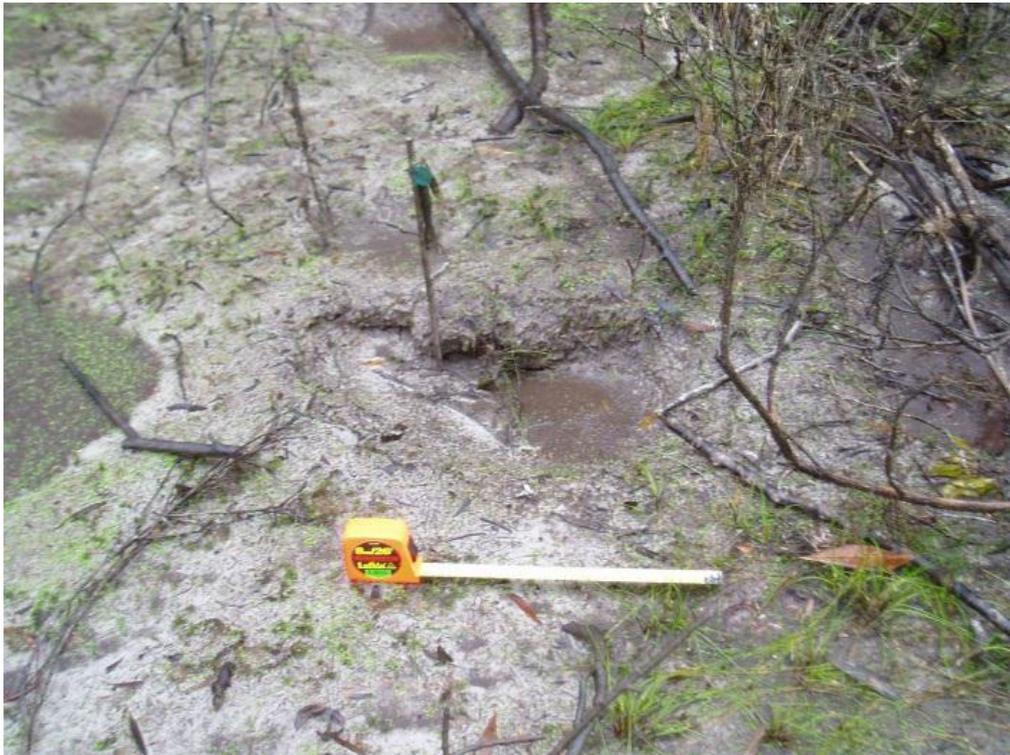
Figure 4.56: Site 2A backwater October 2006. Scour hole at base of pin 2A/7.

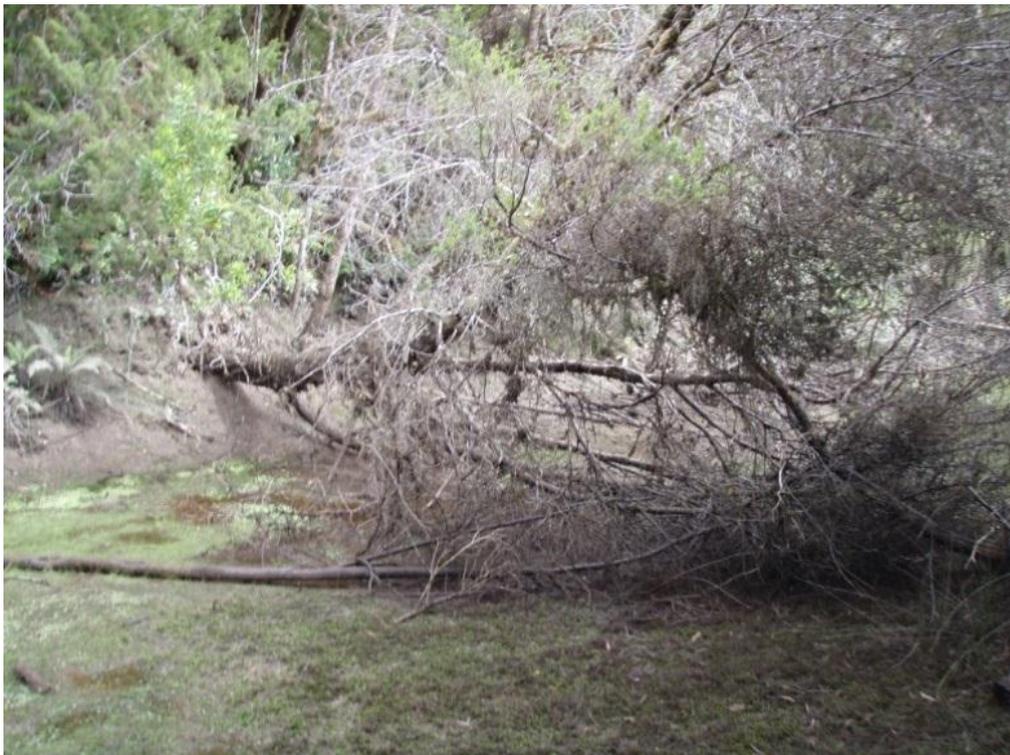
Figure 4.57: Site 2A Backwater December 2007. Left bank of back channel showing tree fall.

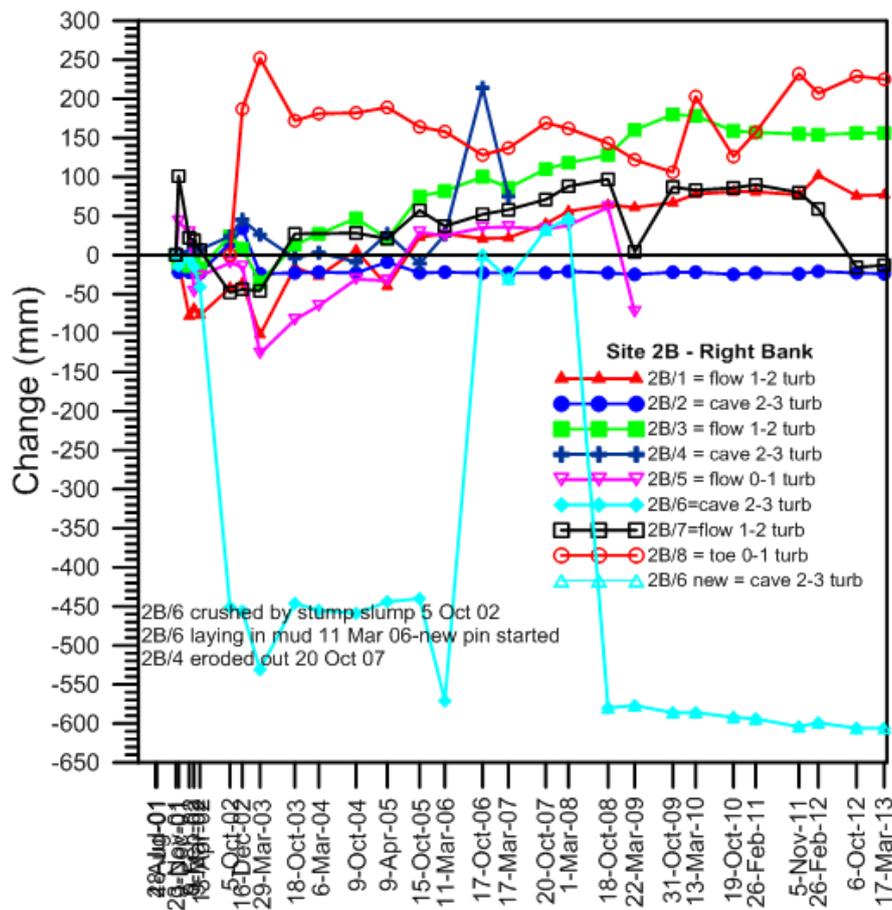
Erosional Processes: Initially the site showed evidence of seepage erosion, but over the period of monitoring erosion has been the dominant process. One cavity has shown little change over time, while the second cavity has collapsed. No sediment flows were observed following the collapse, possibly due to scour removing the material.

Figure 4.60: Erosion in results from site 2B.

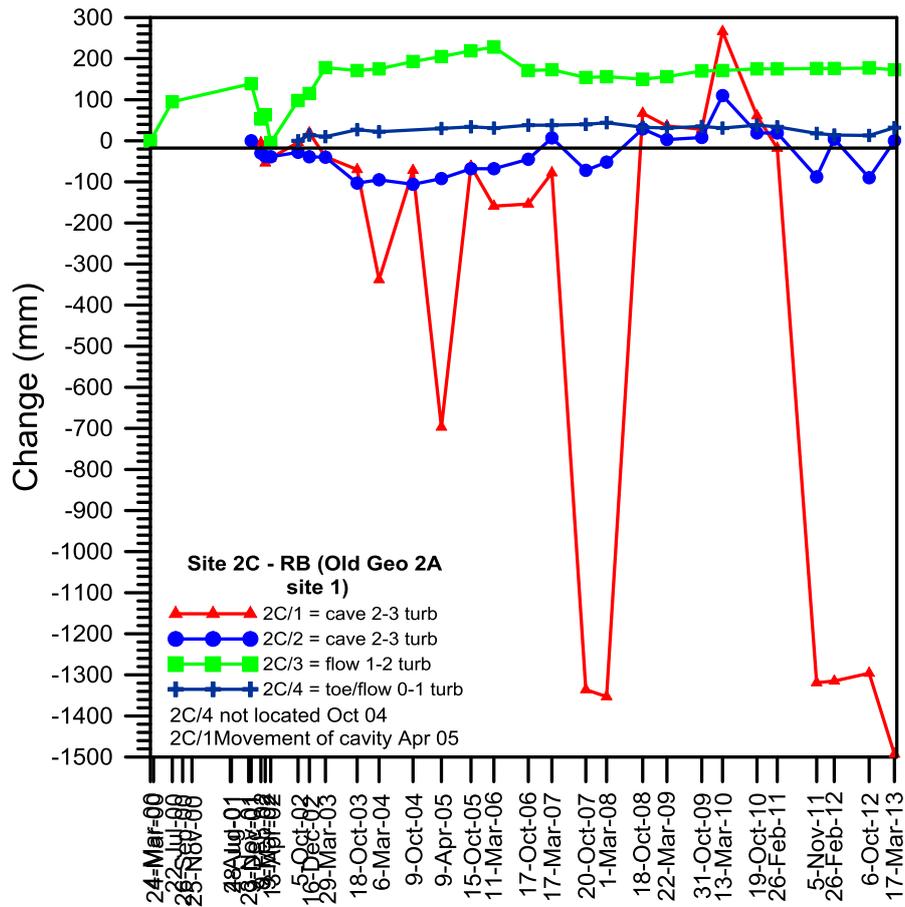
Erosion Processes: This site is one of the ‘wettest’ sites in the river. During the initial IIAS investigations, seepage flows were observed at the base of the root-mat, and the bank itself was prone to seepage processes. The collapse of the root-mat and relatively low level of activity at the site suggests that there was a period of rapid change which coincided with the IIAS and initiation of extended 3-turbine power station operation. The bank profile has changed from convex to concave over the monitoring period, suggesting that there is less material being transported from under the root-mat onto the bank.

Comment: This bank drains slowly compared to other banks and has likely been substantially altered due to field personnel stepping on the bank when very wet.

Figure 4.70: Erosion pin results from site 2C.

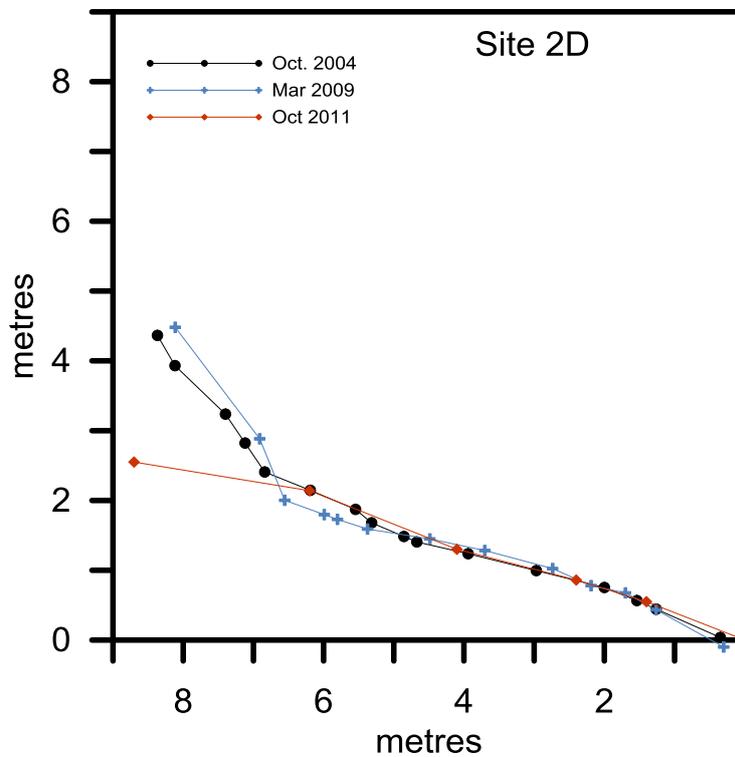
Comment: it is likely the toe of this bank is subjected to very different hydraulic conditions under different flow rates, ranging from scour to fluvial deposition as part of a back-water eddy.

Figure 4.82: Bank profiles differ due to 2013 profile collected along different transect on bank face during combined vegetation and geomorphology monitoring.

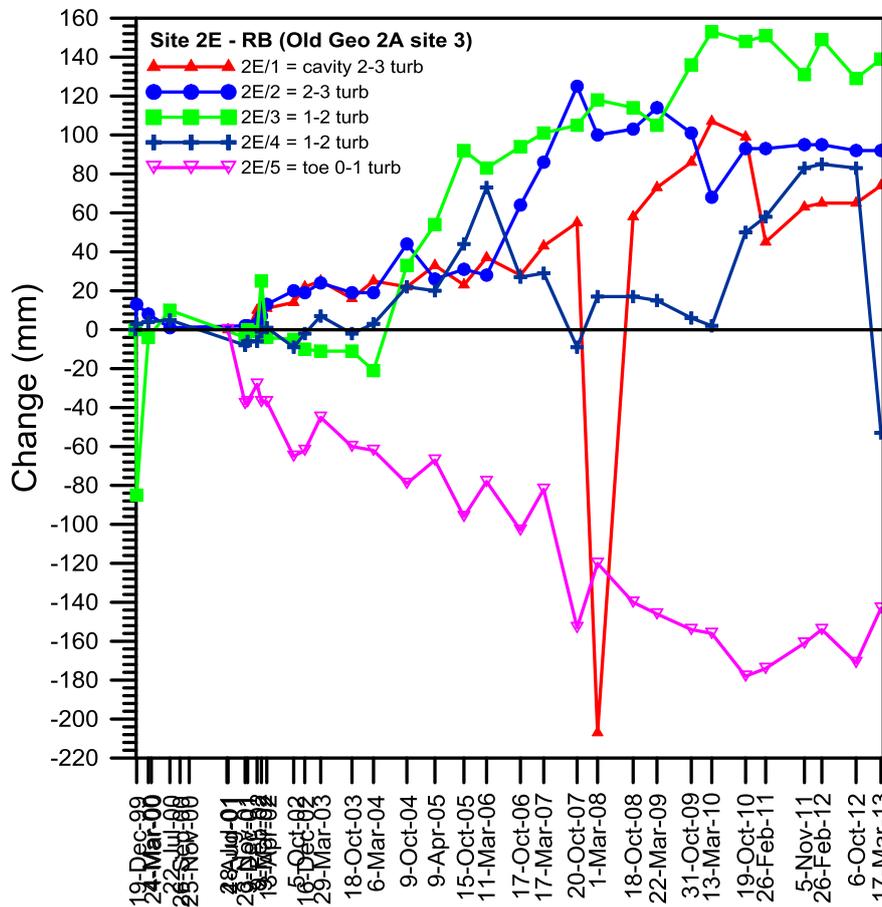
Figure 4.91: Site 2E Erosion pin results.

Erosional Processes: Scour is the predominant process affecting the 1-2 and 2-3 turbine levels. The toe of the bank is flattening through local seepage process. During the initial IIAS investigations sediment flows were observed at this site, but have not been observed for many years.

Comment: Erosion pin 2E is a pipe which is contributing to bank stability by supporting the bank.

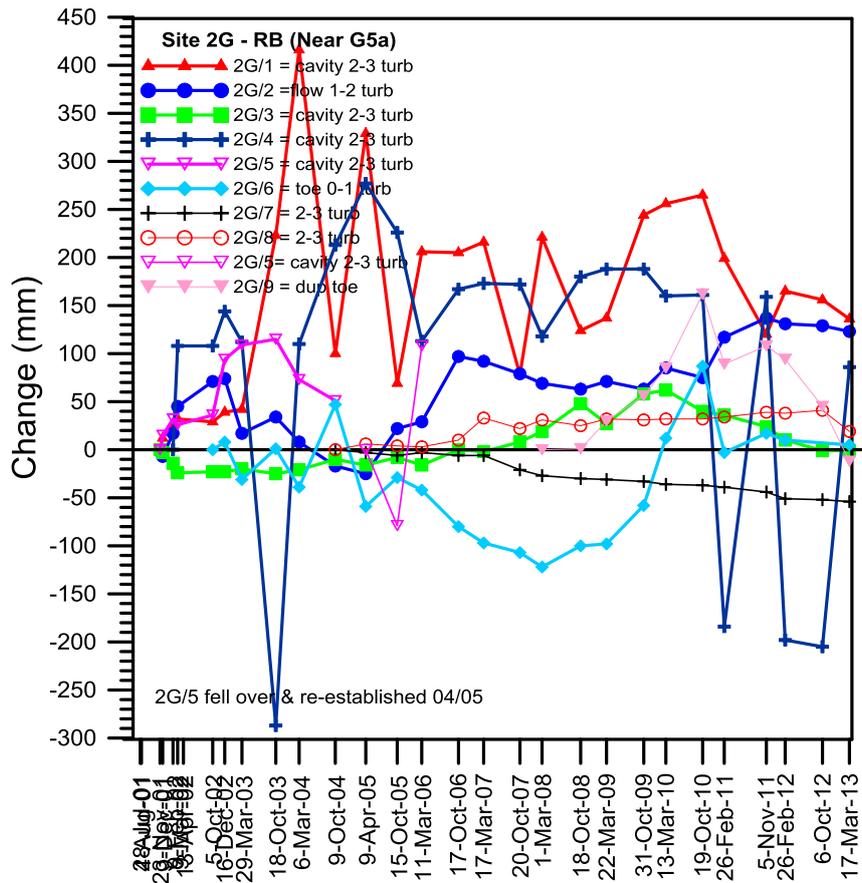
Figure 4.99: Erosion pin results from site 2G.

Erosional Processes: Characteristics of this site include large rills and tension cracks in the sandy lower bank and toe, reflecting local seepage processes. However, the erosion pins tend to record variable results, with net erosion recorded at most pins over the duration of monitoring period. The vegetation mat is slowly being scoured away, revealing a low angle bank under the mat. It is likely that the root system associated with the very large tree is providing bank stability.

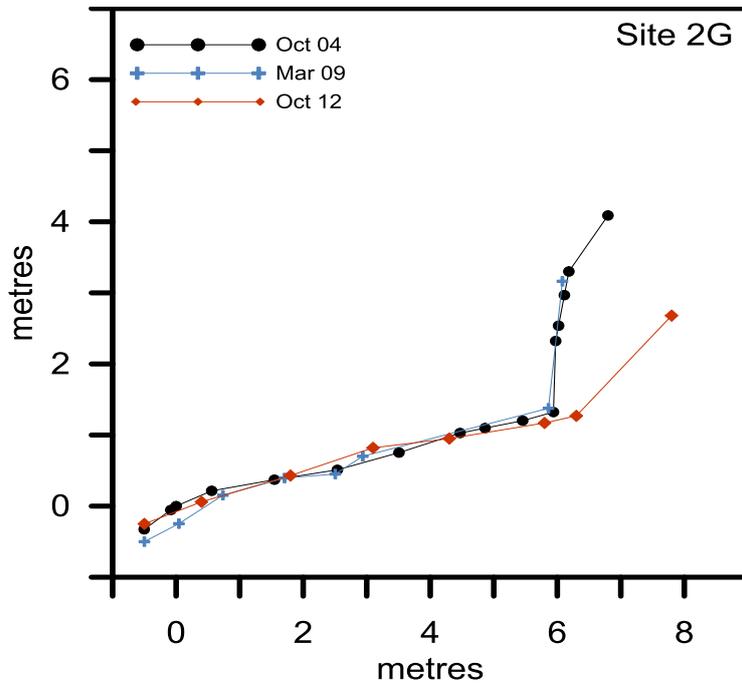
Figure 4.100: Bank profiles form site 2G. 2004 and 2009 profile shows surface of vegetation mat, 2012 profile measures into cavity as root-mat has scoured.

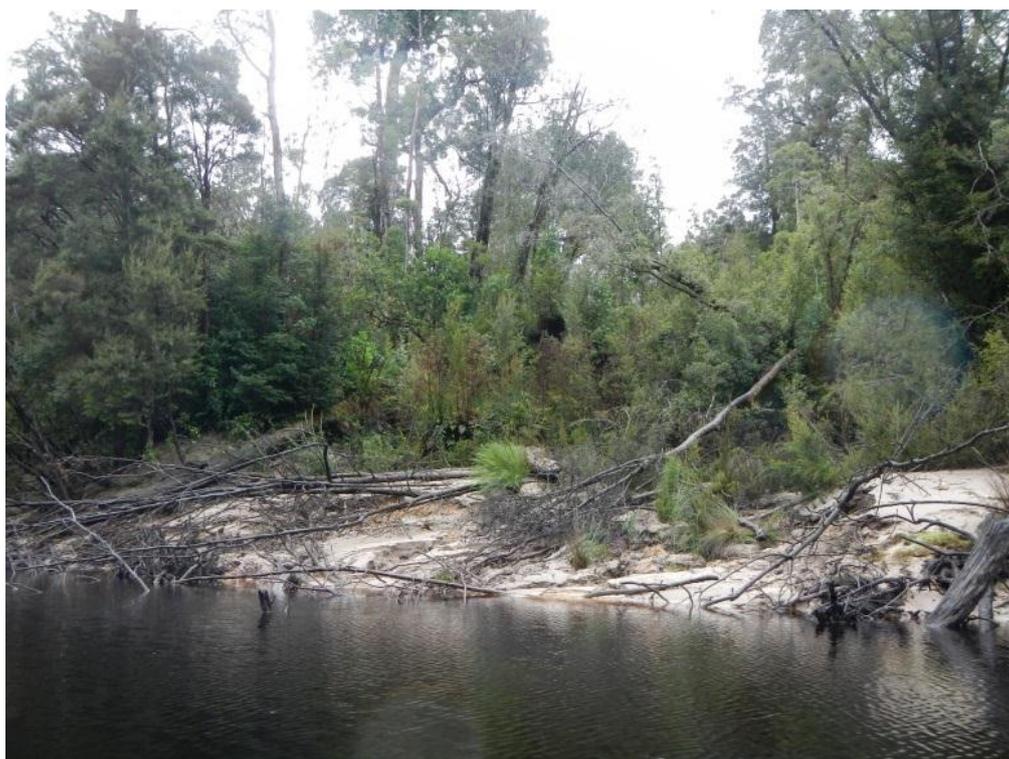
Figure 4.110: Photo monitoring site 2-5.

Comment: If/when the large tree collapses, the site is likely to become similar to photo monitoring site 2-5 which is situated just upstream on the same bank, and is characterised by a long, relatively flat sandy toe with abundant woody debris grading back to a steep break in slope. A photo of this site is shown at the end of the site 2G photos.

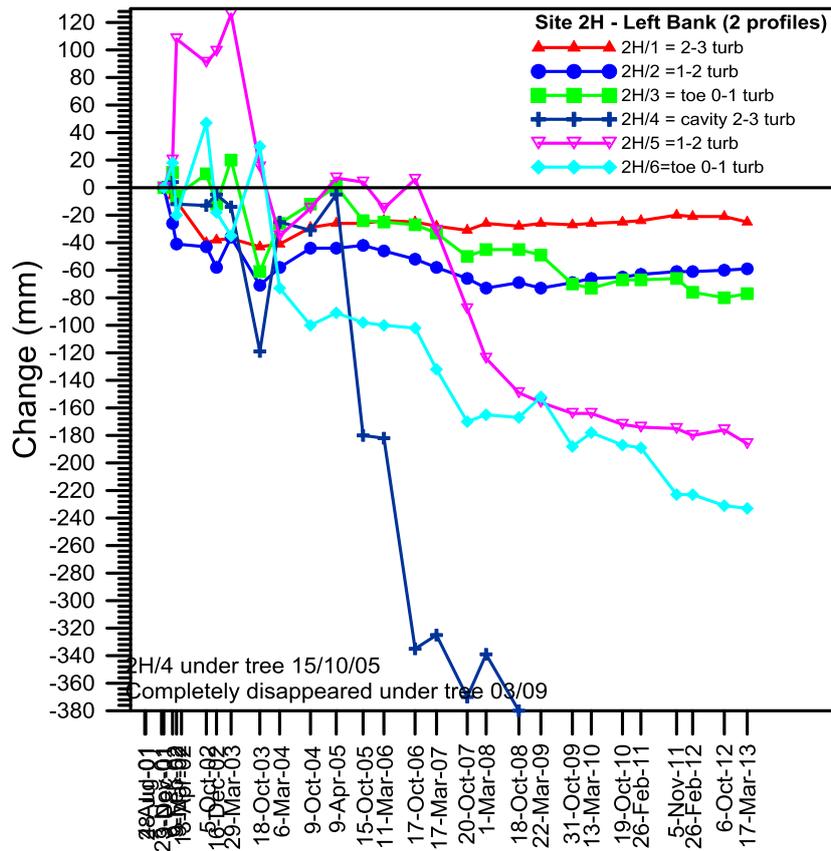
Figure 4.111: Site 2H erosion pin results.

Erosional Processes: This site has it all. The area that supports tea tree is dominated by scour, with the root-mat slowly disappearing. In the past ~3 years, small sand deposits have been present at the base of the degraded root-mat during monitoring, suggesting that sand is being transported under the root mat. The erosion pins in the tea tree profile in the 1-2 and 2-3 turbine levels recorded net deposition during the first two years of monitoring, and little change since. The toe pin of this profile, which is below the level of the root-mat has recorded slow deposition reflecting the ‘flattening’ of the toe over time. The deposition of the pins on the upper bank is probably also reflecting seepage related flattening associated with periods when the bank was saturated.

The pins in the profile associated with the seepage features have shown higher levels of deposition associated with active seepage processes. Pin 2H/4 was lost due to a large Huon pine tree moving downslope over the pin. At present, only flagging tape is visible extending from under the tree. Between April 2005 and October 2008 the tree moved ~380 mm downslope, or about 185 mm/year.

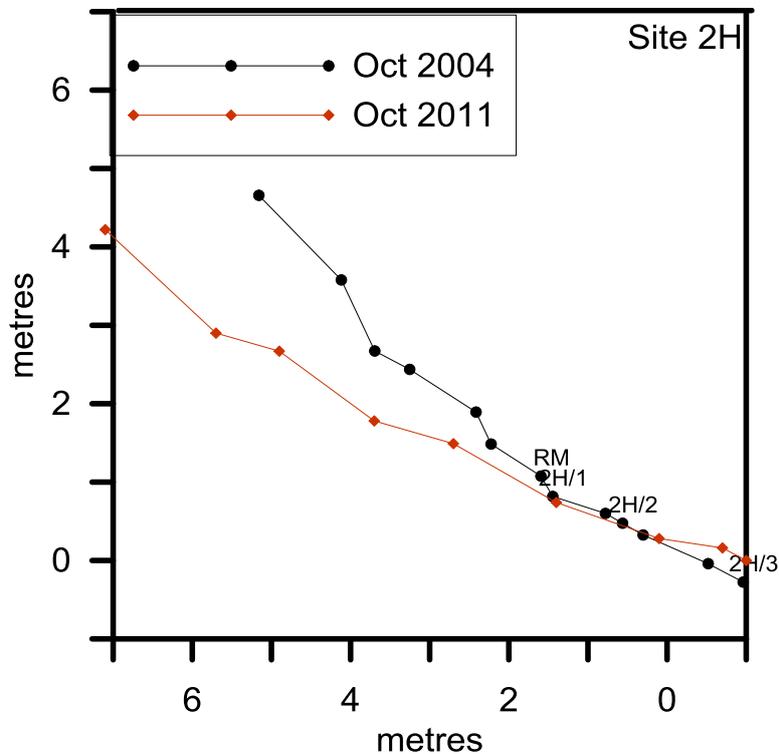
Figure 4.112: Approximate bank profiles for site 2H. 'RM' is location of root-mat. Profiles not collected at exact location in 2011 which accounts for change in upper bank. The flattening of the bank toe is consistent with the erosion pin results.
