Basslink Review Report 2006-12
Gordon River Basslink Monitoring Program
The Appendices

May 2013

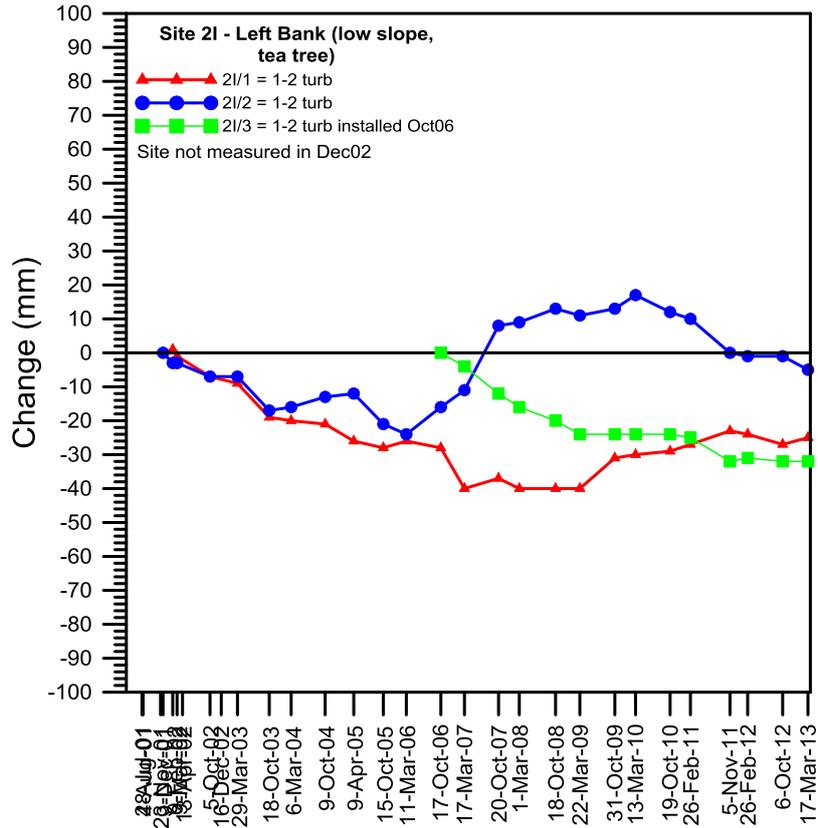
Erosional processes: The toe of the bank is stabilised by a degraded root-mat. The mat and bank toe are being scoured. The surface of the bank, where the erosion pins are located, shows little change. The deposition recorded by the pins is likely associated with the accumulation of organic matter and fine sediments during periods of low power station usage, and sands being washed down slope from under the root-mat.

Comment: It is likely the toe of this bank will continue to scour, revealing the underlying cobbles.

Figure 4.118: Erosion pin results for site 2I. Pin 1 is highest on the bank, pin 3 is lowest.

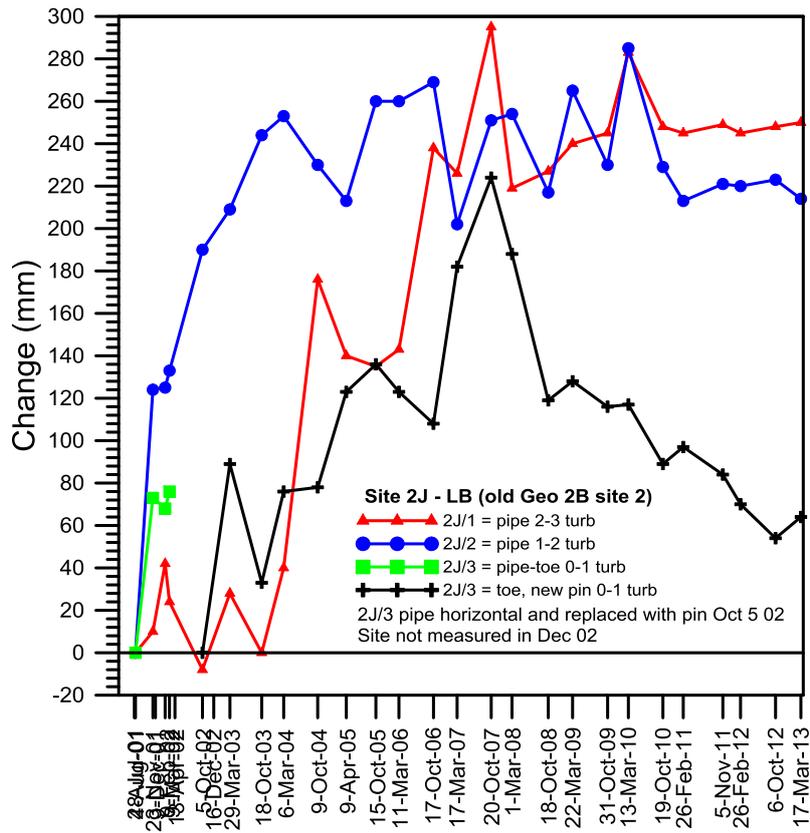
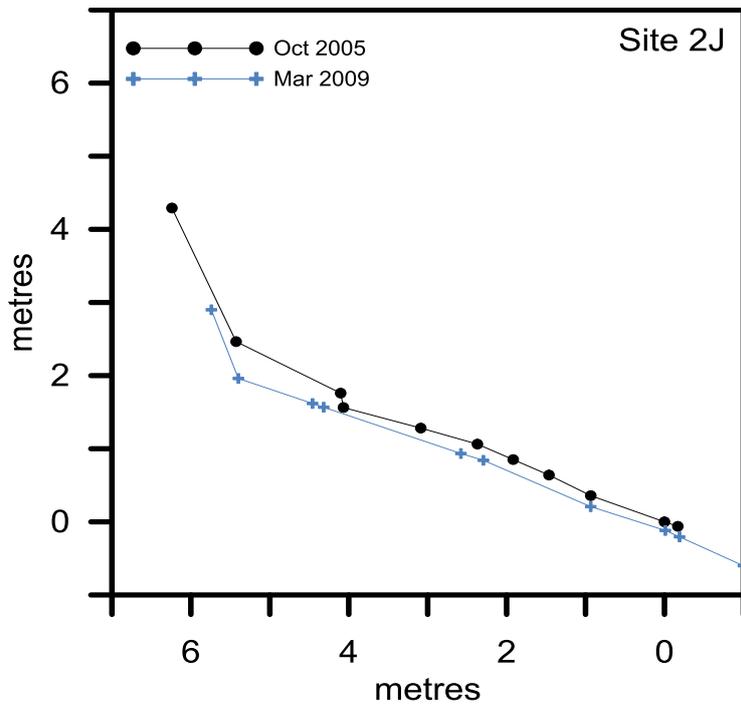
Figure 4.127: Erosion pin results from site 2J.

Comment: This bank, along with the adjacent site 2K always appear very active, and erosion pins which were installed vertically end up pointing towards the river reflecting the movement of the bank.

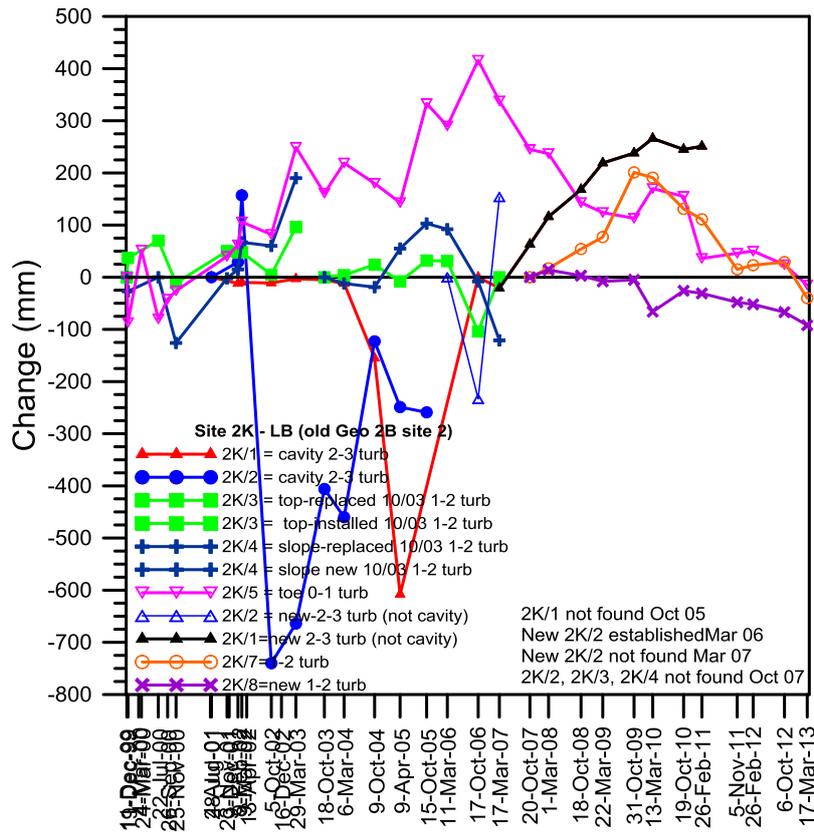
Figure 4.134: Erosion pin results form site 2K.

Comment: Similar to site 2J this is a highly active site. The bank toe appears to see-saw depending on the relative contributions from scour and the deposition of seepage derived material.

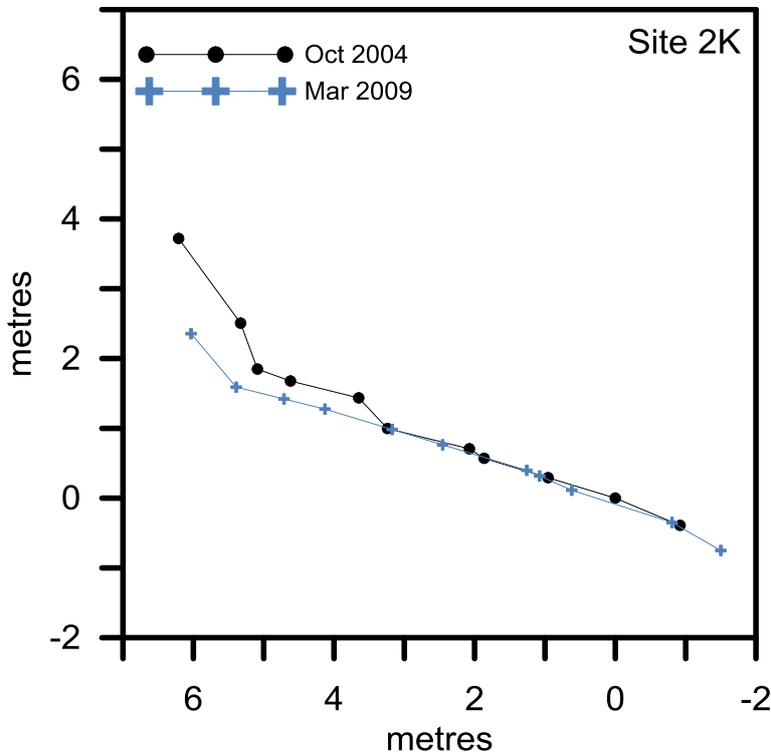
Figure 4.135: Bank profiles from site 2K for October 2004 and March 2009. Removal of material at back of site is associated with the erosion of the vegetation mat.

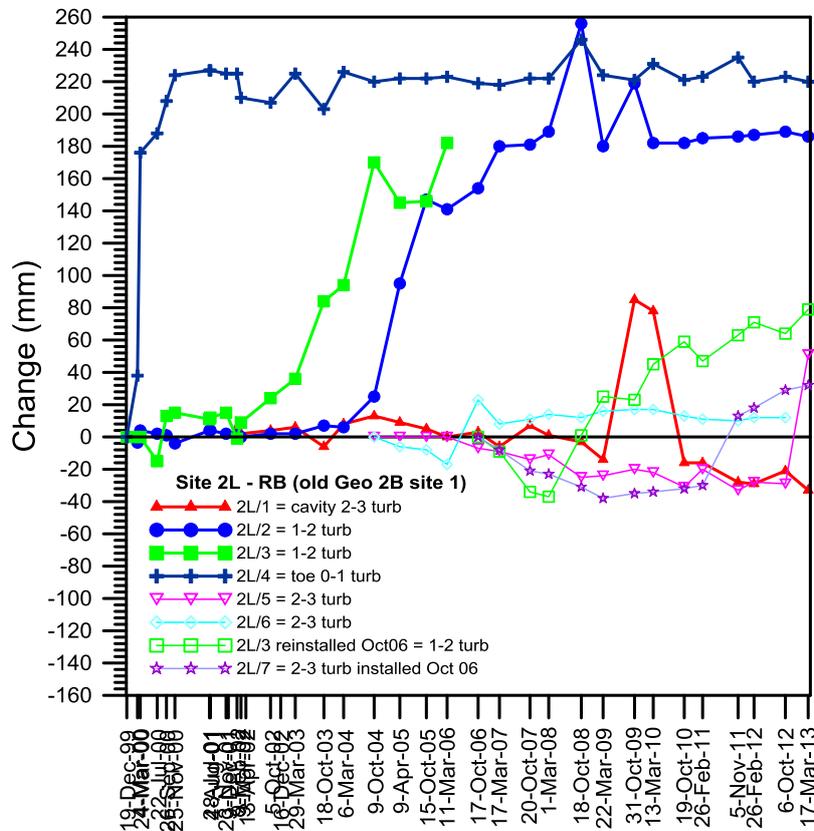
Figure 4.142: Erosion pin results for site 2L.

Comment: This site could show some interesting changes over the next few decades.

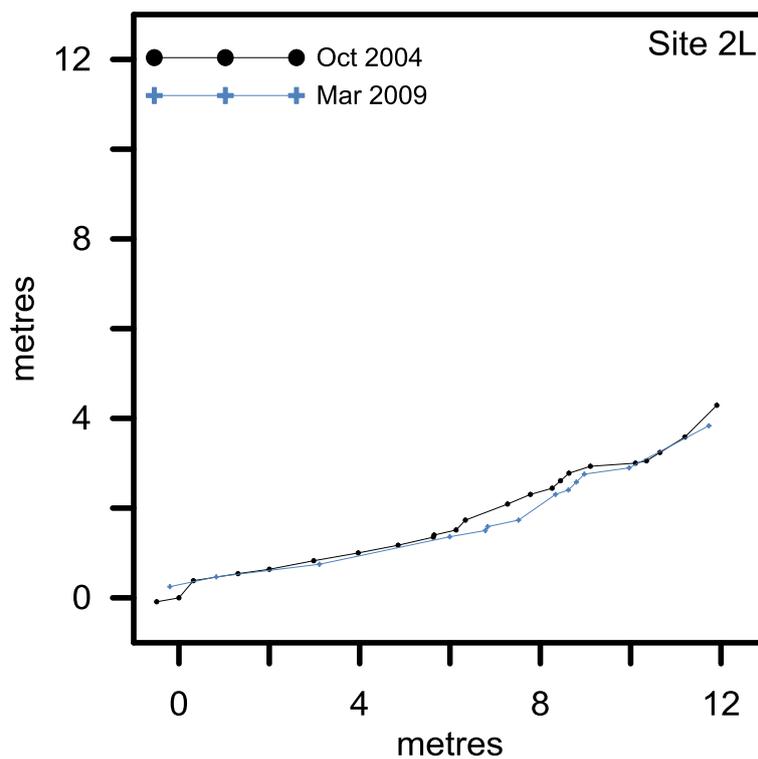
Figure 4.143: Bank profiles for site 2L from 2004 and 2009 showing erosion in 1 – 2 turbine bank level.

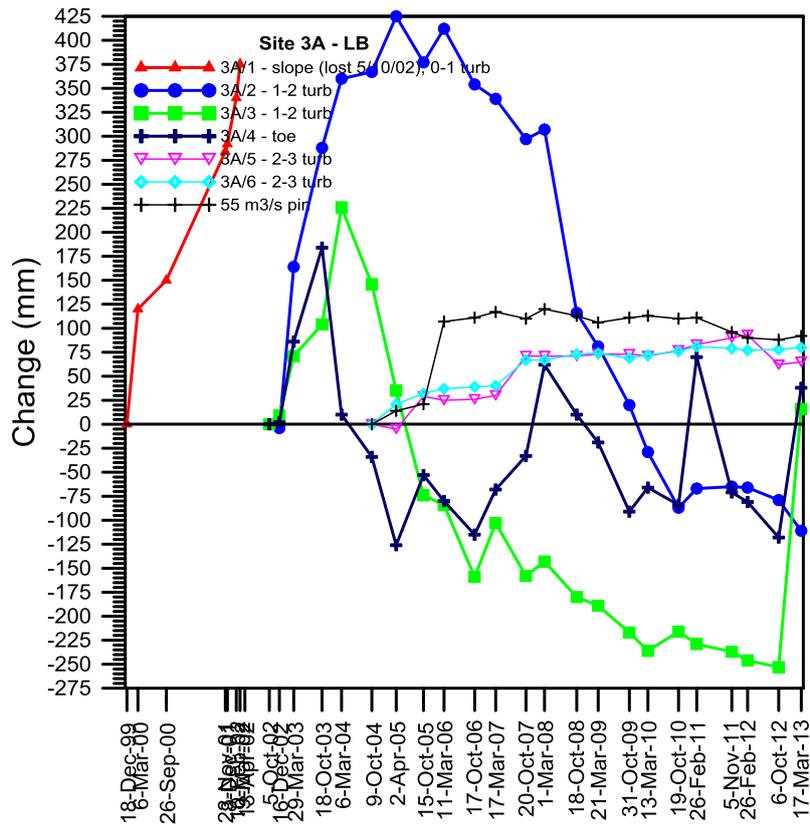
Figure 4.162: Erosion pin results from site 3A.

Erosion processes: Site 3A is one of the few sites where fluvial deposition is commonly observed. At this site, the toe is affected by scour and deposition, with the toe results showing variable changes over the period of monitoring of ± 175 mm. The 1-2 turbine bank level has also shown large fluctuations, whereas the 2-3 turbine level, which is located in the tea tree bank behind the sandy toe, has recorded erosion, consistent with other tea tree bearing banks in the middle Gordon.

Comment: The deposition of mud veneers on bank toes is common throughout zone 3, and is presumably also related to the reduction in flow velocity due to the Denison River inflow.

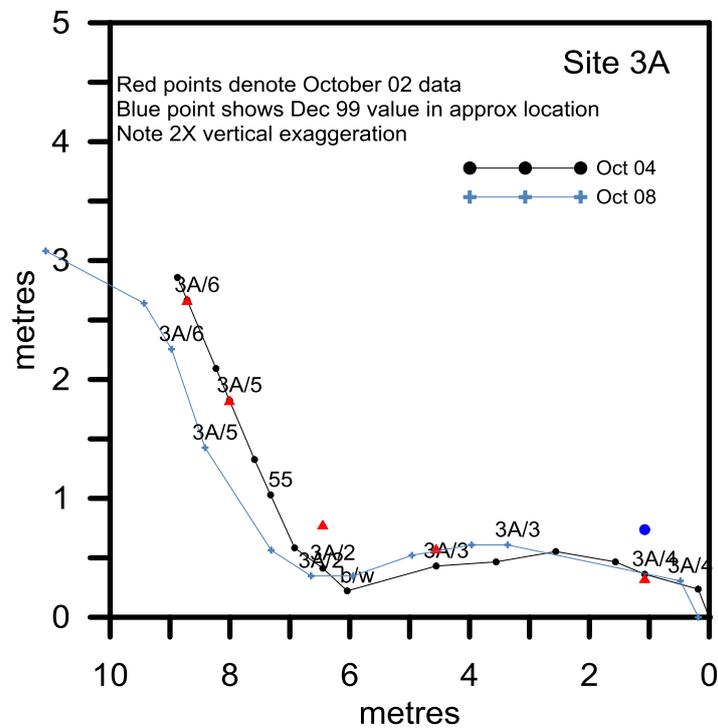
Figure 4.163: Bank profiles from 2004 and 2008. Changes to pins 3A/5 and 3A/6 are ~75 mm showing the profiles are off set.

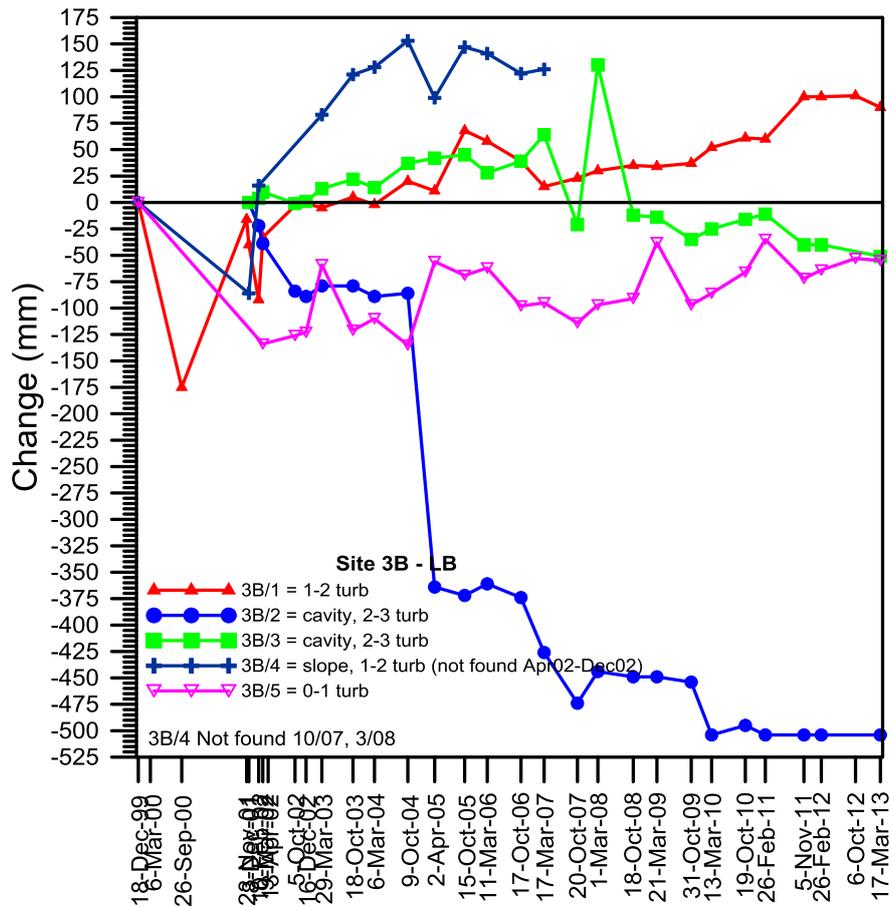
Figure 4.172: Erosion pin results for site 3B.

Erosional processes: One of the two cavities at this site has collapsed due to vegetation slumping (as evident in the bank profiles). One erosion pin was lost during monitoring, possibly due to rilling eroding around the base of the pin. The site has not shown evidence of seepage flows for many years. The toe has 'flattened' over the monitoring period, and scour has been recorded with little change been recorded in the 2-3 turbine bank level.

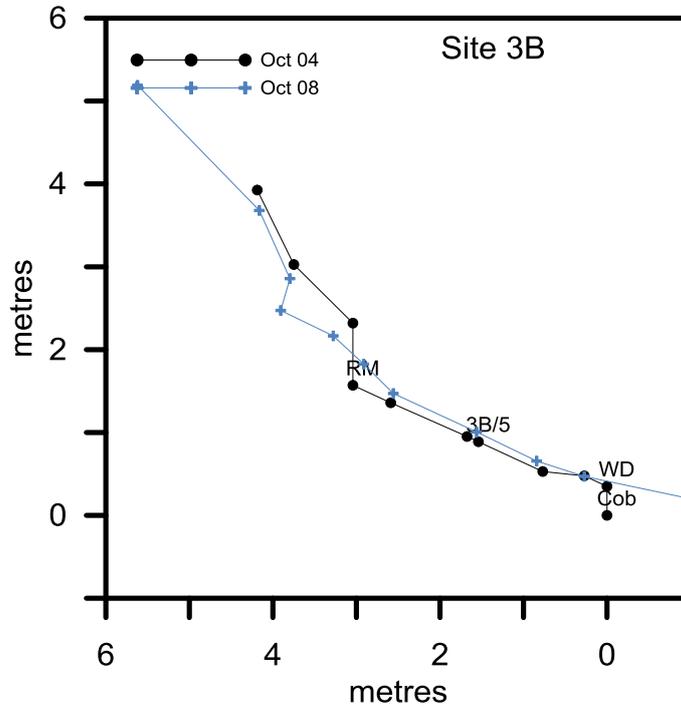
Figure 4.173: Bank profiles from site 3B from 2004 and 2008. 'RM' is root-mat, 'WD' is woody debris and 'Cob' is cobble.

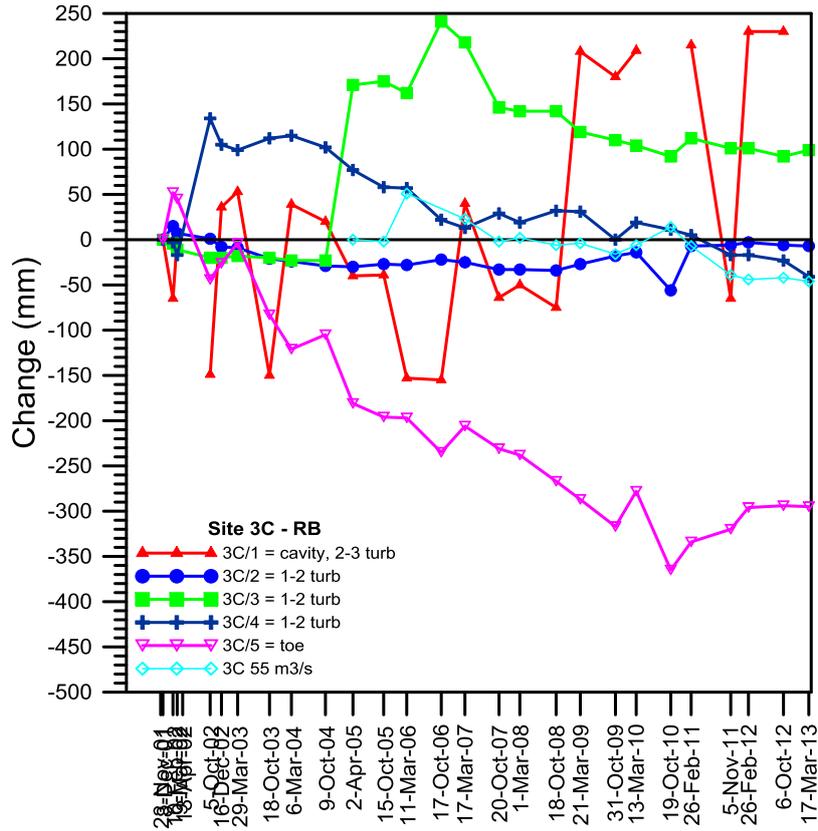
Figure 4.179: Erosion pin results for site 3C.

Erosional processes: The muddy root mat which initially extended into the 1-2 turbine bank level has been eroded through scour, resulting in erosion recorded in the 1-2 turbine level. The toe has recorded deposition, associated with local seepage deposition and processes. Muddy veneers on the lower bank are common at this site, indicating fluvial deposition does occur, although the lack of mud layers at depth suggests that the mud is scoured during high flows.

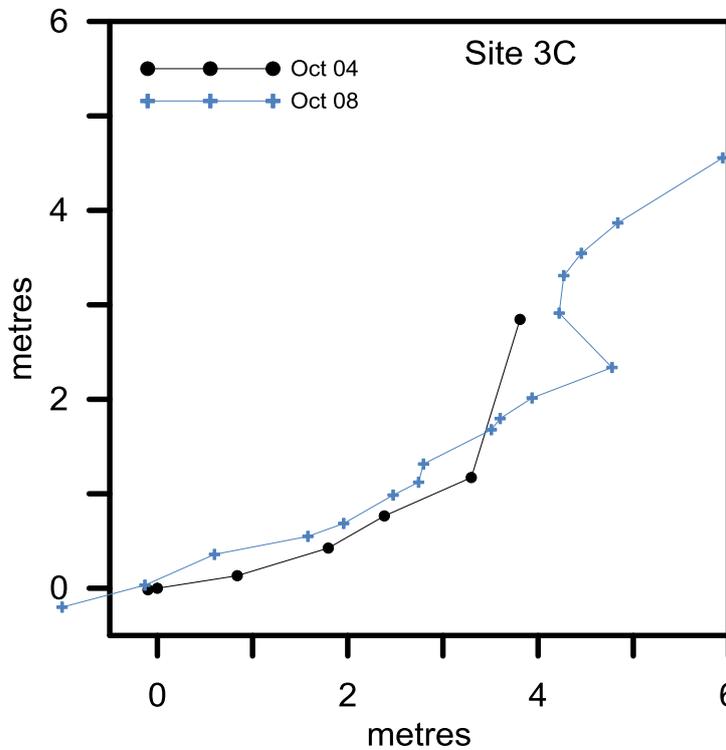
Figure 4.180: Bank profiles for site 3C from 2004 and 2008. The 2004 profile shows the surface of the vegetation mat, the 2008 profile shows the surface of the underlying bank as the vegetation was removed through scour.

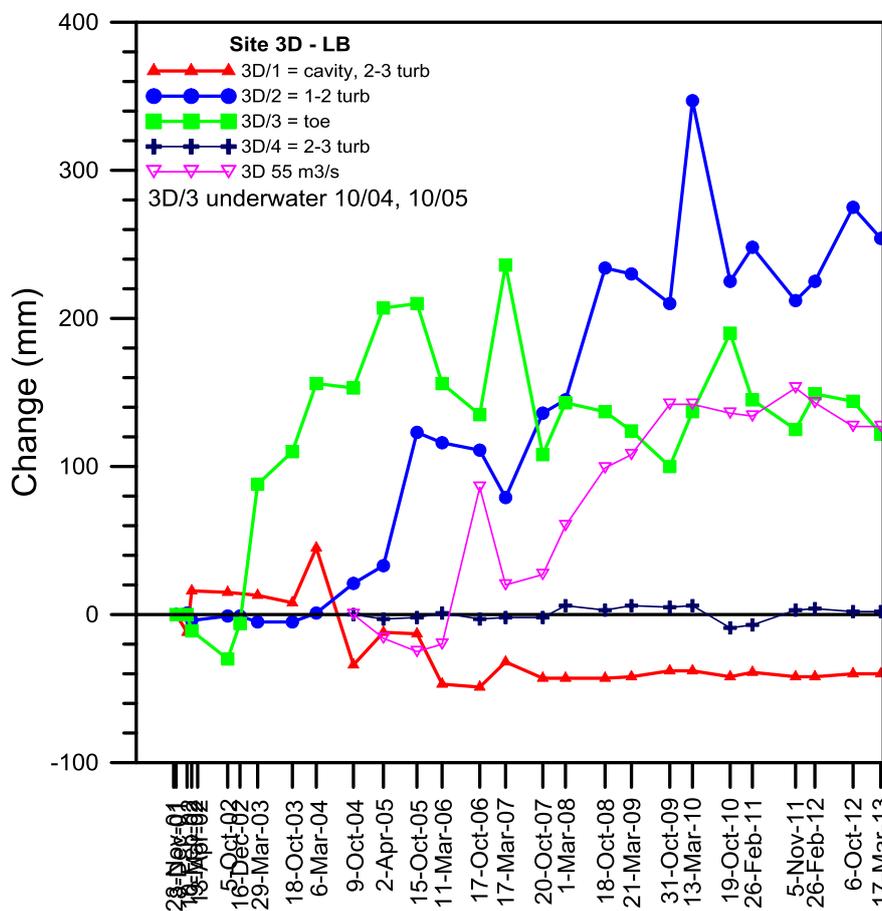
Figure 4.185: Erosion pin results from site 3D.

Erosional processes: The site is predominantly affected by scour, with the cavity showing little activity during the monitoring period. The 1-2 turbine bank level has recorded the highest level of erosion, and this is likely associated with the higher flow variability in this range post-Basslink. After initially recording scour, the toe has shown variability but little net change since 2007, which coincided with increase erosion at the 55 m³s⁻¹ pin, and in the 1-2 turbine bank level. The 2-3 turbine bank level has shown very little change over the monitoring duration, and may actually be located above the 2-3 turbine bank level. It is also common at this bank to have mud veneers on the bank toes during monitoring.

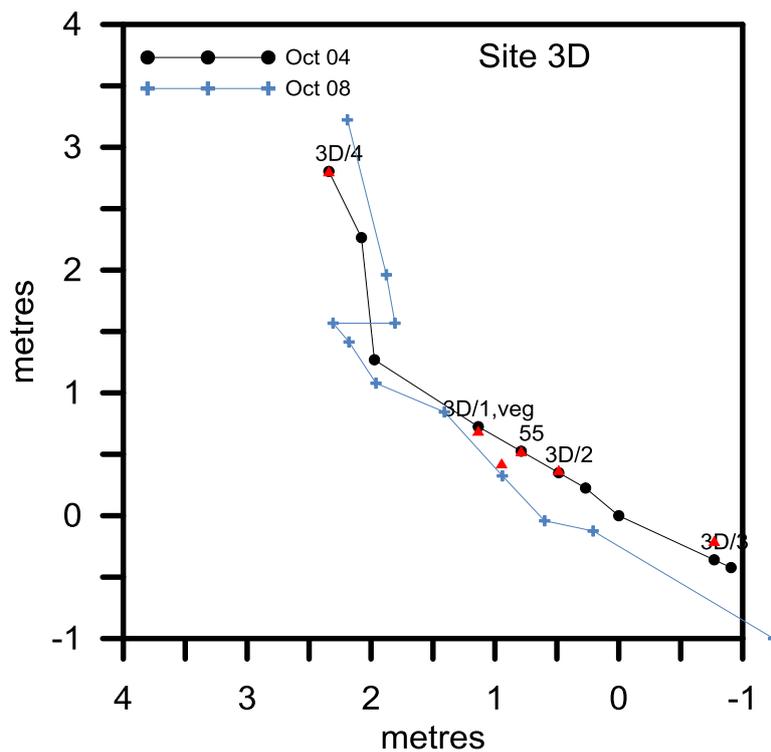
Figure 4.186: Bank profiles from 2004 and 2008. 'Veg' is the most downslope extent of vegetation.

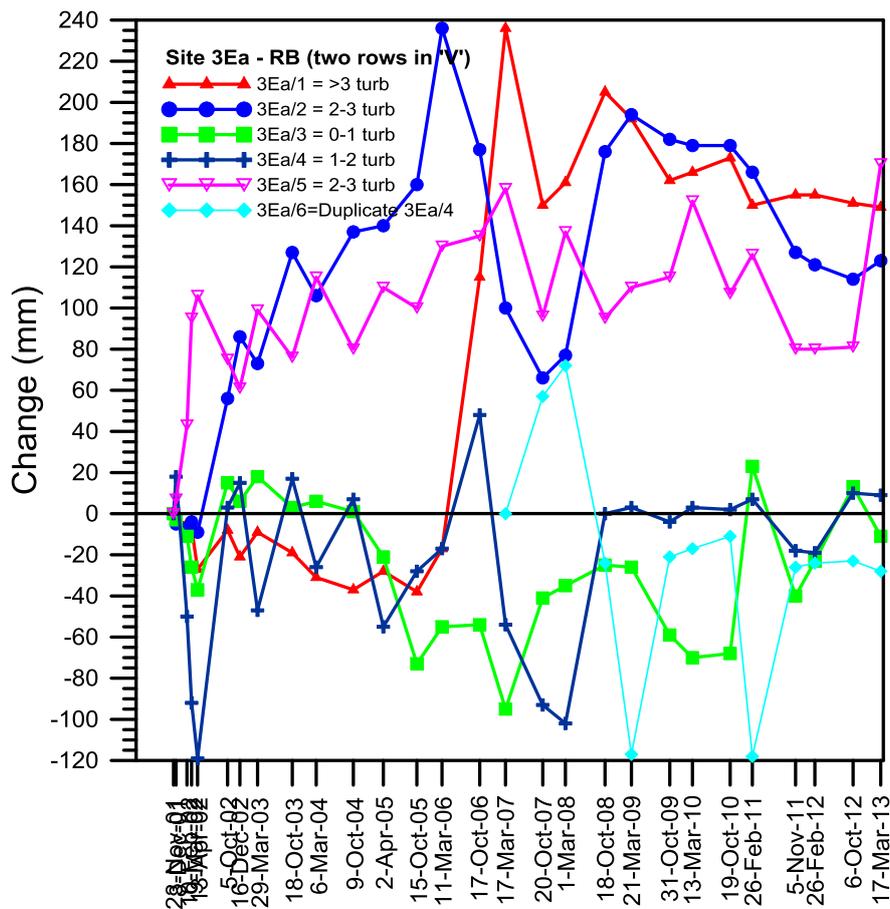
Figure 4.196: Erosion pin results from site 3Ea.

Erosion processes: The gully has flattened over the duration of monitoring, with erosion occurring in the 2-3 turbine bank level. The lower bank levels have shown variability – this is consistent with field observations that have noted episodic sediment deposition in the drainage line. The deposits are subsequently scoured, as evident in the photos.

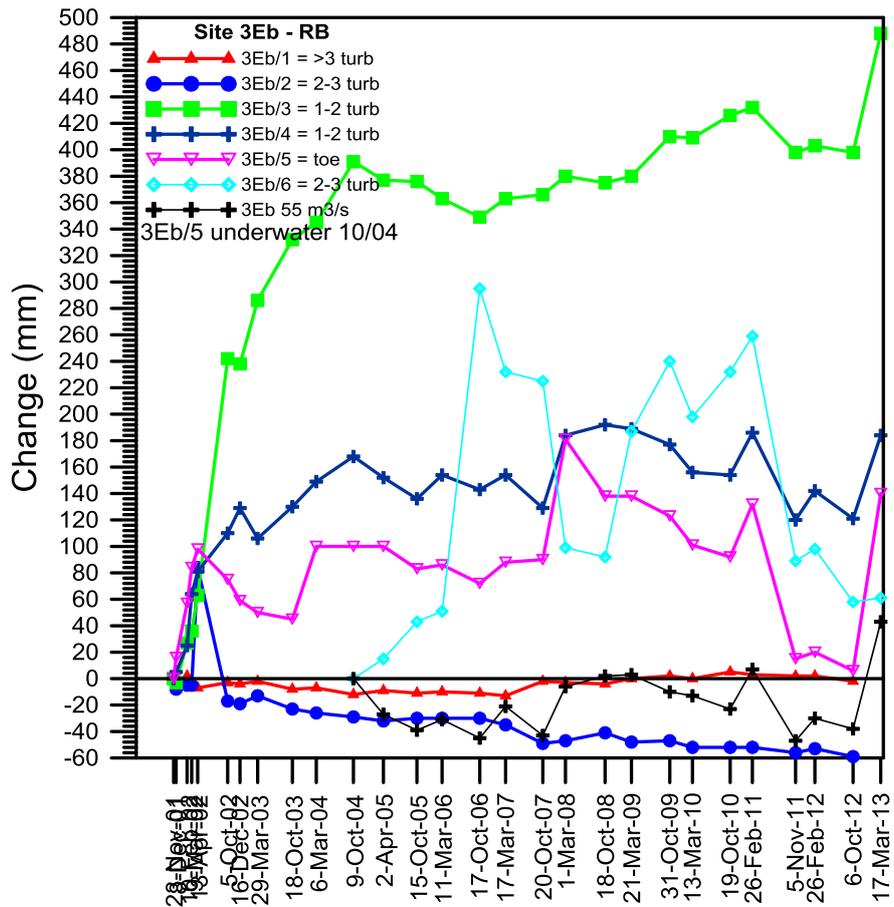
Figure 4.202: Erosion pin results for site 3Eb.

Erosion processes: Net scour in the 1-2 turbine bank level is the dominant change recorded at the site. Similar to other sites, this is associated with the erosion of benches which were hypothesised to be related to the 1 or 2 turbine efficient load water levels. Post-Basslink the power station discharge is more variable which has translated into less pronounced breaks in slope on the bank. Some of this change also reflects the continued scour of the remnant root-mat in the 2-3 turbine bank level.

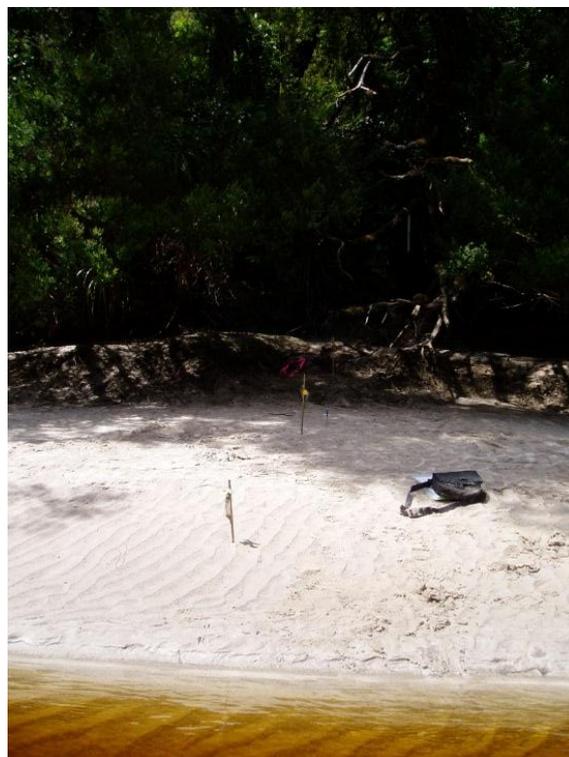
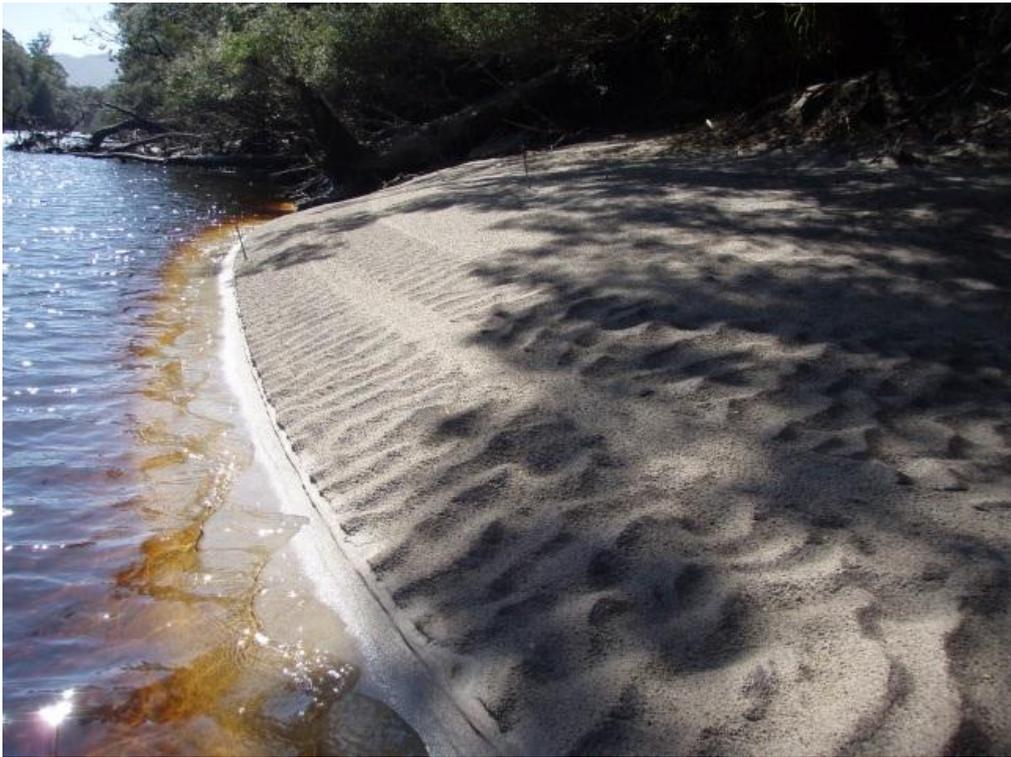
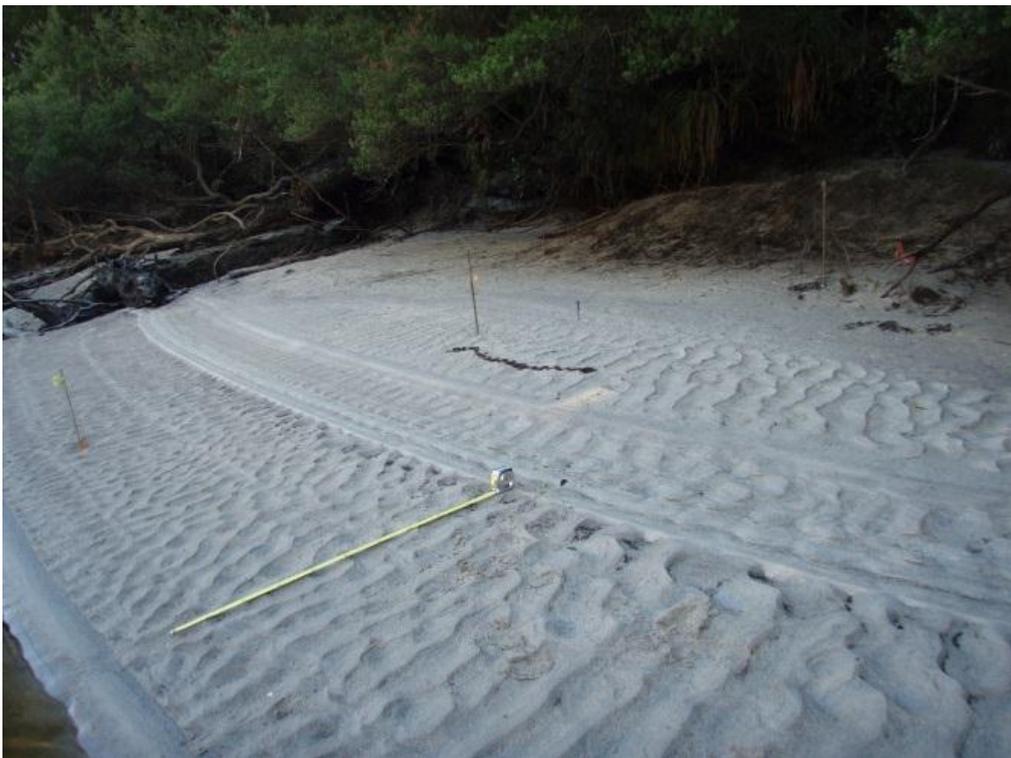
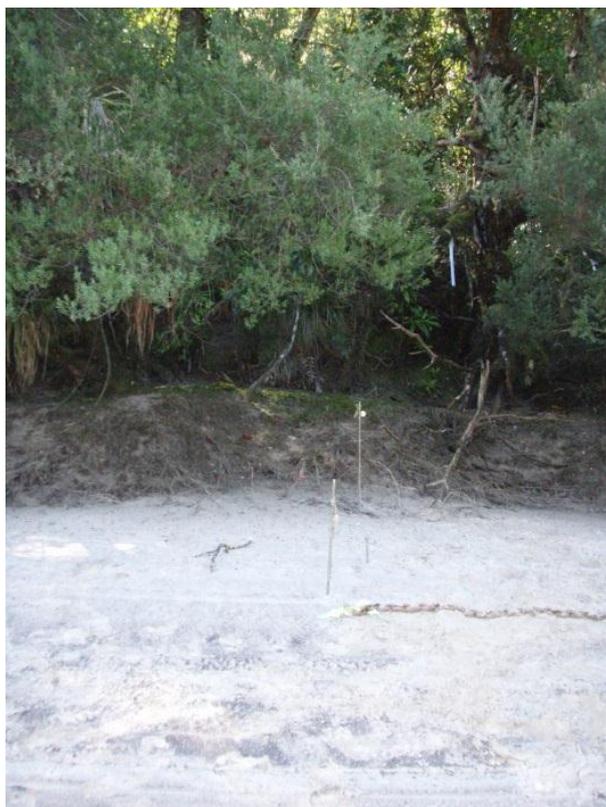
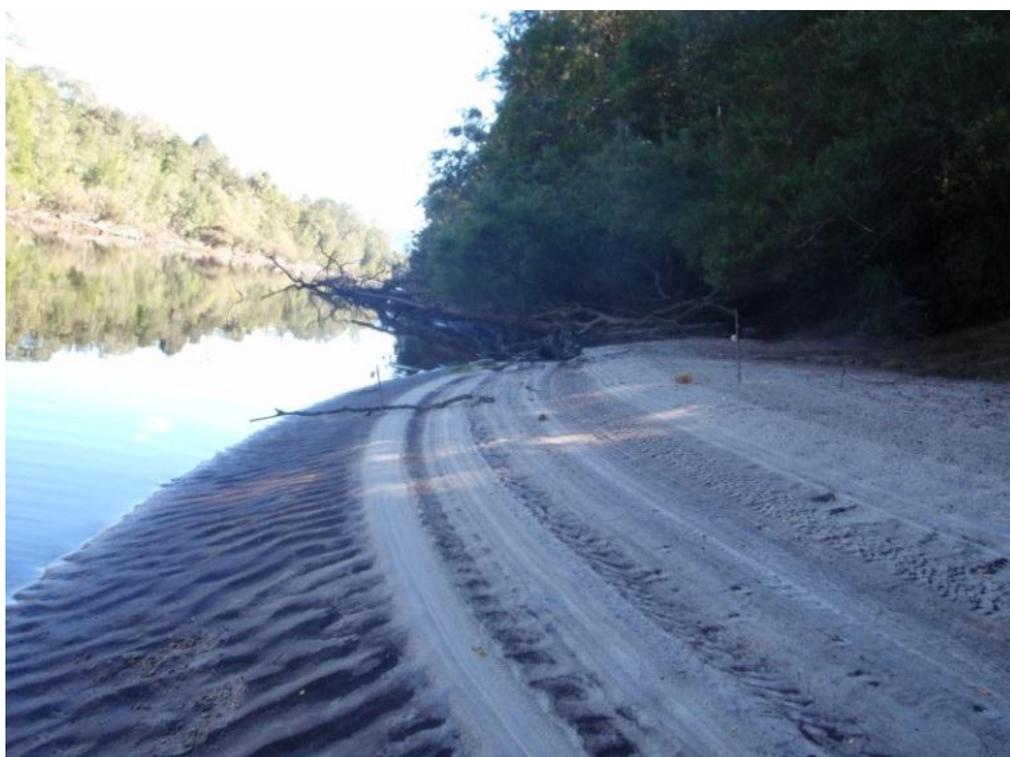
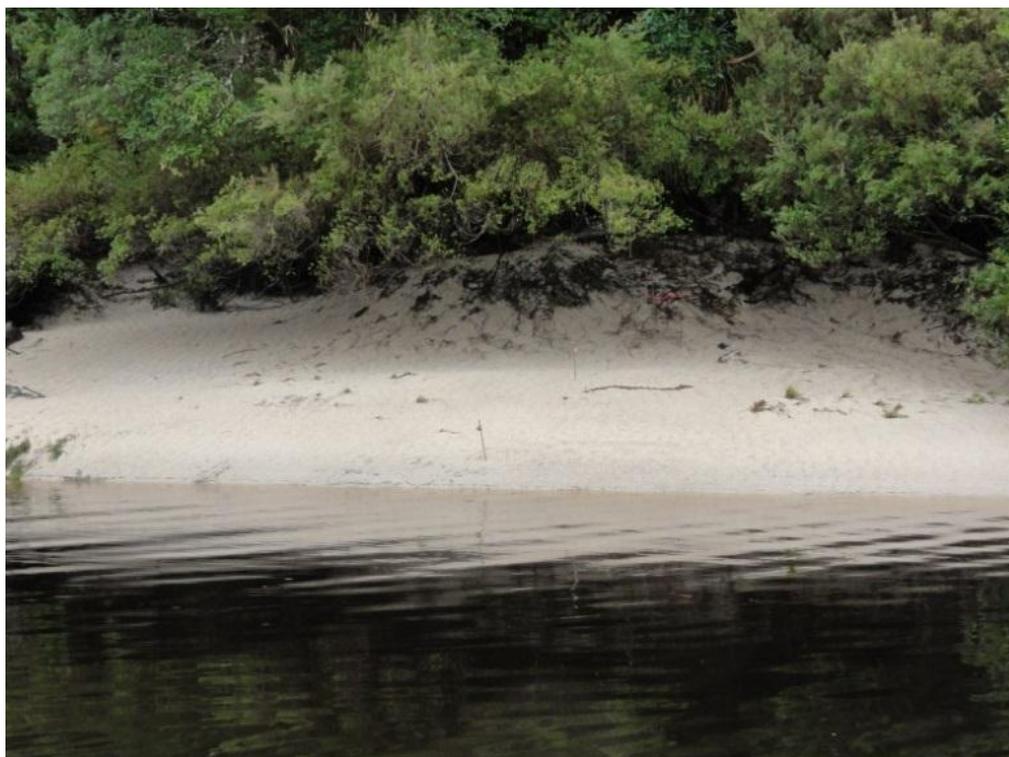
Description: Site 3Eb is located on a prominent bank with a sandy toe on the right side of the river on a straight reach. The ripple marks on the bank have continually indicated that flow at the site is upstream suggesting the site is an eddy during high flow. These local hydraulics can also account for the sandy bank extending upstream (in front of site 3Ea). The top of the sandy bank is overlain by vegetation and degraded root-mat.

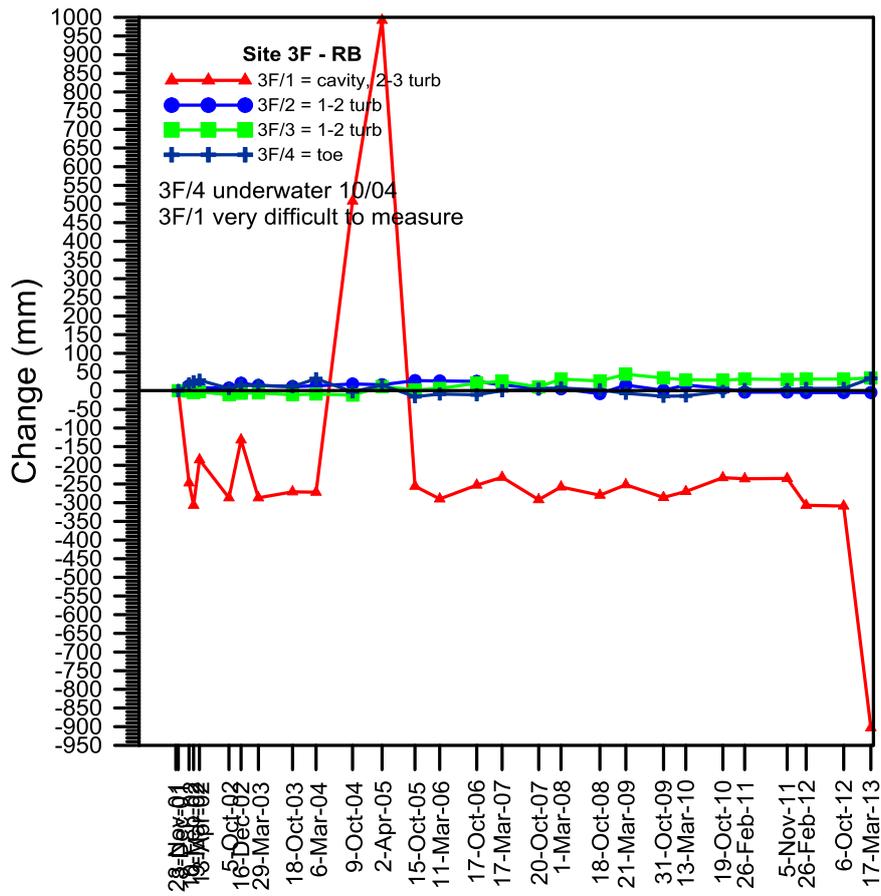
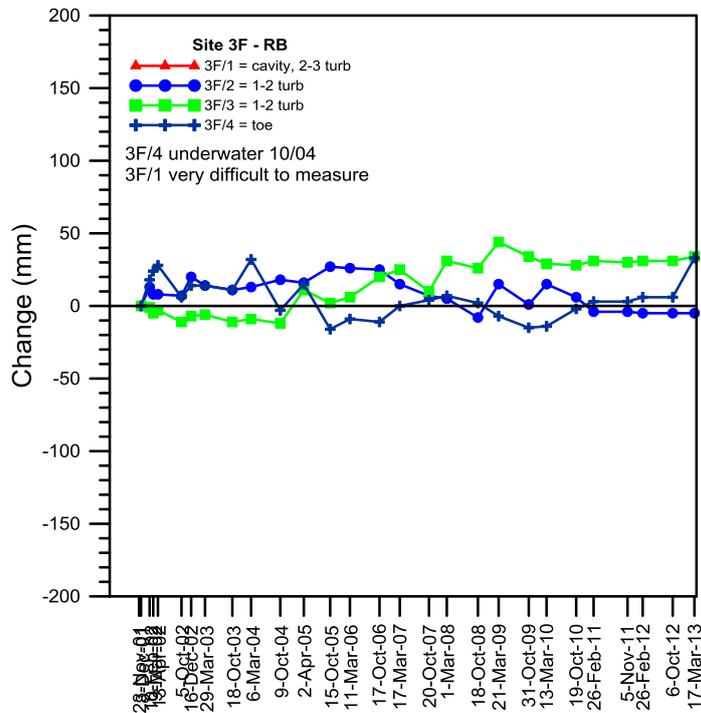
Erosional processes: The tea tree bank has shown some scour over the monitoring period, but overall the site appears very stable. The cavity located in the 2-3 turbine bank level is very deep and difficult to measure. Small sediment flows (evident as lighter coloured sand in the photos) are associated with this feature. The combination of the cobbles, bedrock, tree buttressing and Huon pine combine to make this a stable site.

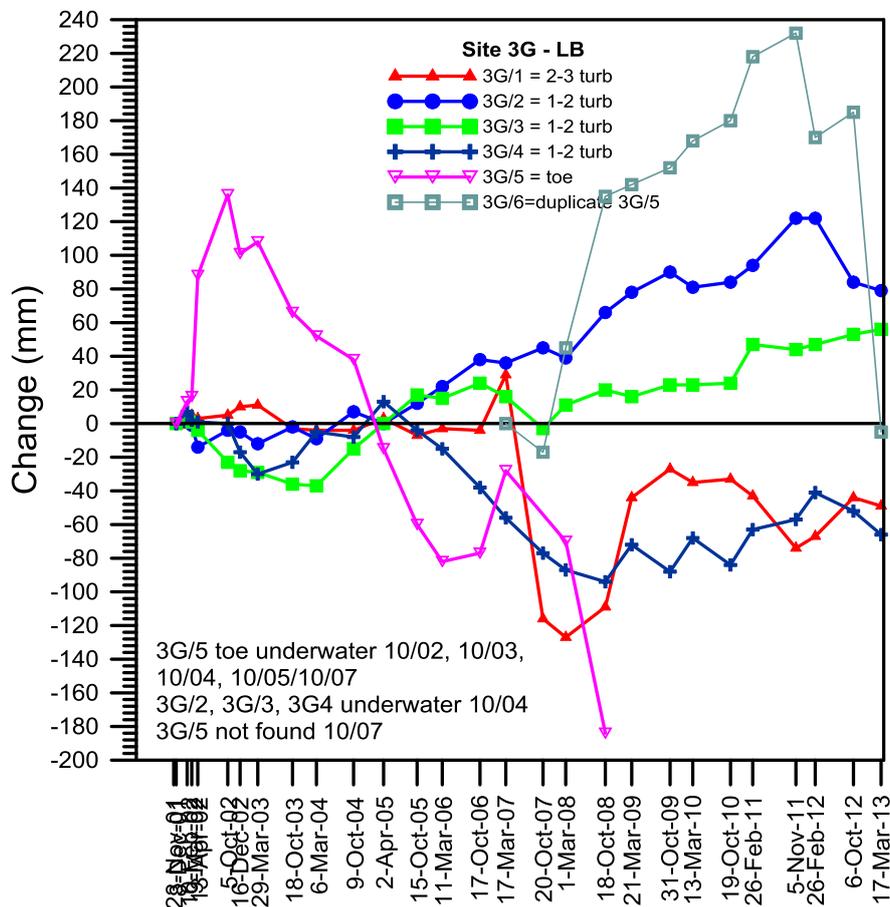
Figure 4.217: Erosion pin results from site 3G.

Erosional processes: It is likely that site 3G is a backwater when flow in the Denison River are higher than in the Gordon, which could account for the organic matter and muds frequently deposited on the bank toe. Digging into the toe reveals layers of organic matter, and when the submerged toe is stepped on, gas bubbles are released. In spite of this depositional evidence on the toe, the erosion pins show the 1-2 turbine bank level has scoured, and the 2-3 turbine bank level shows local deposition associated with collapse of the root-mat. The toe of the bank has recorded highly variable changes with no clear trend.

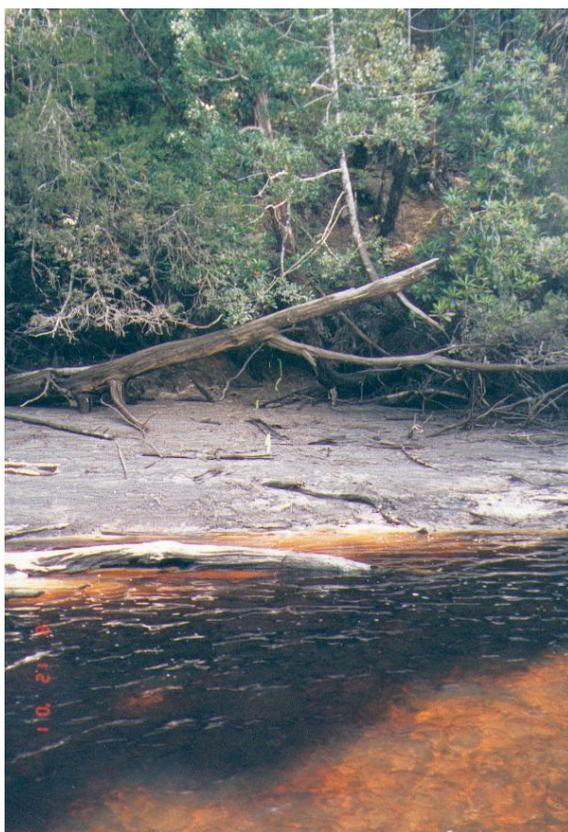
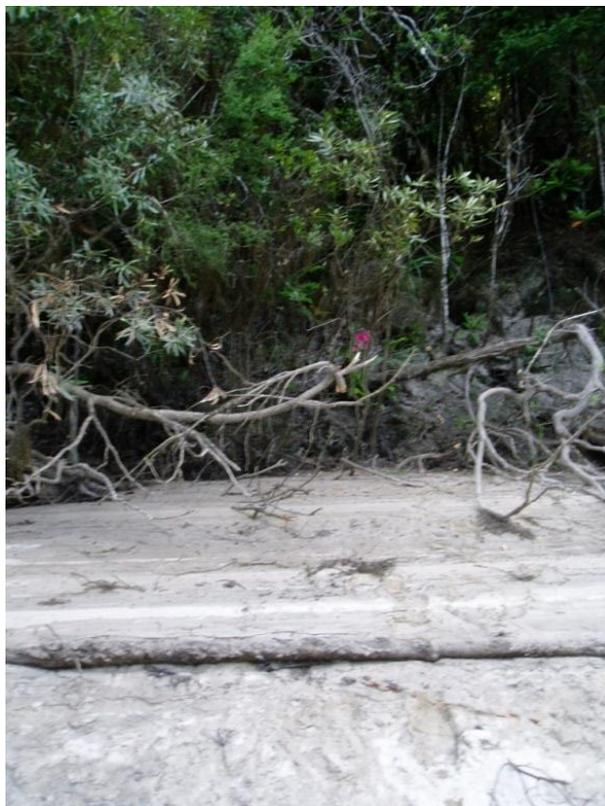
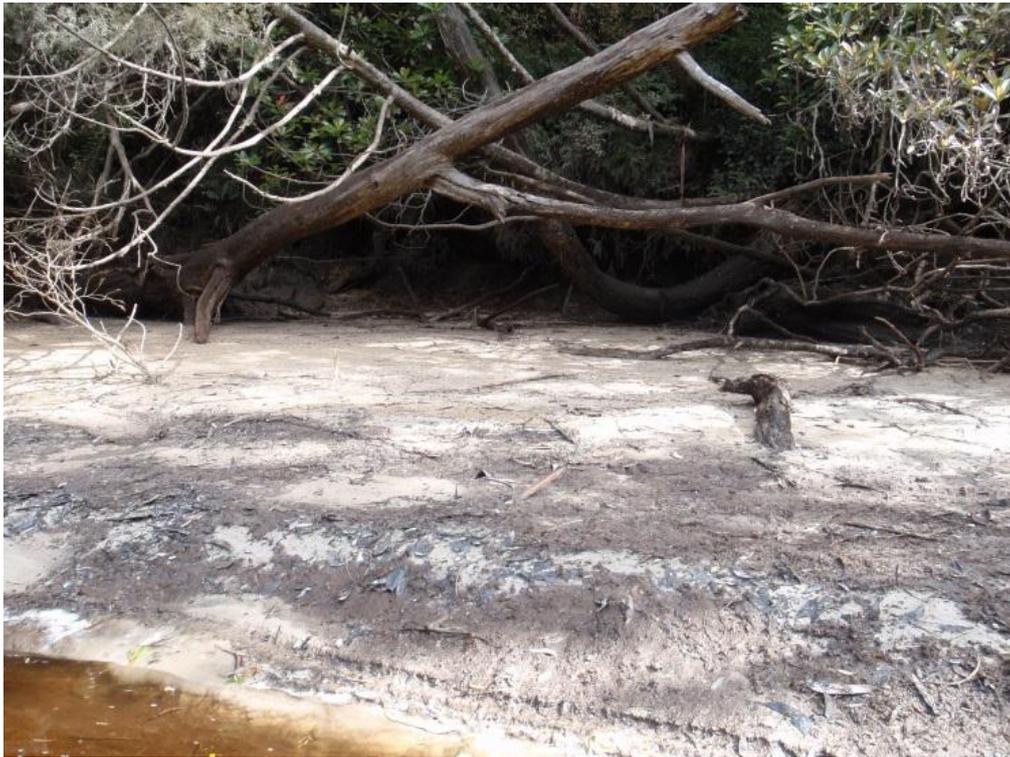
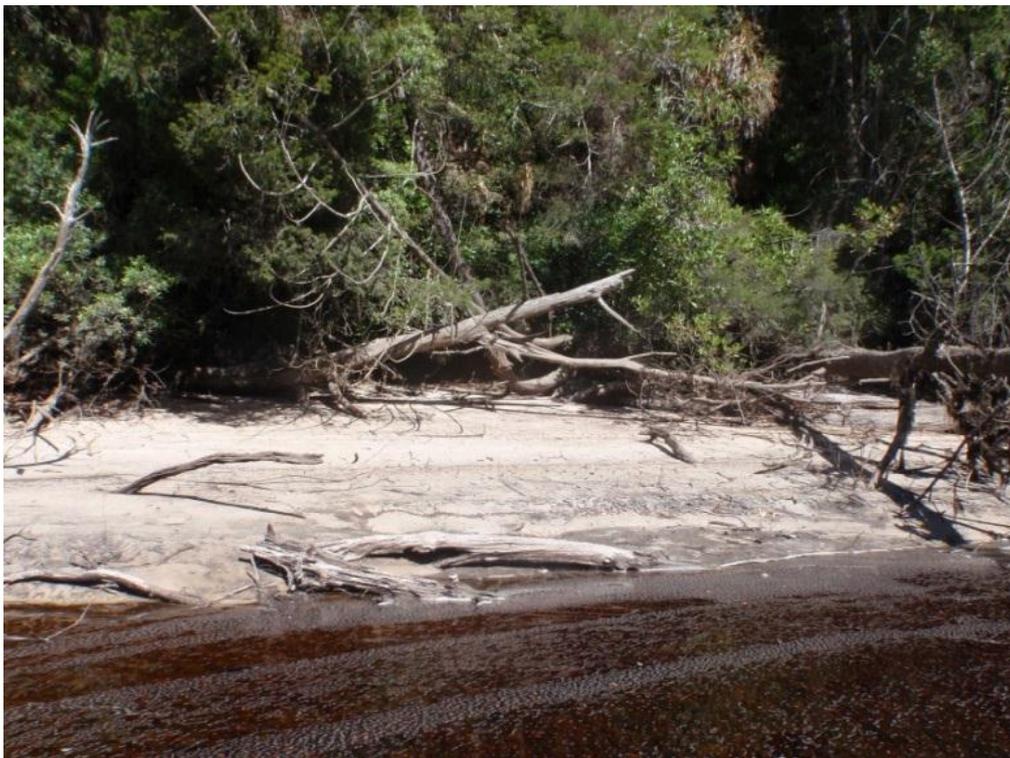
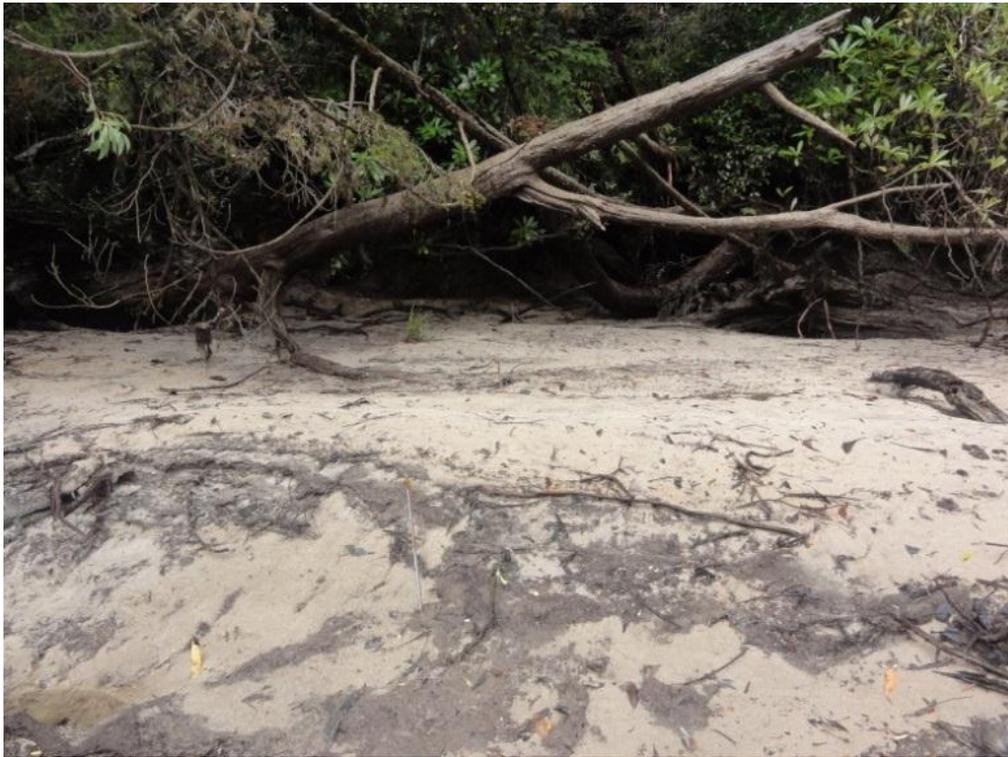
Description: Site 3G is located on the left bank, across from site 3F just upstream of the confluence with the Denison River. The bank is composed of a flat lying toe, extending up to a steeper sandy bank, which is overlain by a degraded root mat and vegetation. This site is frequently affected by backwater from the Denison, and the toe pin at this site has been submerged when other toe pins in the zone have been exposed.
