Basslink Review Report 2006-12
Gordon River Basslink Monitoring Program
The Appendices

May 2013

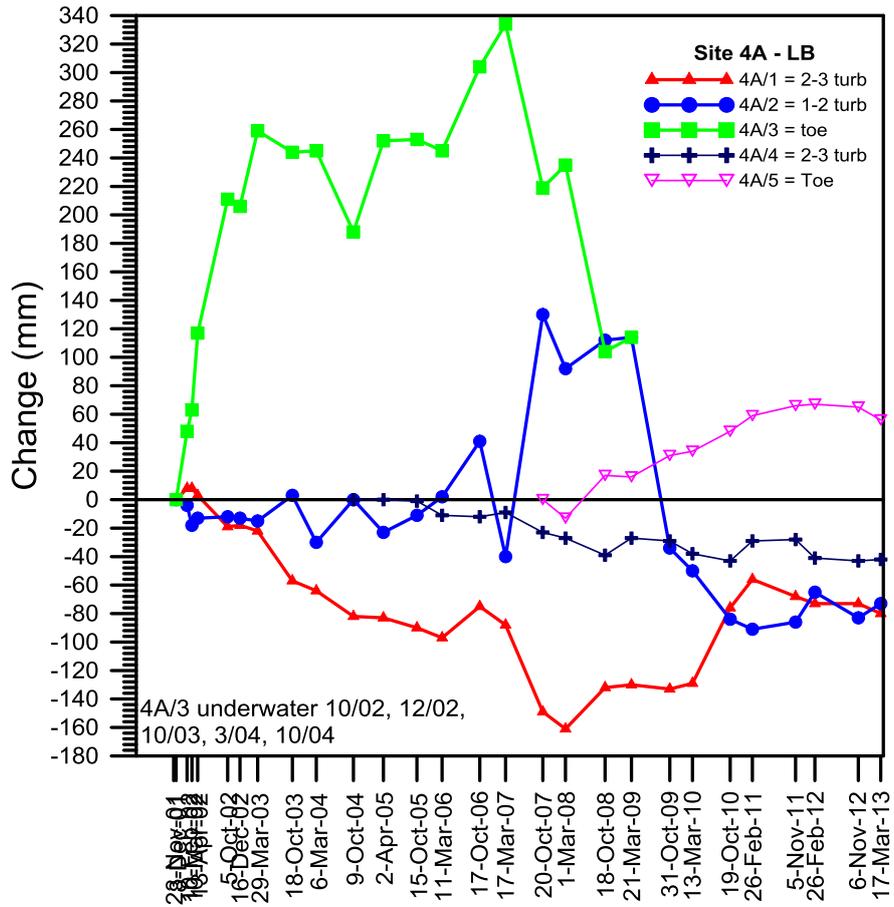
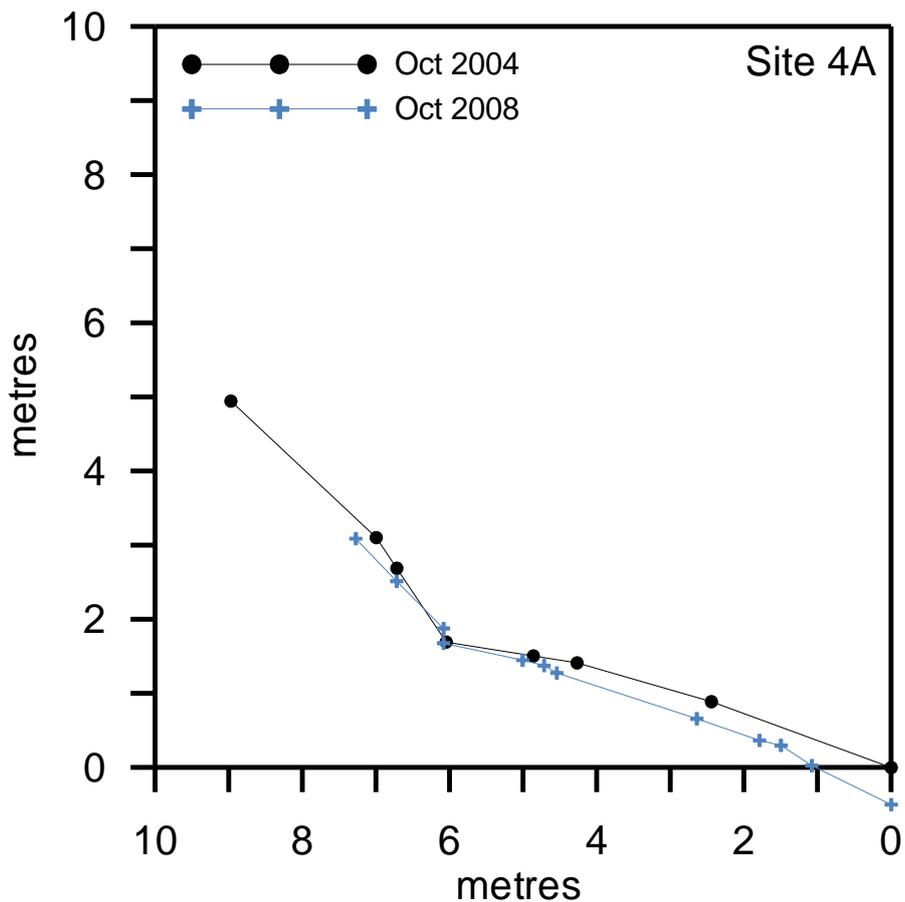
Erosional processes: In general, seepage processes in zone 4 are reduced and fluvial deposition is increased relative to the upstream zones. The toe of site 4A has undergone scour, while the 2-3 turbine zone has recorded deposition. A large depositional event in the 2-3 turbine bank level occurred at this site between March and October 2007, and was likely related to the very large flood in August 2007. The same period recorded scour in the 1-2 turbine level and deposition on the toe. The root-mat is progressively being removed from the 2-3 turbine zone, with the underlying sands slumping once exposed.

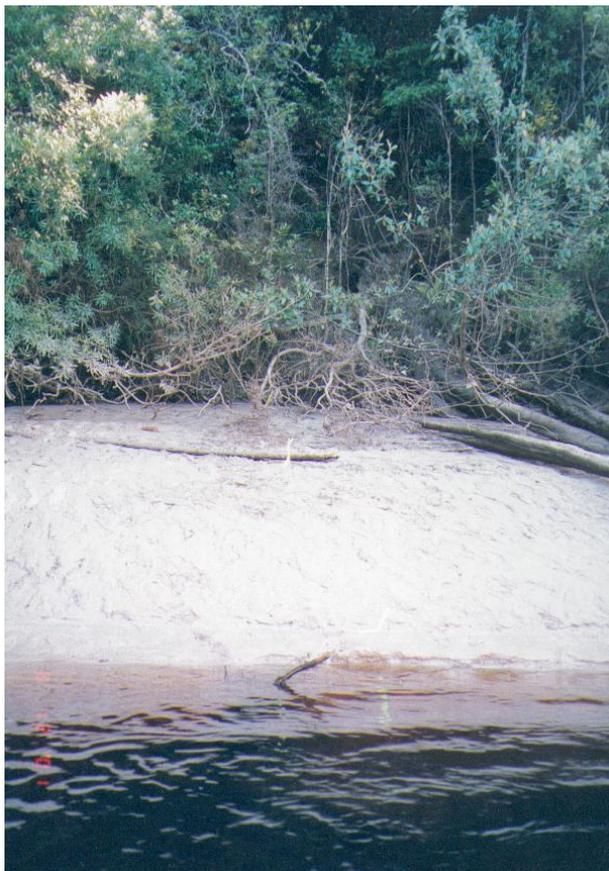
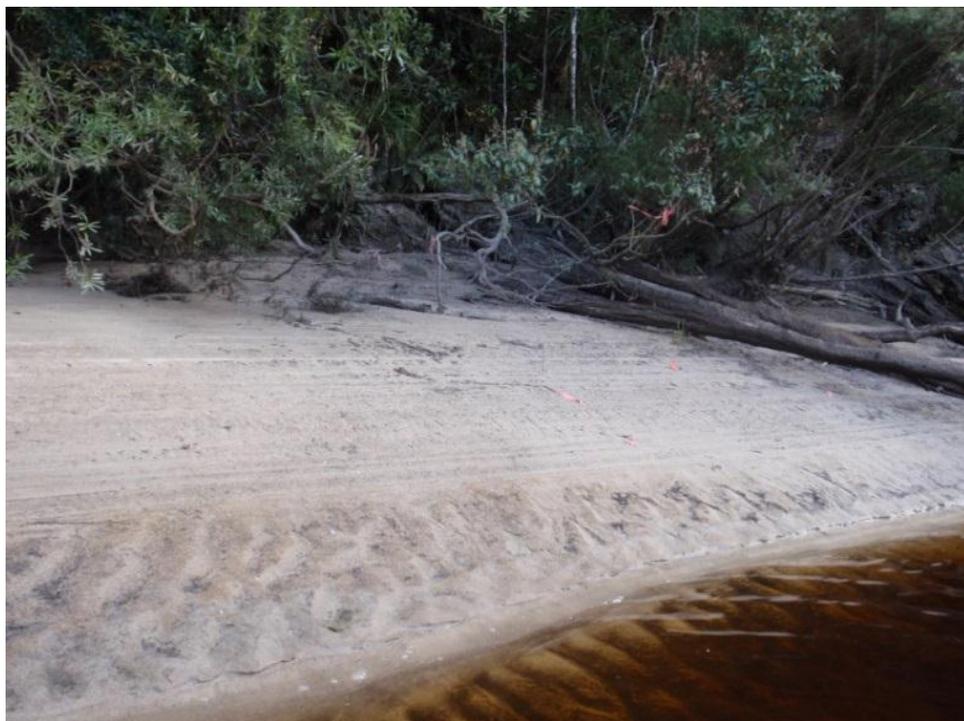
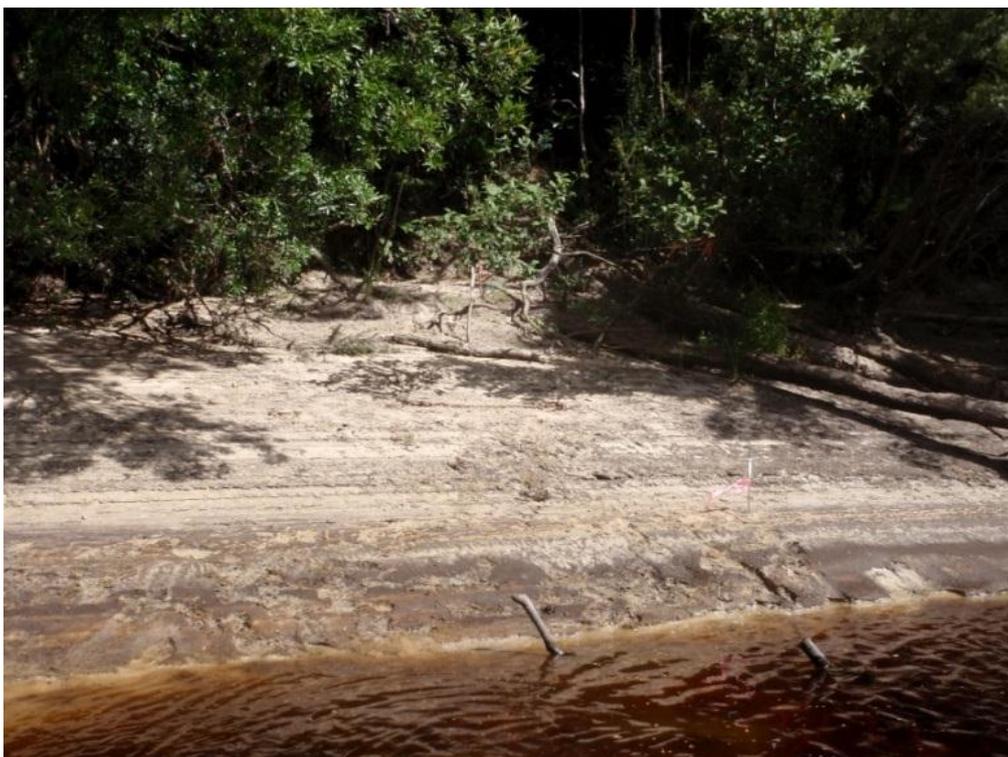
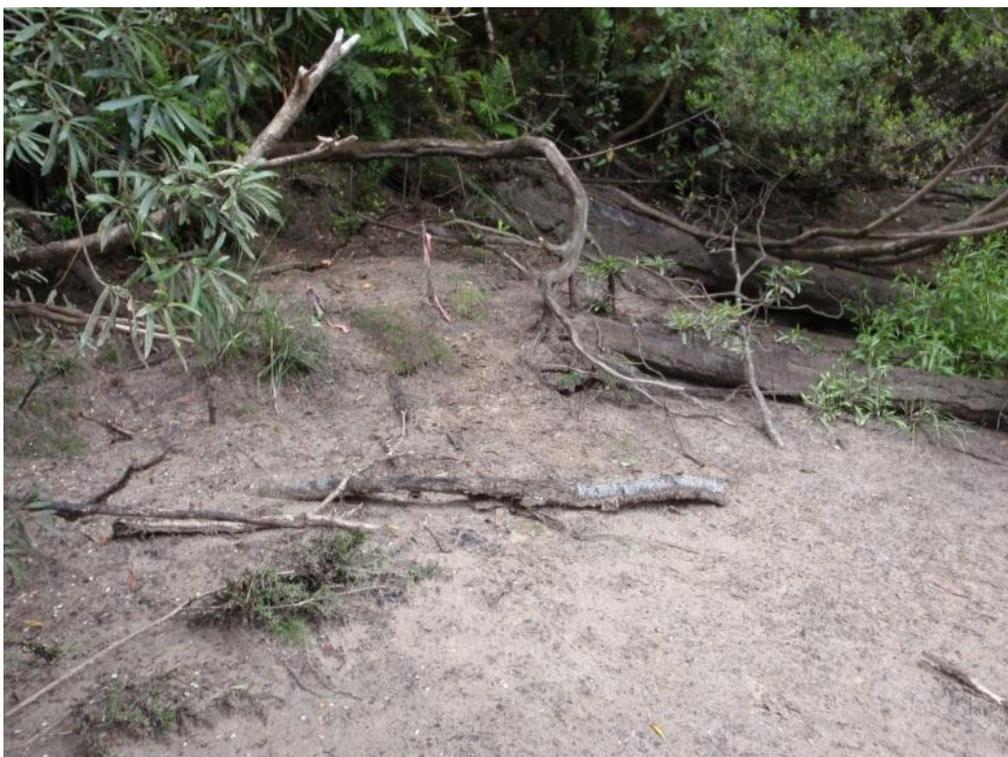
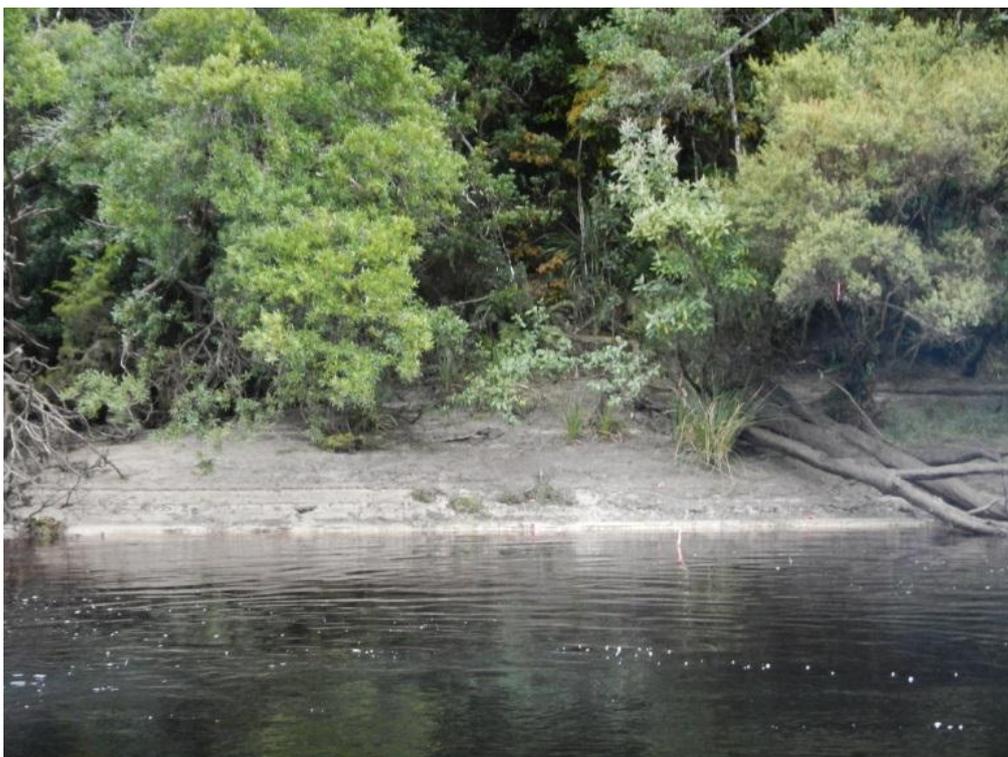
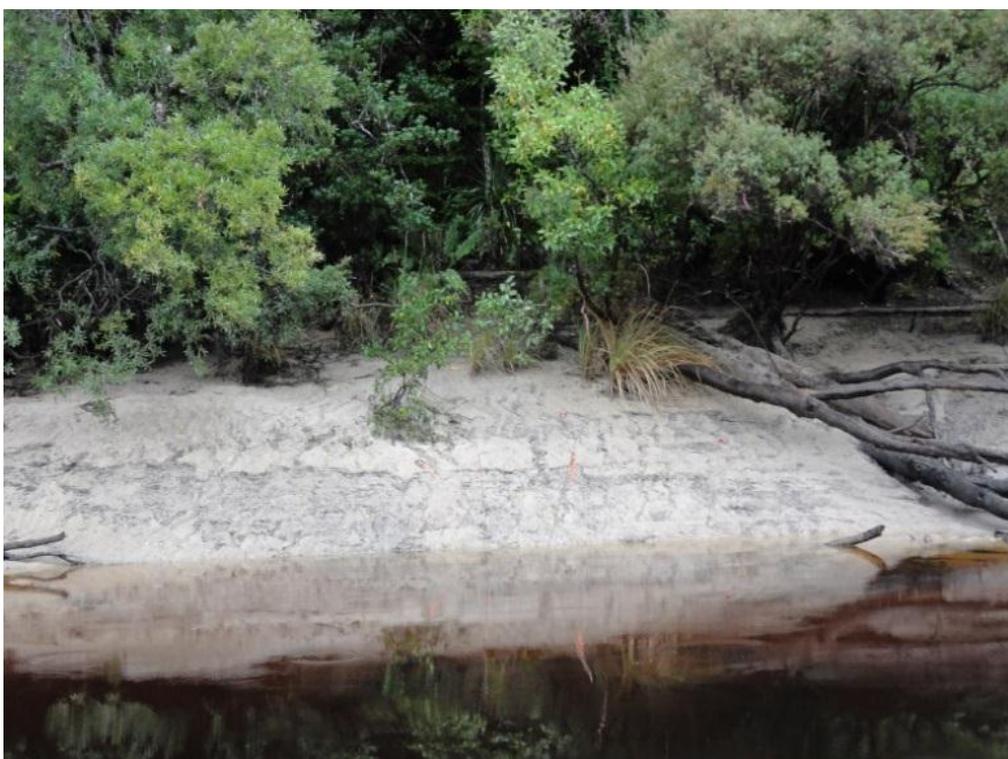
Description: Site 4A is located on the left bank of the river, on an outside bend in a reach with limestone bedrock exposed along the banks and in the channel. The site is located in an alluvial pocket and has a moderately sloping sandy toe extending up below a vegetation / degraded root-mat layer. Erosion pins are installed in a profile down the bank.

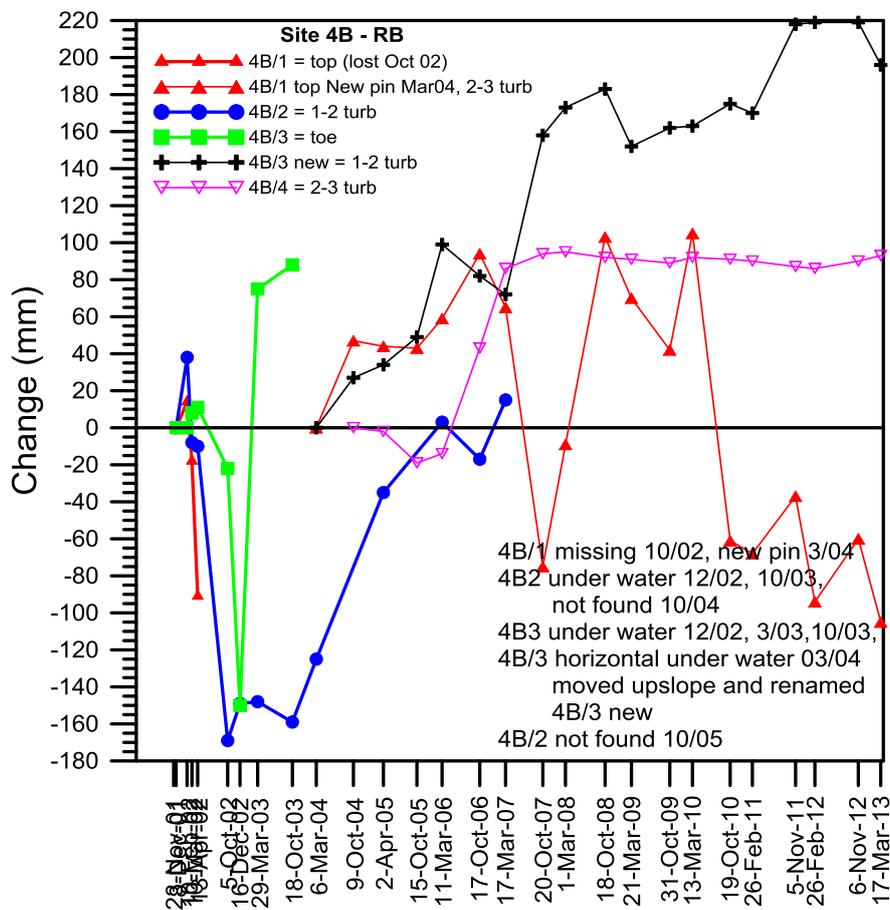
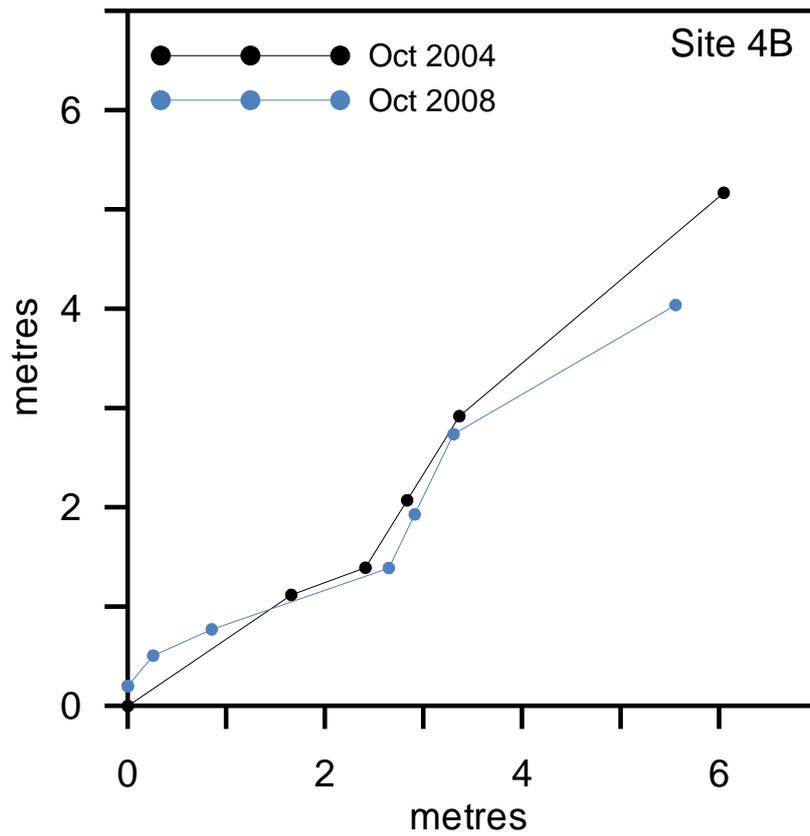
Erosional processes: This site is similar to site 2C in that it tends to be more saturated than other banks and frequently shows signs of seepage processes (rilling, tension cracks). The original toe pin installed at the site moved down slope as the saturated bank ‘seeped’ into the river. Post-Basslink, when the power station usage was reduced saturation of the bank was also reduced. The root-mat in the 2-3 turbine zone and underlying sands are being scoured, whilst the toe is flattening through local seepage processes.

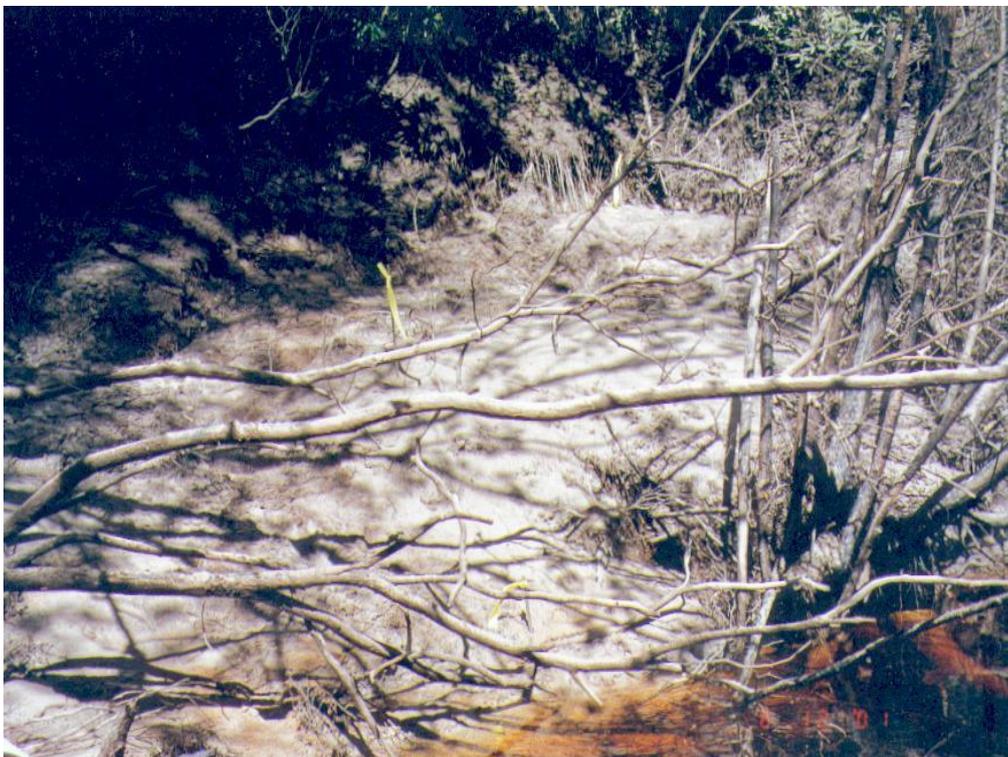
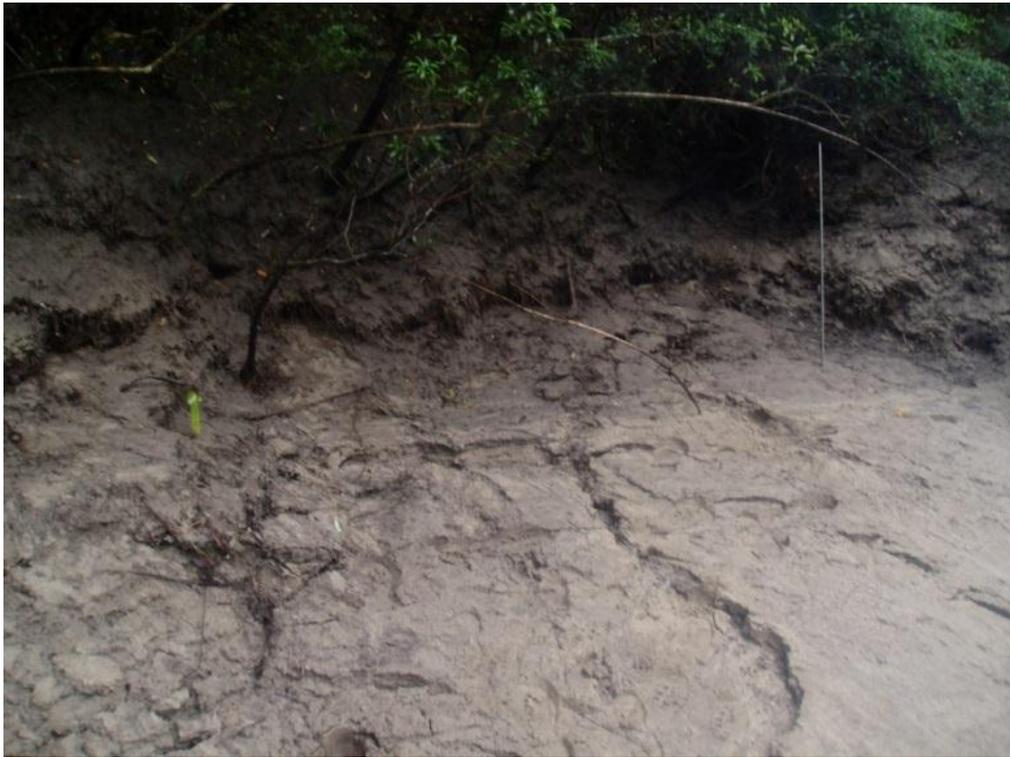
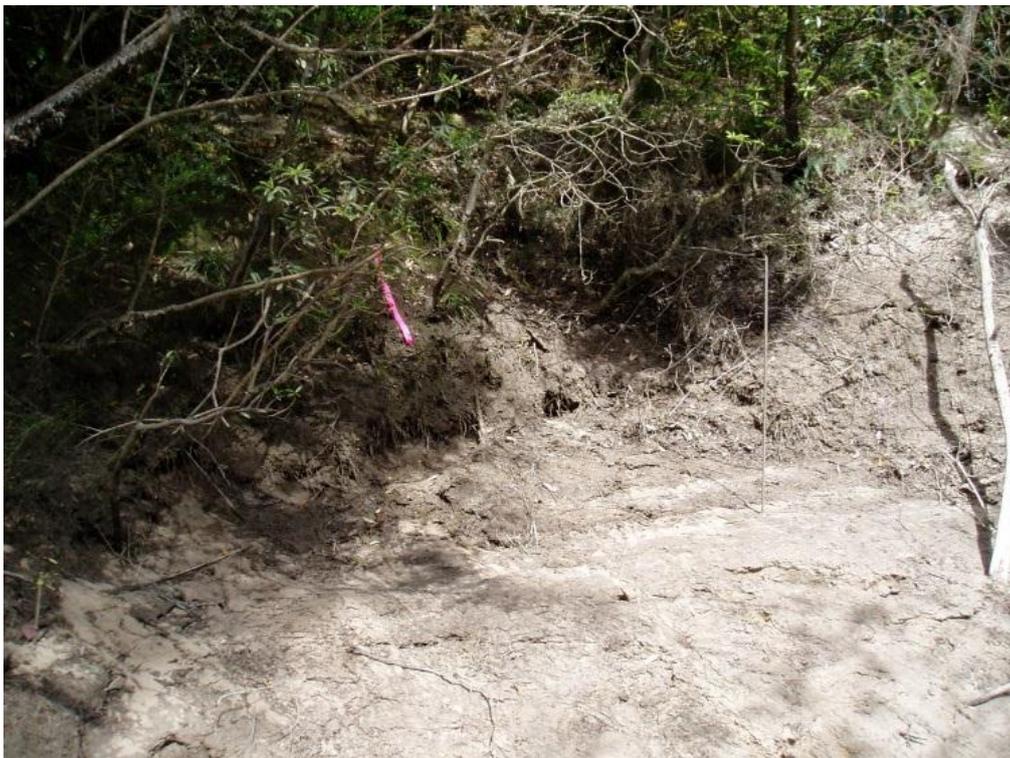
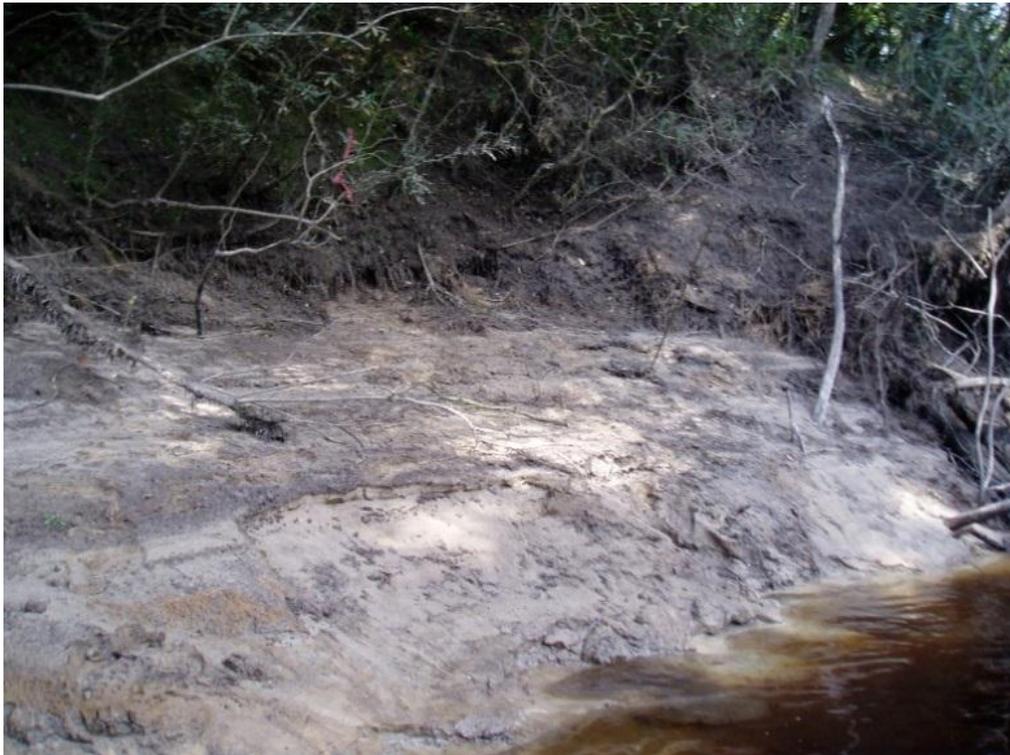
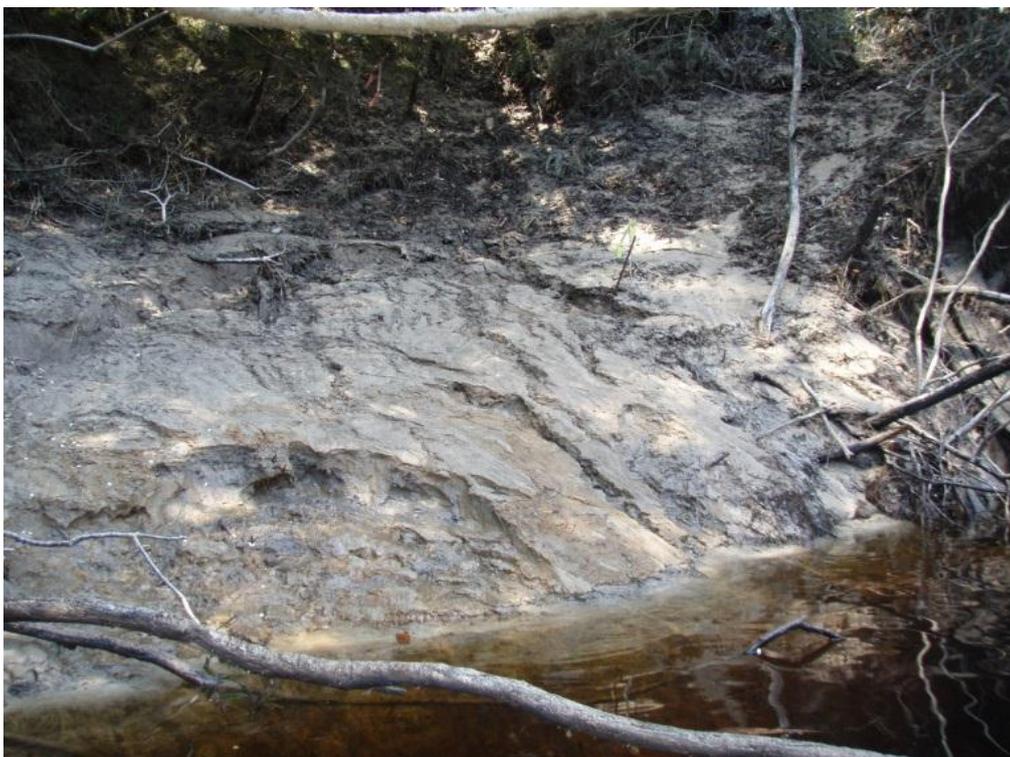
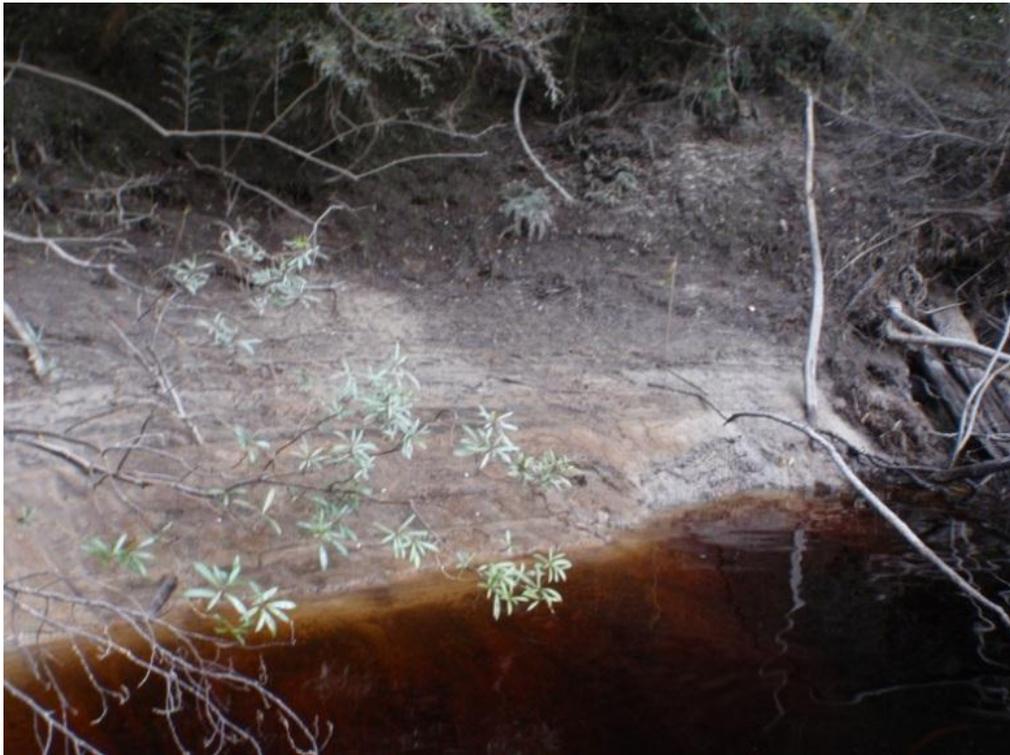
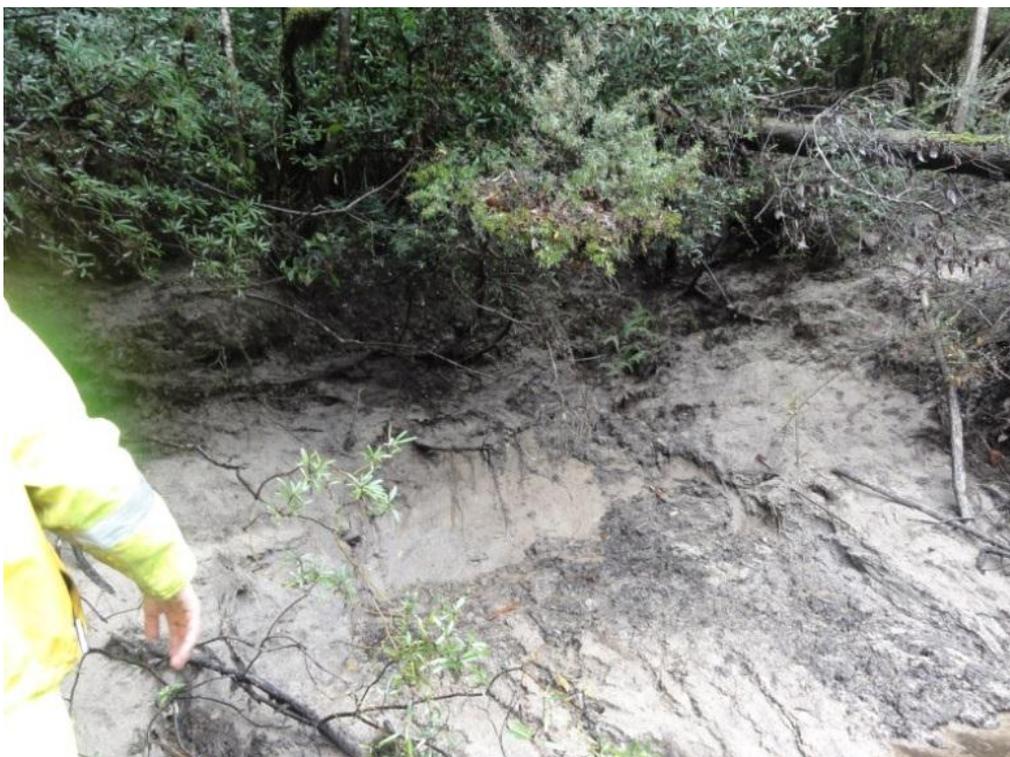
Description: Site 4B is located on the right bank across from site 4A on an inside bend, and is composed of vegetation and degraded root-mat overlying sands. There are outcrops of bedrock in the channel and upstream and downstream of this site.

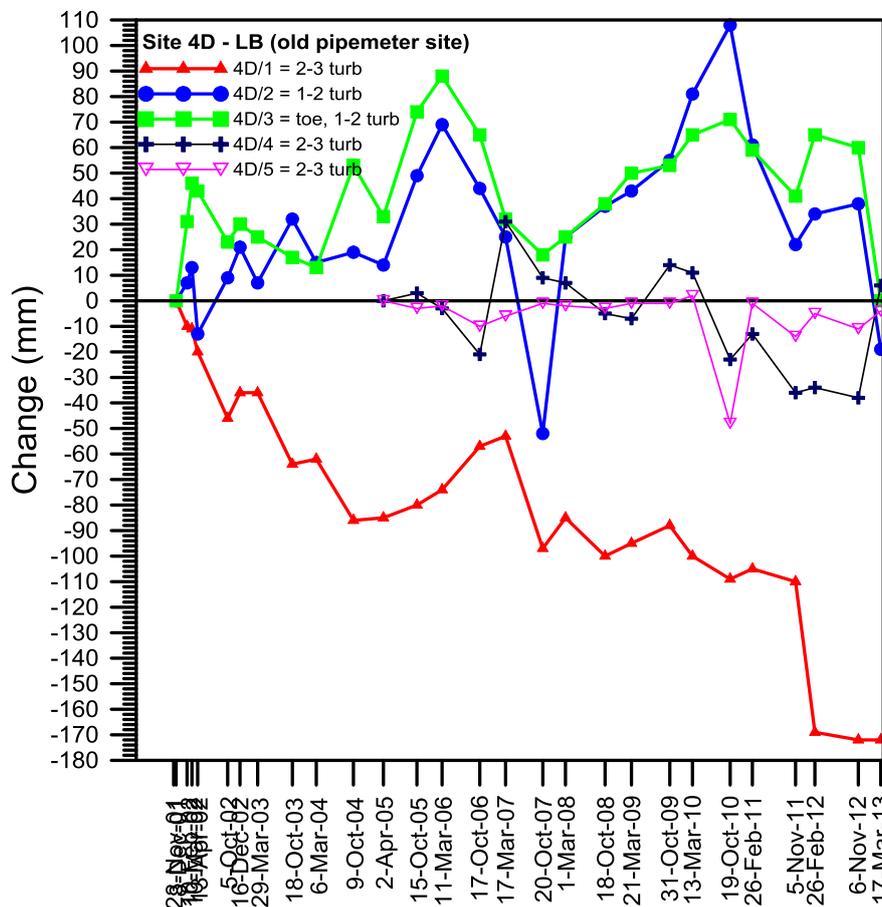
Erosional processes: The erosion pin in the lower 2-3 turbine bank level has recorded deposition, reflecting the slumping of sands from under the degraded root-mat. The rest of the pins on the site have shown variability over the monitoring period but little net change. When the site was established in 2001, a clump of dead tea tree was present in the 1-2 turbine bank level. In 2013, the root ball and some of the branches remain, suggesting that the erosion of tea tree can be slow. In this case the buttressing of the bank by the large tree undoubtedly has contributed to the stability of the site.

Figure 4.245: Erosion pin results from site 4D.

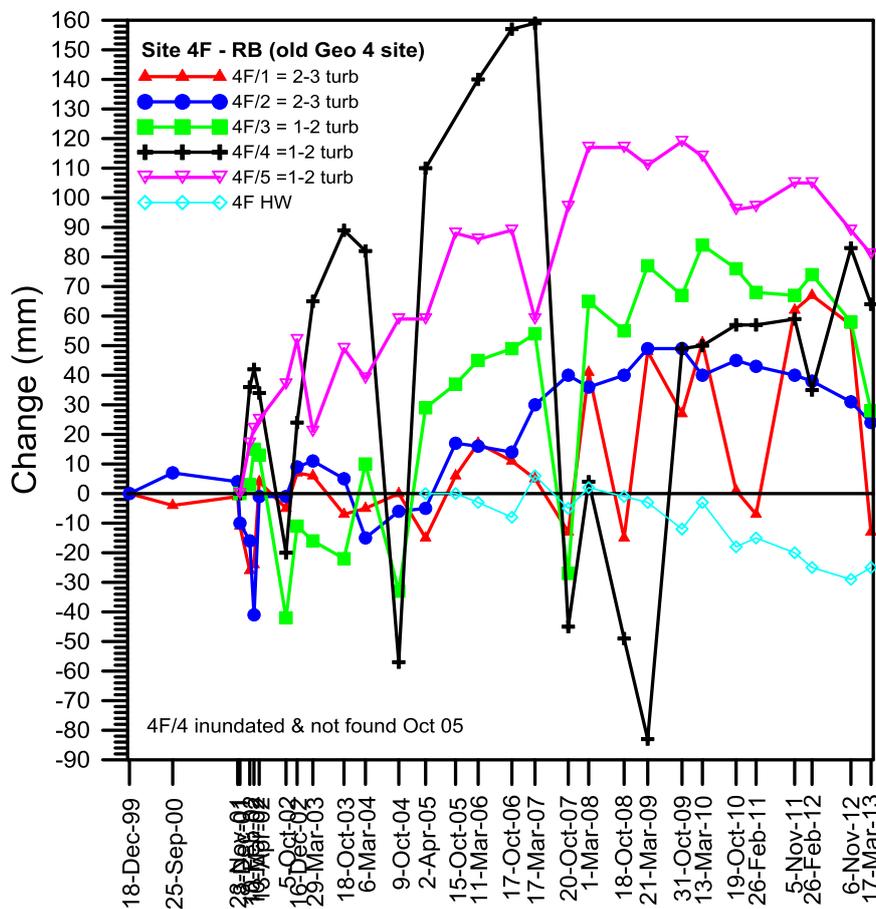
Erosional processes: This bank is highly variable, with evidence of scour, slumping and fluvial deposition observed at various times. In general, the bank appears to scour in the summer, when power station operations dominate the flow pattern, with deposition recorded in the winter, when unregulated inflows contribute a large proportion of the flow. The net impact of these processes on the bank has been erosion and steepening of the 2-3 turbine bank level, which has resulted in the exposure of an oxidised scour chain see Figure 4.255.

Figure 4.252: Erosion pin results from site 4E.

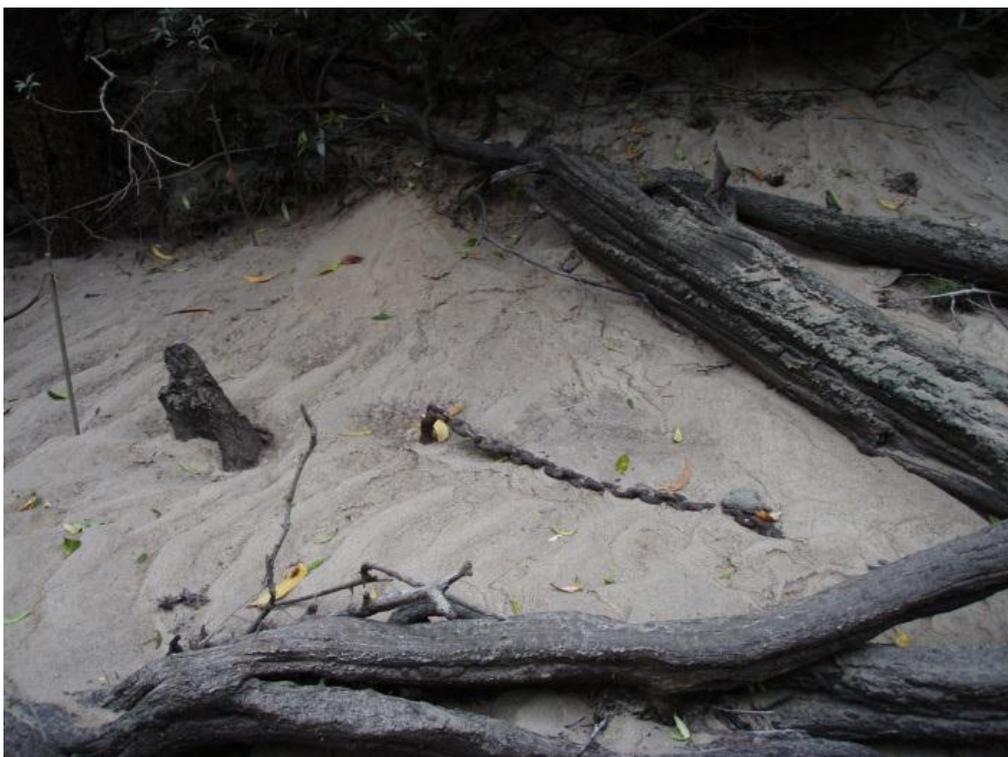
Figure 4.255: Site 4E February 2011.

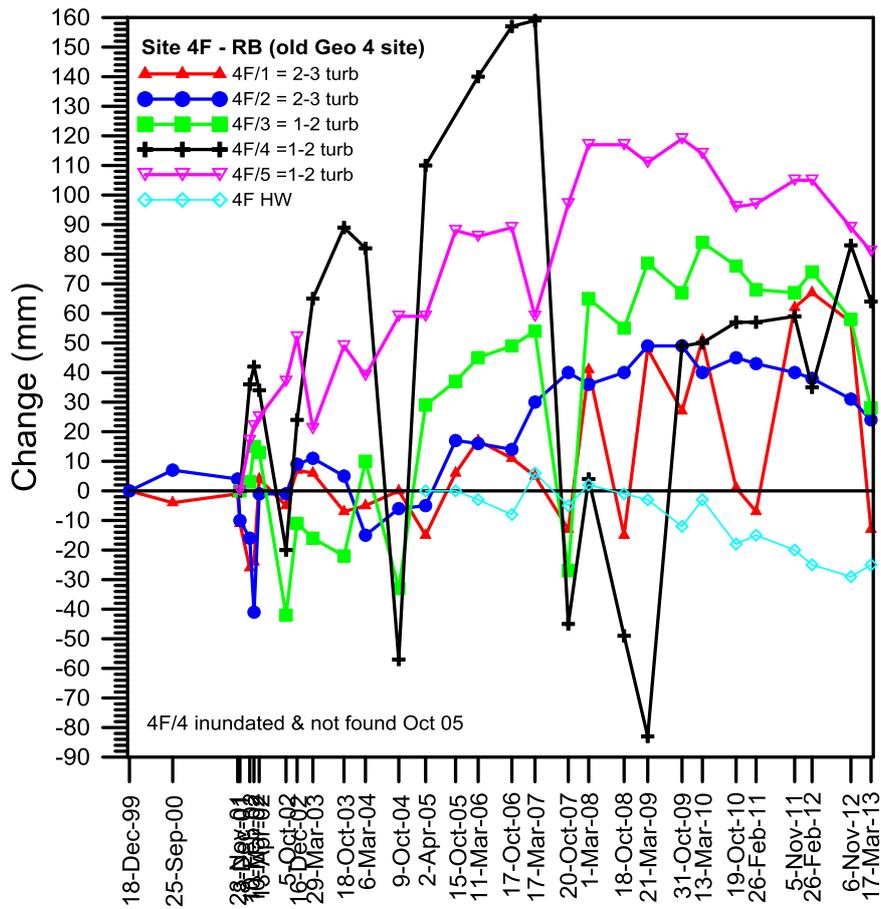
Erosional processes: Similar to site 4E, this site has shown seasonal fluctuations, with net erosion the general trend. An exception to this is pin 4F/4 which has shown very large fluctuations. This pin is located in an area of the banks which receives fluvial deposition as well as being subjected to scour. A large tree fall probably associated with the August 2007 flood also affected this pin, resulting in increased deposition.

Figure 4.258: Erosion pin results from site 4F.

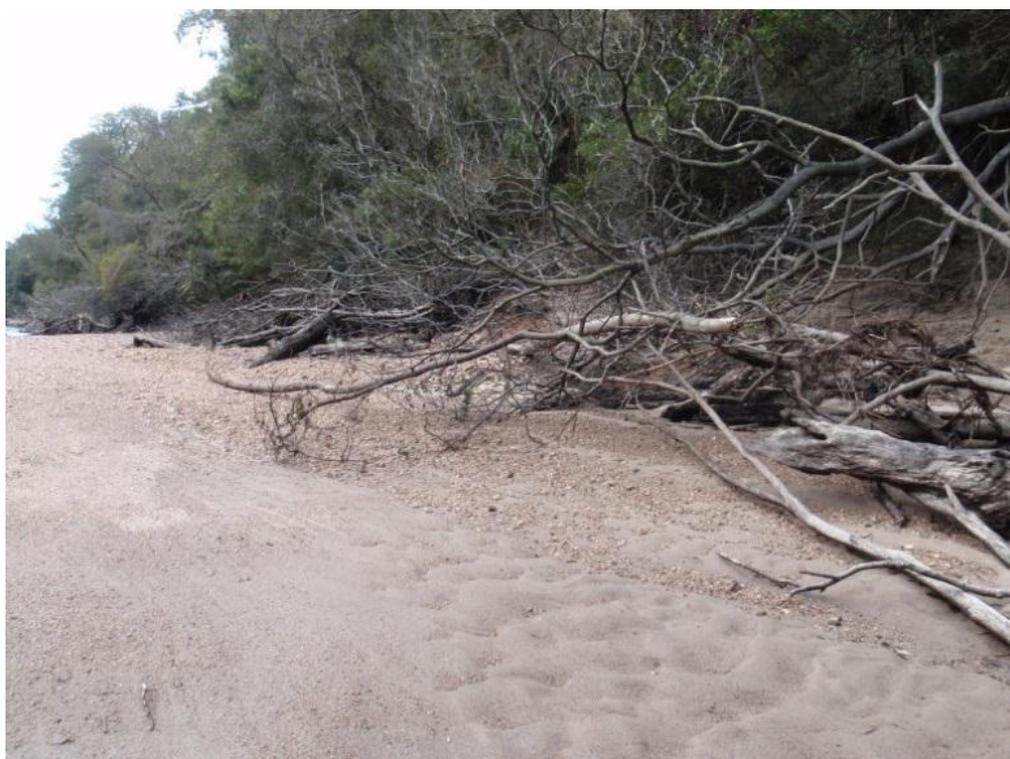
Figure 4.261: Site 4F October 2009 – sandy bank downstream of bedrock.

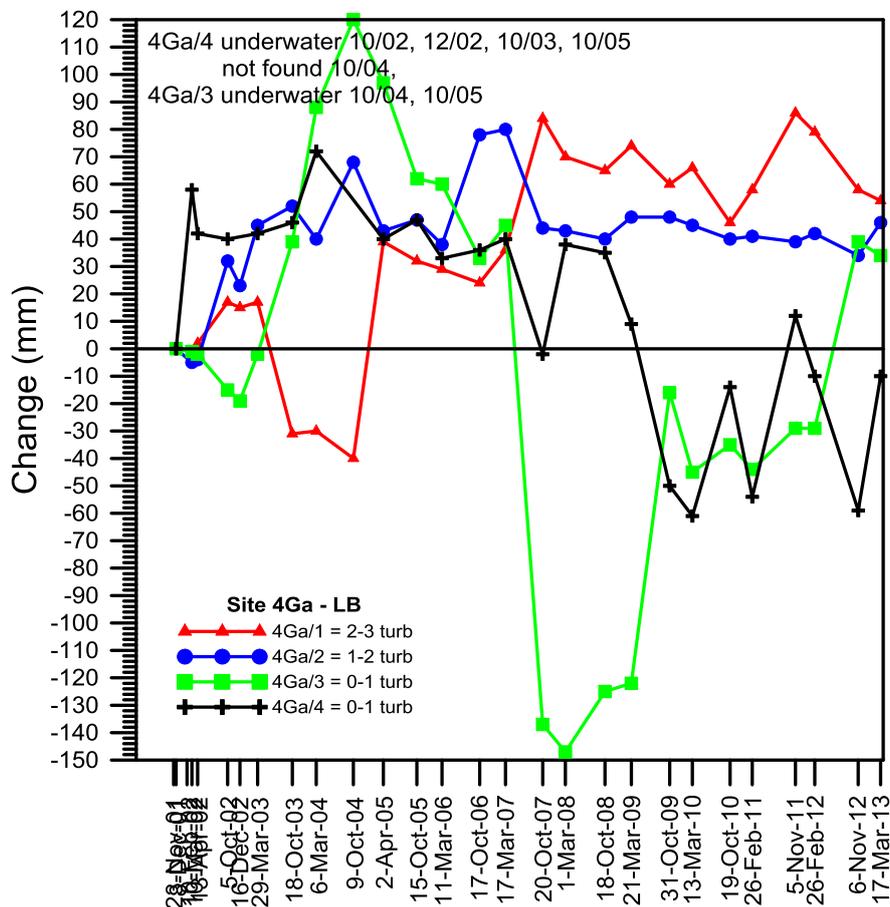
Erosional processes: This bank always appears very dynamic, with sand and woody debris moving around. The local hydraulics of the site are greatly affected by the woody debris on the bank and in the river off of the toe. The large flood event in 2007 resulted in deposition on the toe and in the 1-2 turbine bank level, but scour in the 2-3 turbine level. Similar to other sites it appears that the tea tree stabilised bank is slowly scouring, with the underlying sands being washed down slope, which contributes to the flattening of the bank toe.

Figure 4.264: Erosion pin results from site 4Ga.

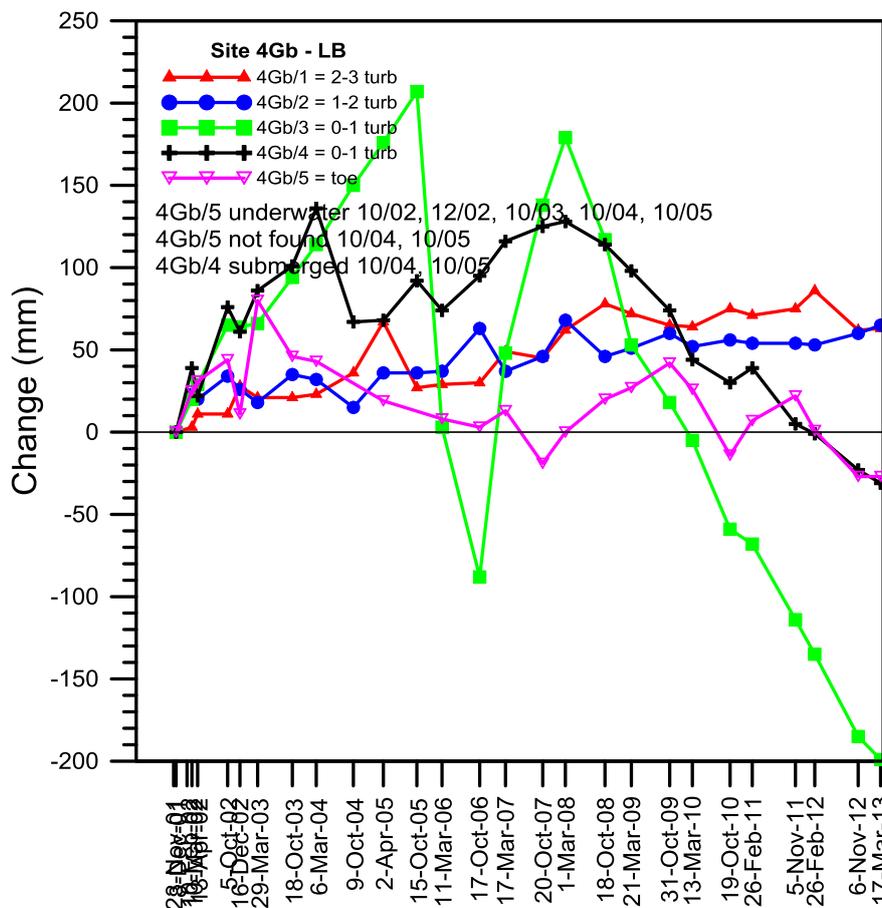
Erosional processes: This site has not been affected by tree falls, and has appeared less dynamic as compared to site 4Ga although it is on the same bank. The tea tree root mat in the 2-3 turbine bank level is slowly scouring, and the erosion pin on the toe of the bank has shown variability. The 0-1 turbine bank level has shown the greatest changes during monitoring, see-sawing between extended periods of erosion and deposition.

Figure 4.273: Erosion pin results from site 4Gb.

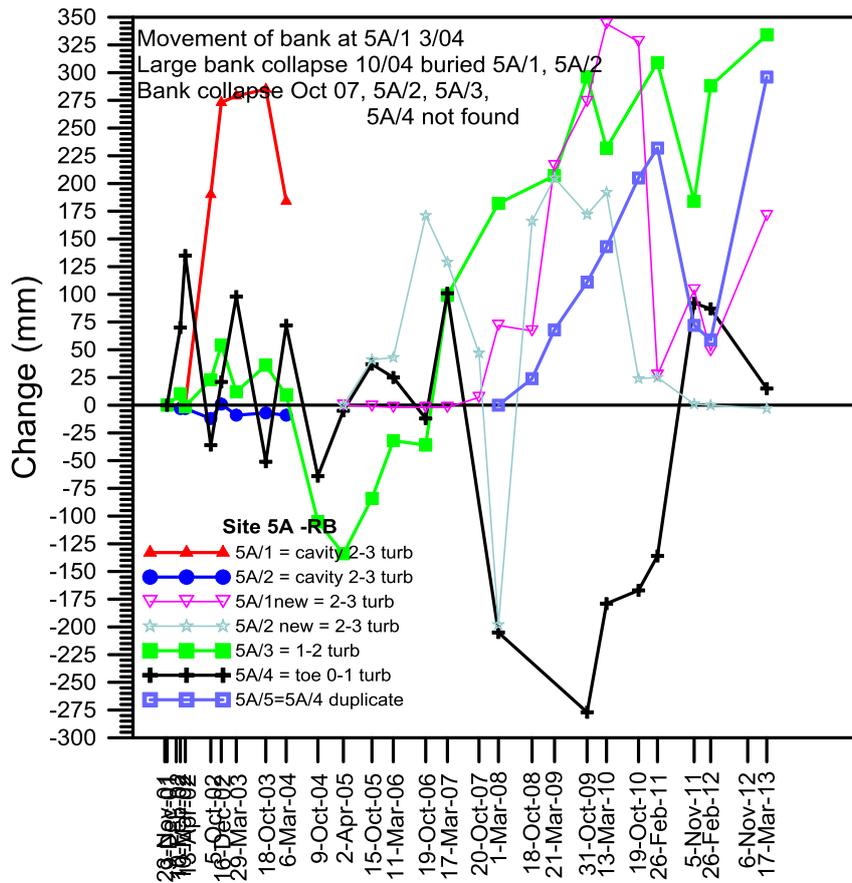
Figure 4.289: Erosion pin results from site 5A.

Erosional processes: During the pre-Basslink period, the erosion pin results from the lower bank tended to show erosion during summer when power station operations dominated the flow regime, and deposition in winter associated with unregulated tributary inflows. Since October 2007, following the high flow event in August 2007, the site was highly altered due to a large rotational slump which occurred on the bank at a distance of about 15 m from the river’s edge, disturbing the bank and overlying vegetation. Since this disturbance the bank toe has recorded deposition, associated with seepage related processes with sands derived from higher on the bank. Discrete sediment flows have not been observed, but rather a more general downslope movement of sands exposed due to the slump and scour of the root-mat, and eroded from the 1-2 turbine bank level. The 1-2 turbine bank level has been eroded through scour, likely associated with the more variable flow levels since the introduction of Basslink.

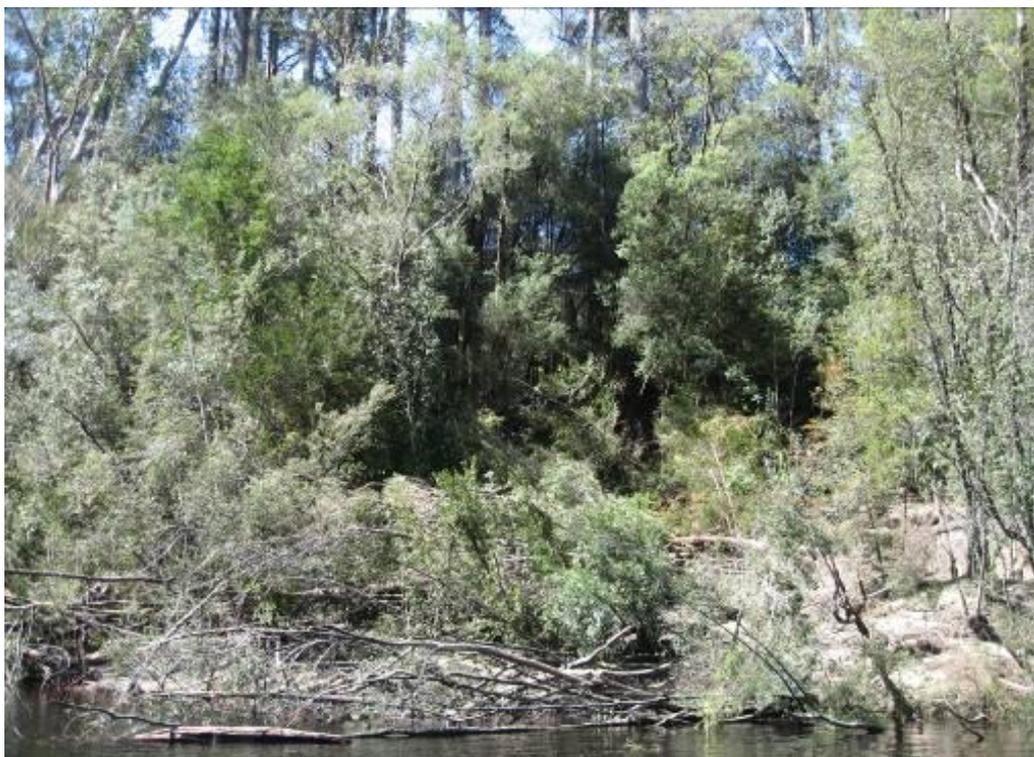
Figure 4.294: Site 5A October 2007 after flood.

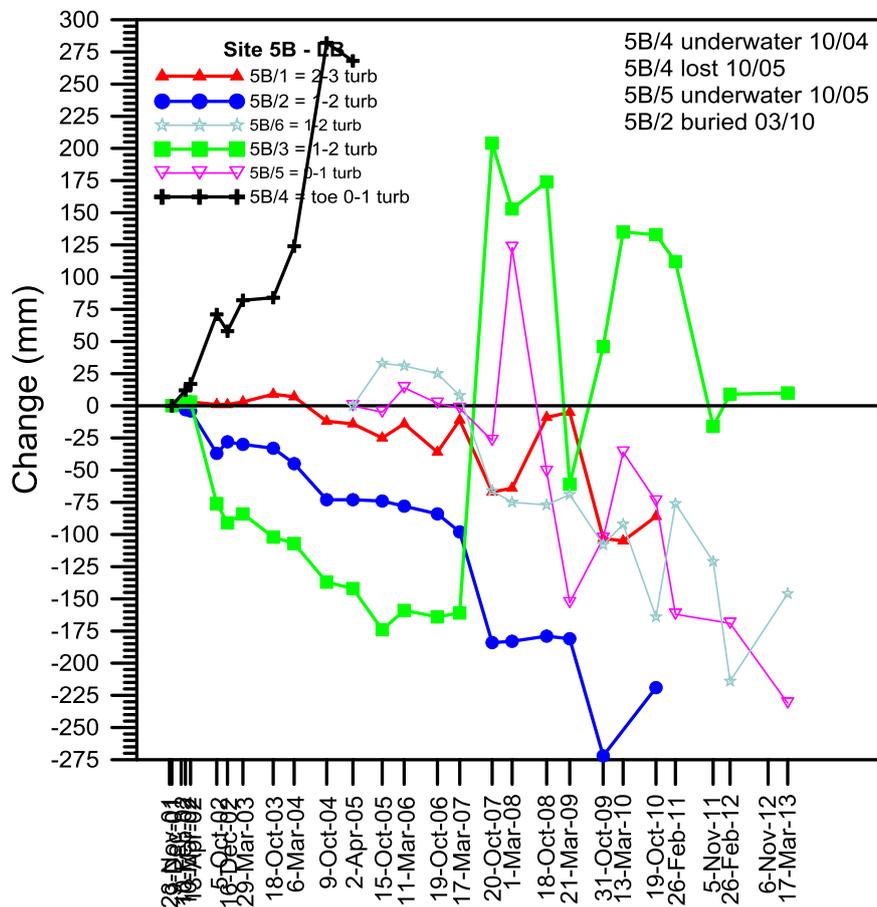
Figure 4.297: Erosion pin results from site 5B.

Erosional processes: The flat-lying bank appears to be ‘maintained’ by grey-silt that is washed out from beneath the root-mat. The bank tends to be more saturated than other banks, probably due to the higher proportion of clays and silts deposited in the back water. The sands on the bank are subject to movement when the woody debris is disturbed. Scour was recorded at the site following the August 2007 high flow event, but overall the trend is for ‘flattening’ of the bank, consistent with a back water environment.
