Basslink Review Report 2006-12
Gordon River Basslink Monitoring Program
The Appendices

May 2013

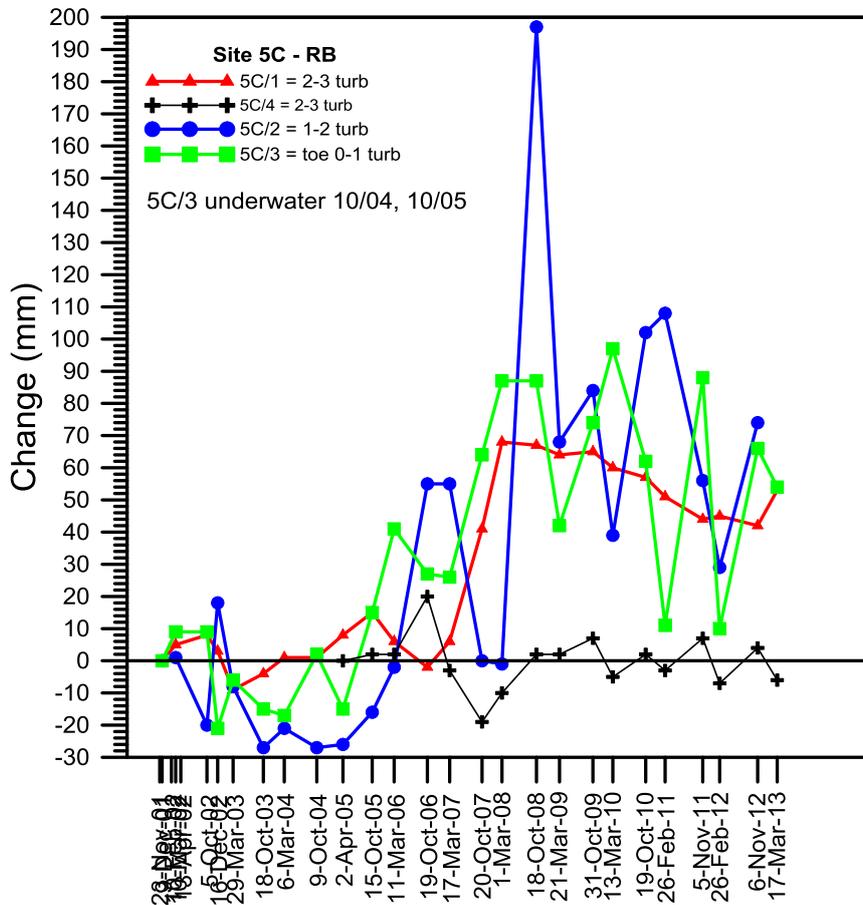
Figure 4.306: Erosion pin results from site 5C.

Erosional processes: Similar to other sites on straight uniform reaches, scour is the dominant erosional process which maintains the steepness of the bank, with the water velocity sufficient to create ripples on the bank. Erosion is generally higher in the summer period, and reduced during the winter when unregulated inflows generally predominate. Deposition on the bank is derived from fluvial deposition combined with the re-working of sands derived from under the degraded root-mat.

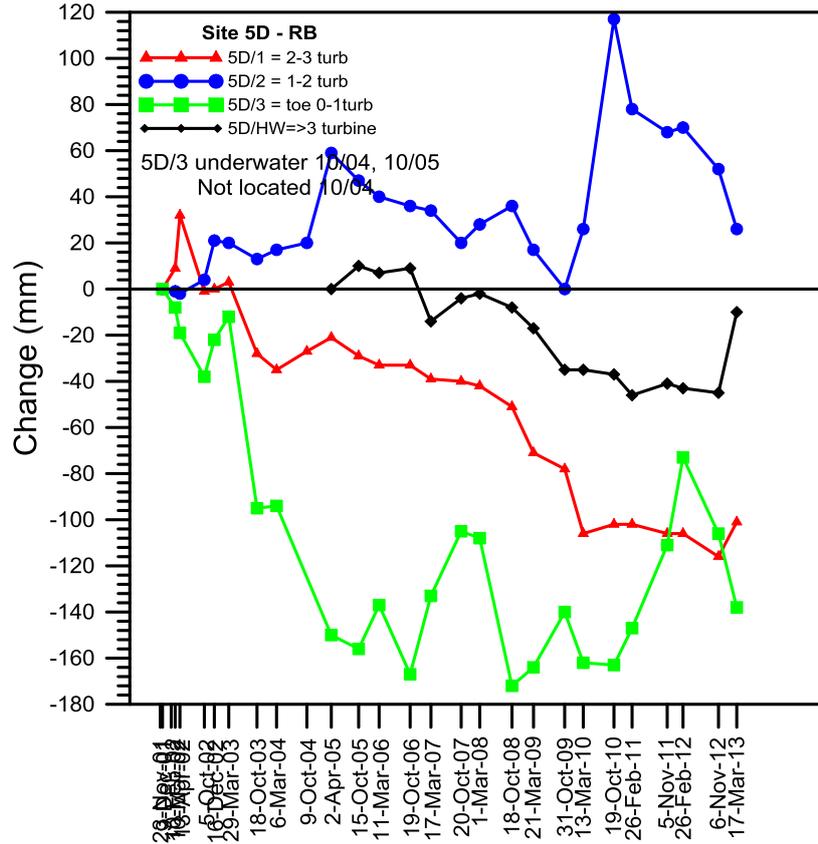
Figure 4.310: Erosion pin results from site 5D.

Erosional processes: The bank has recorded scour in the 1-2 turbine bank level, and deposition in the other bank levels. This suggests that the sand being deposited by the river, and derived from under the root-mat is leading to more deposition than erosion associated with scour along the straight reach.

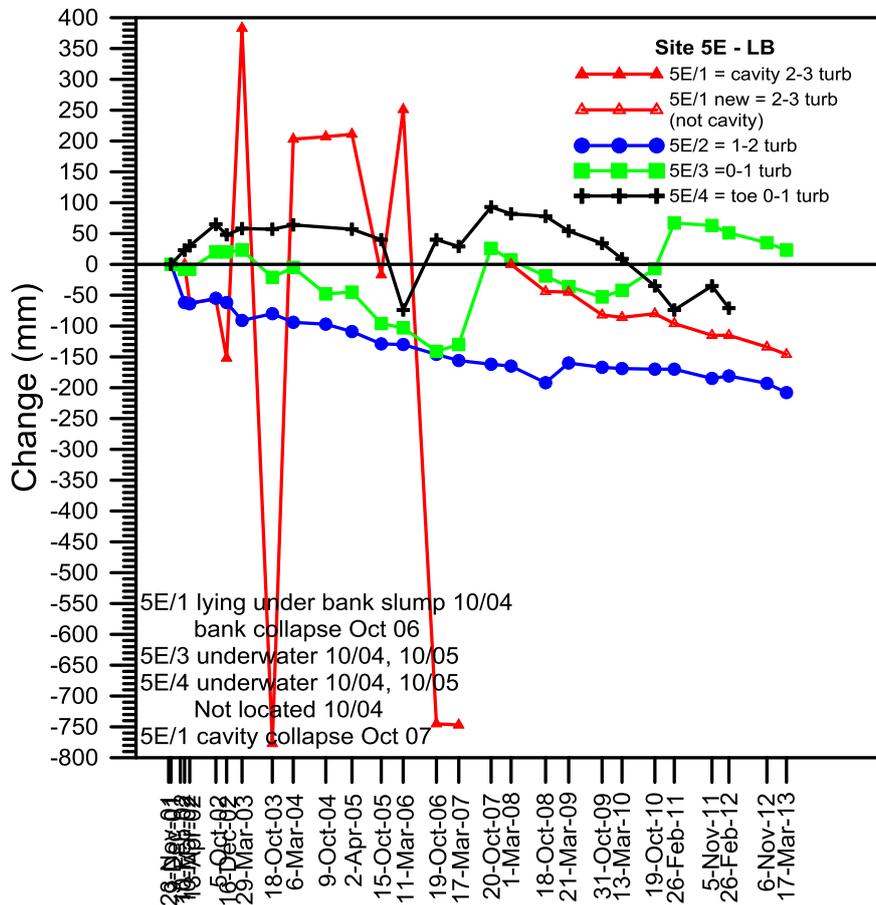
Figure 4.315: Erosion pin results from site 5E.

Erosional processes: The cavity at the back of the bank collapsed following the large flood event in August 2007. The flat laying sands are likely the result of sand delivery from the upper bank original via the cavity and ore recently washing out from under the degraded root-mat, combined with the fluvial deposition of material in a backwater environment. The filamentous algae provide stability for the bank face. The erosion pins suggest the bank is flattening, consistent with the ongoing adjustment to power station operations.

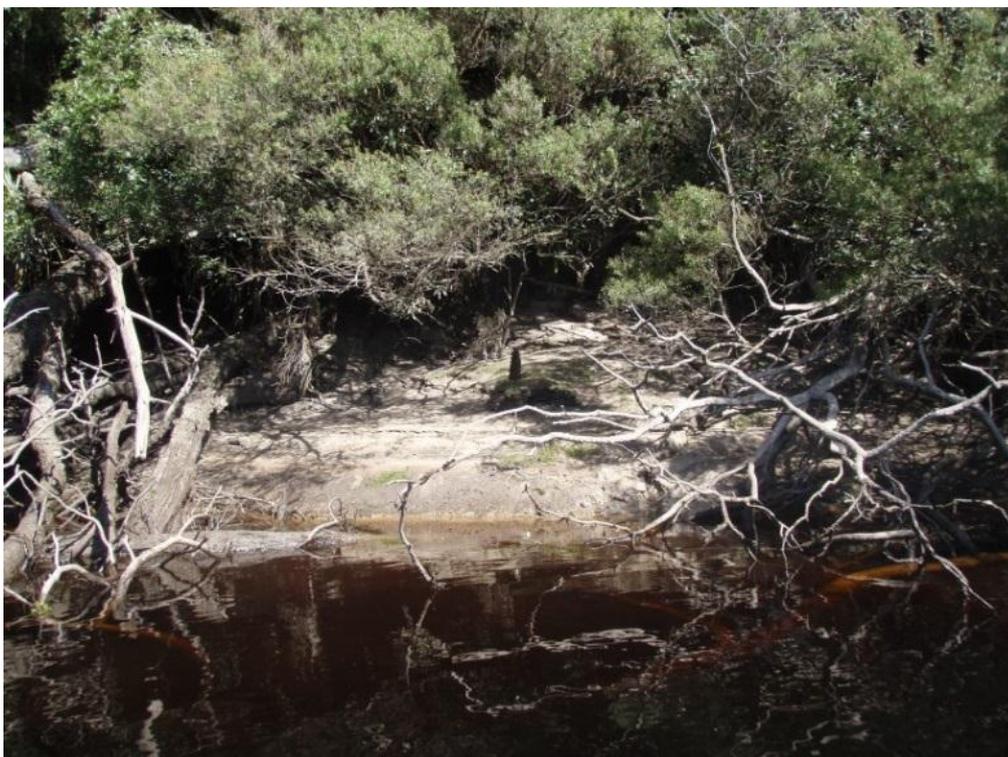
Figure 4.319: Site 5E October 2008. Vegetation decreased erosion on bank.

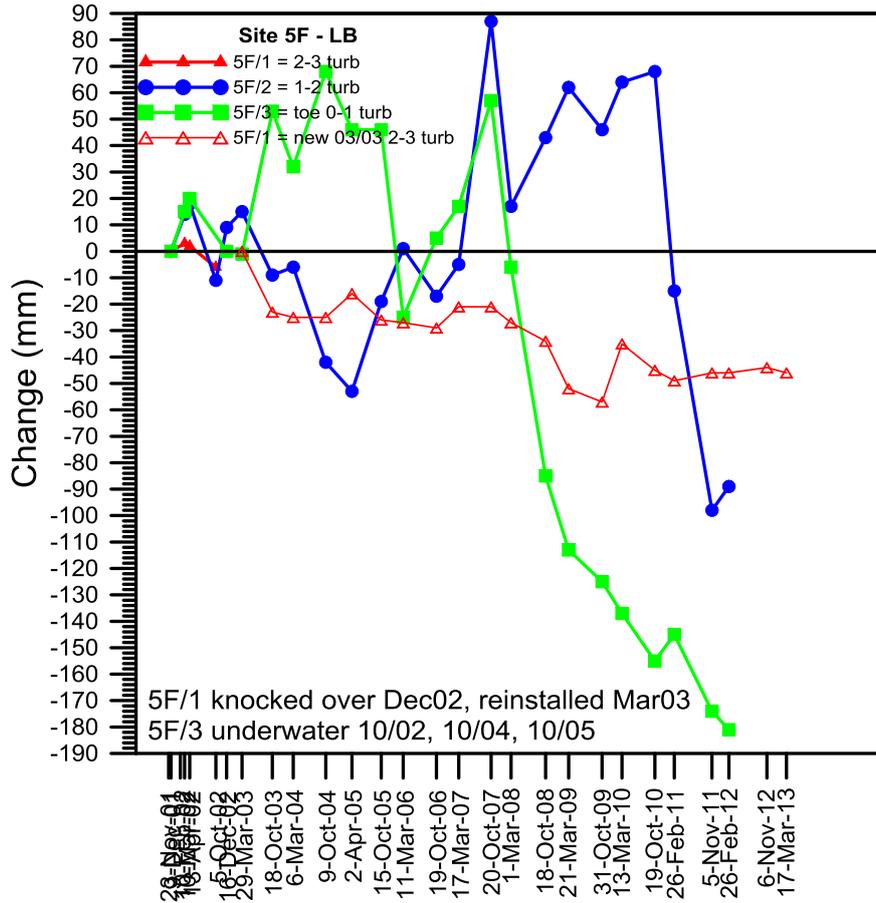
Figure 4.320: Erosion pin results from site 5F.

Erosional processes: This site is showing a similar pattern of flattening, with erosion in the 1-2 turbine level and deposition on the lower bank. The large flood event eroded the 0-1 turbine level, but since that time deposition has been recorded by the toe.

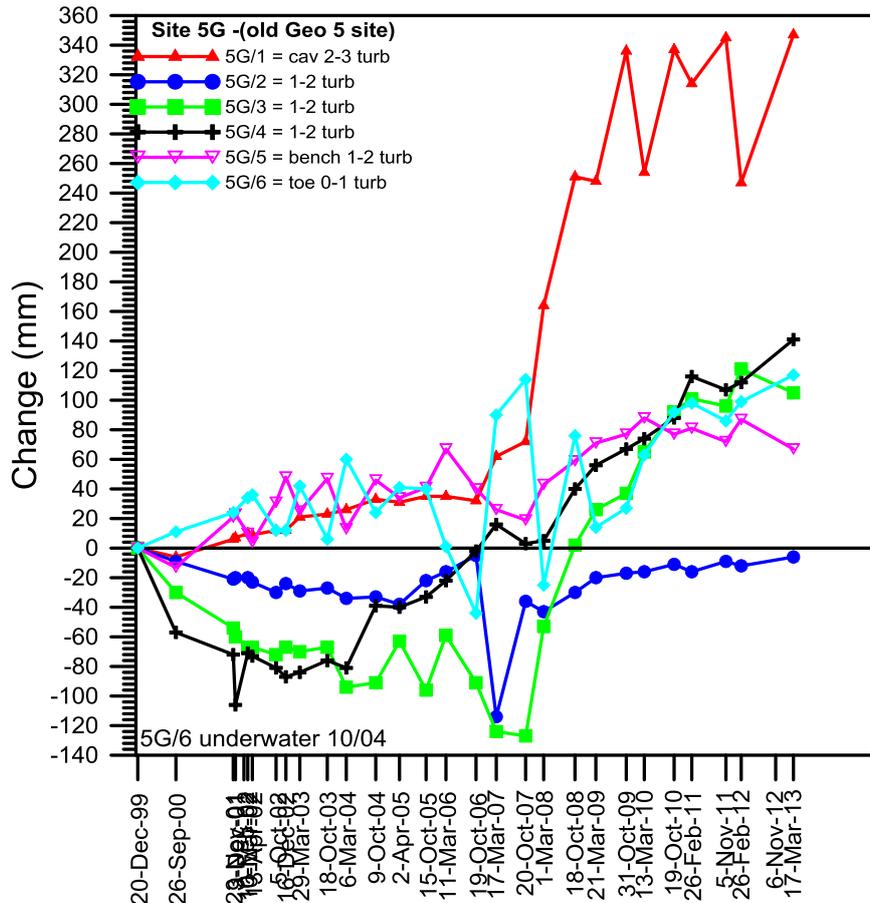
Figure 4.324: Erosion pin results from site 5G.

Erosional processes: Scour appears to be the dominant process affecting the bank, with stability provided by the Huon pine, cobble bar. The cavity at the back of the site is not active, and the vertical bank at the back of the cavity is eroding. The erosion pin results and bank profile suggests the low-angle toe extending back through scour of the steep bank face in the 2-3 turbine bank level.

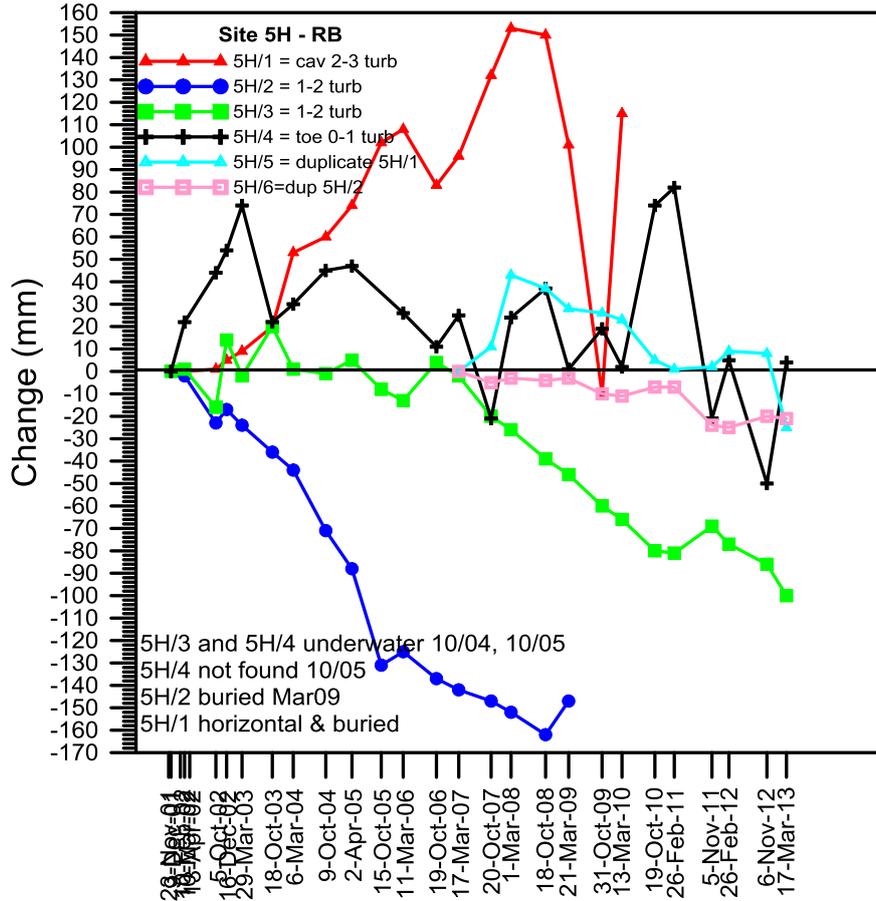
Figure 4.330: Erosion pin results from site 5H.

Erosional processes: Toe has shown episodic steepening through scour, although little net change over the monitoring period. The 1-2 turbine level is aggrading as the bank flattens through fluvial deposition and the movement of locally derived material from the upper bank. Tension cracks have been repeatedly observed on the upper bank following extended periods of low power station usage, indicating slumping of the saturated sands.

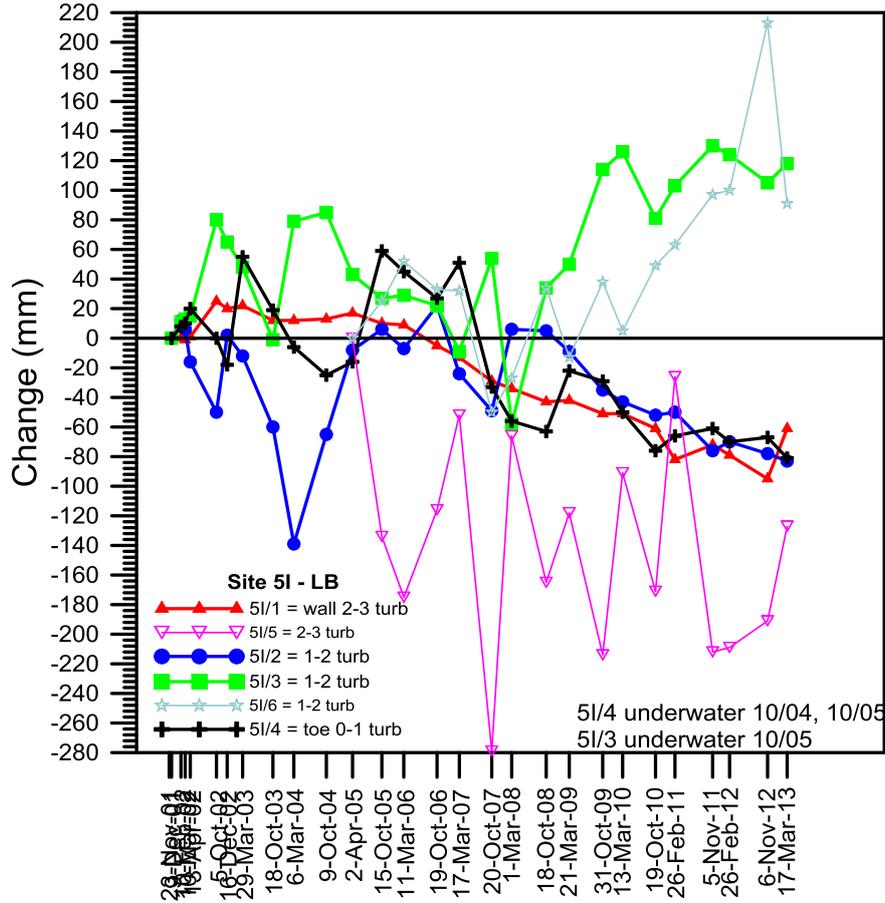
Figure 4.335: Erosion pin results from site 5I.

Erosional processes: The woody debris and sands on the lower bank are frequently moved by the river's current resulting in variability of the bank toe. The erosion pin results show the toe is more frequently recording deposition, which is likely associated with the scour of the 1-2 turbine bank level, and fluvial deposition under backwater conditions. The sands on the toe of this bank have been observed to shift as woody debris moves. The ongoing scour of the root-mat continues to expose sands which are likely contributing to the deposition in the 2-3 turbine bank level.

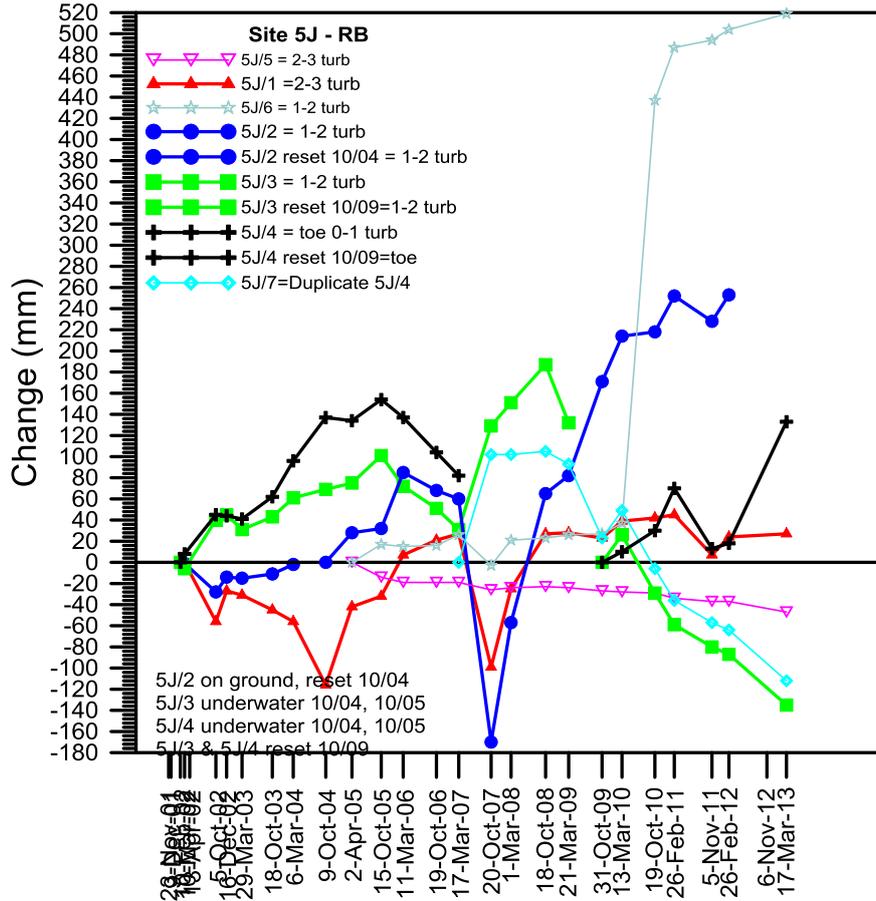
Figure 4.340: Erosion pin results from site 5J.

Erosional processes: Prior to the large flood event in August 2007, the erosion pins at the site generally recorded erosion. The event resulted in deposition on the bank associated with slumping. An unidentified event between October 2009 and March 2010 resulted in the scour of sands from behind the large log, and the loss of erosion pins which were found lying on the ground. The 1-2 turbine bank level continues to change, recording both deposition and erosion within the same turbine level. It is likely that these changes are associated with the local dynamics of the log, combined with the continued regression of the root-mat and underlying sands.

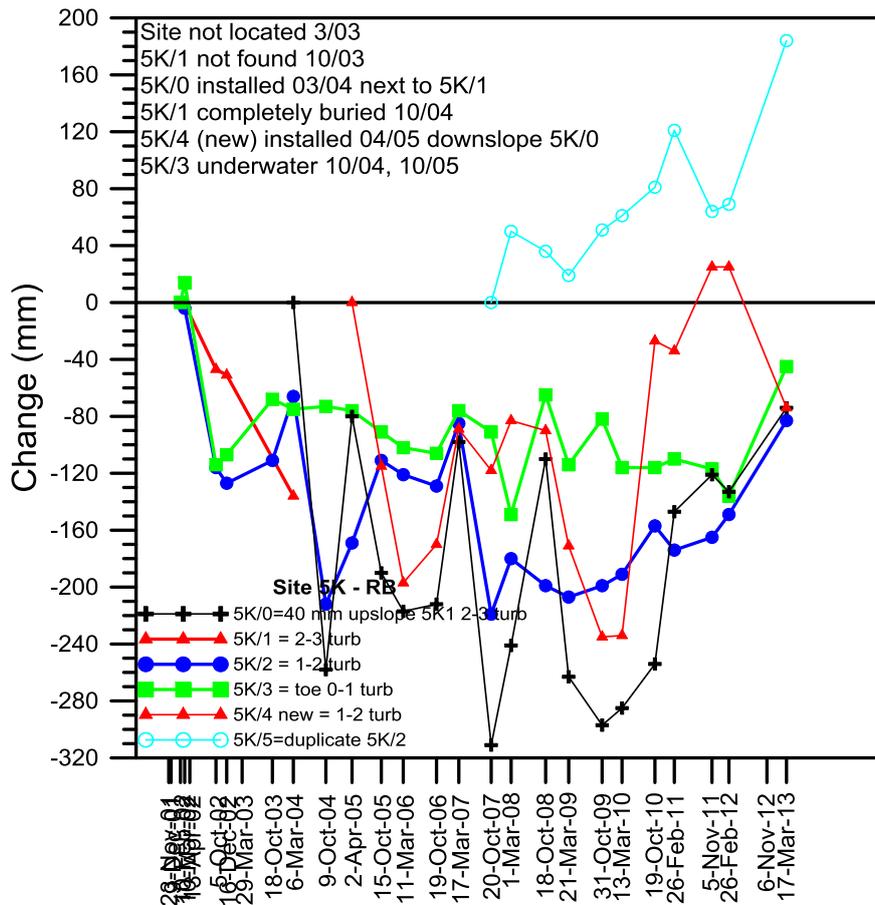
Figure 4.346: Erosion pin results from site 5K.

Erosional processes: this site shows a lot of variability with shifting and transient woody debris affecting the site. The site has recorded overall deposition, but in the last few years, when the power station discharge has been low, the pins have generally recorded erosion. This would be consistent with scour affecting the site at low to moderate flows, and deposition at high flows when it is a backwater.

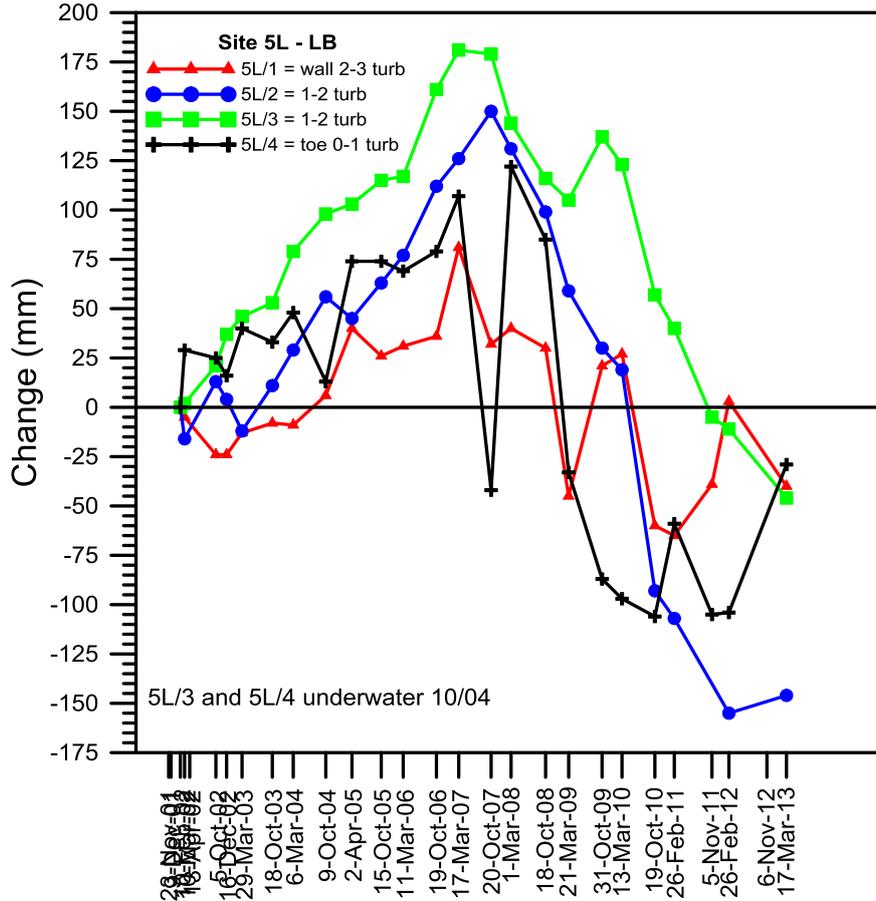
Figure 4.350: Erosion pin results from site 5L.

Erosional processes: The site recorded erosion between the time of establishment and October 2007, consistent with other sites on straight reaches. Following October 2007, the site has recorded deposition which exceeds the original erosion. It is hypothesised that the flood weakened / removed the remnant root-mat and tea tree in the 2-3 turbine bank level which has promoted the movement of sands from the upper bank to the lower bank.

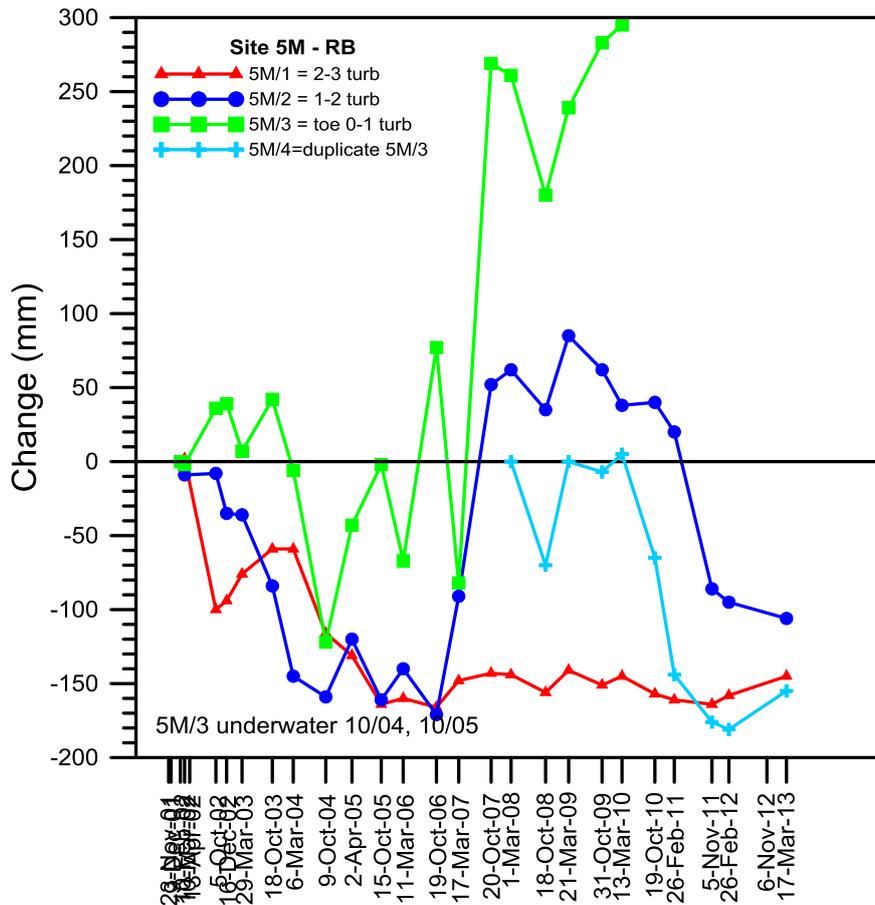
Figure 4.356: Erosion pin results from site 5M.

Erosional processes: The site has generally recorded variable levels of deposition except for October 2007 when a large erosive change was documented. The variable deposition is consistent with the backwater setting of the site.
