# Mersey-Forth Water Management Review

TECHNICAL AND SOCIAL STUDY

## Acid Drainage Investigation Downstream of Wilmot Dam and in the Cethana Power Station

Technical Advice on Water

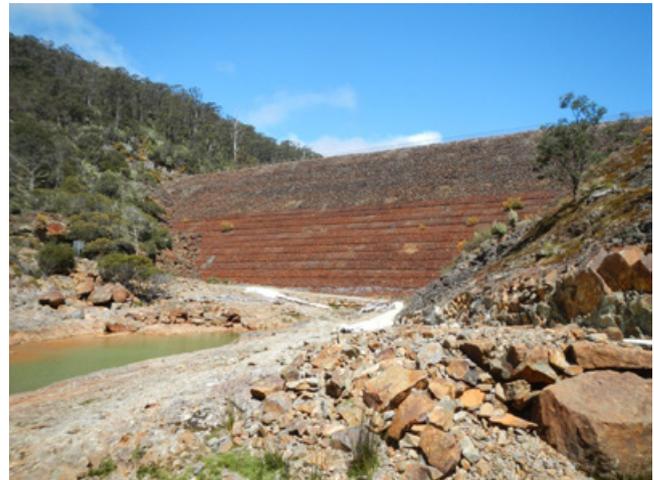
Lake Gairdner was created through damming of the Wilmot River by the Wilmot Dam (Photograph 2.1). The dam is located at the northern end of the impoundment and is a concrete faced, rock fill dam and spillway which was constructed during the late 1960s and commissioned in 1971. The fill material for the dam was locally sourced Moina Sandstone, the excavation of which resulted in the creation of a borrow pit shown in Map 2.1 and in Map 2.2 where the location is superimposed on a geologic map of the region.

Photograph 2.1: Wilmot Dam viewed from downstream in Wilmot River
