Erratum

Paragraph 1 on Page ii in the Executive Summary should be replaced with the following:

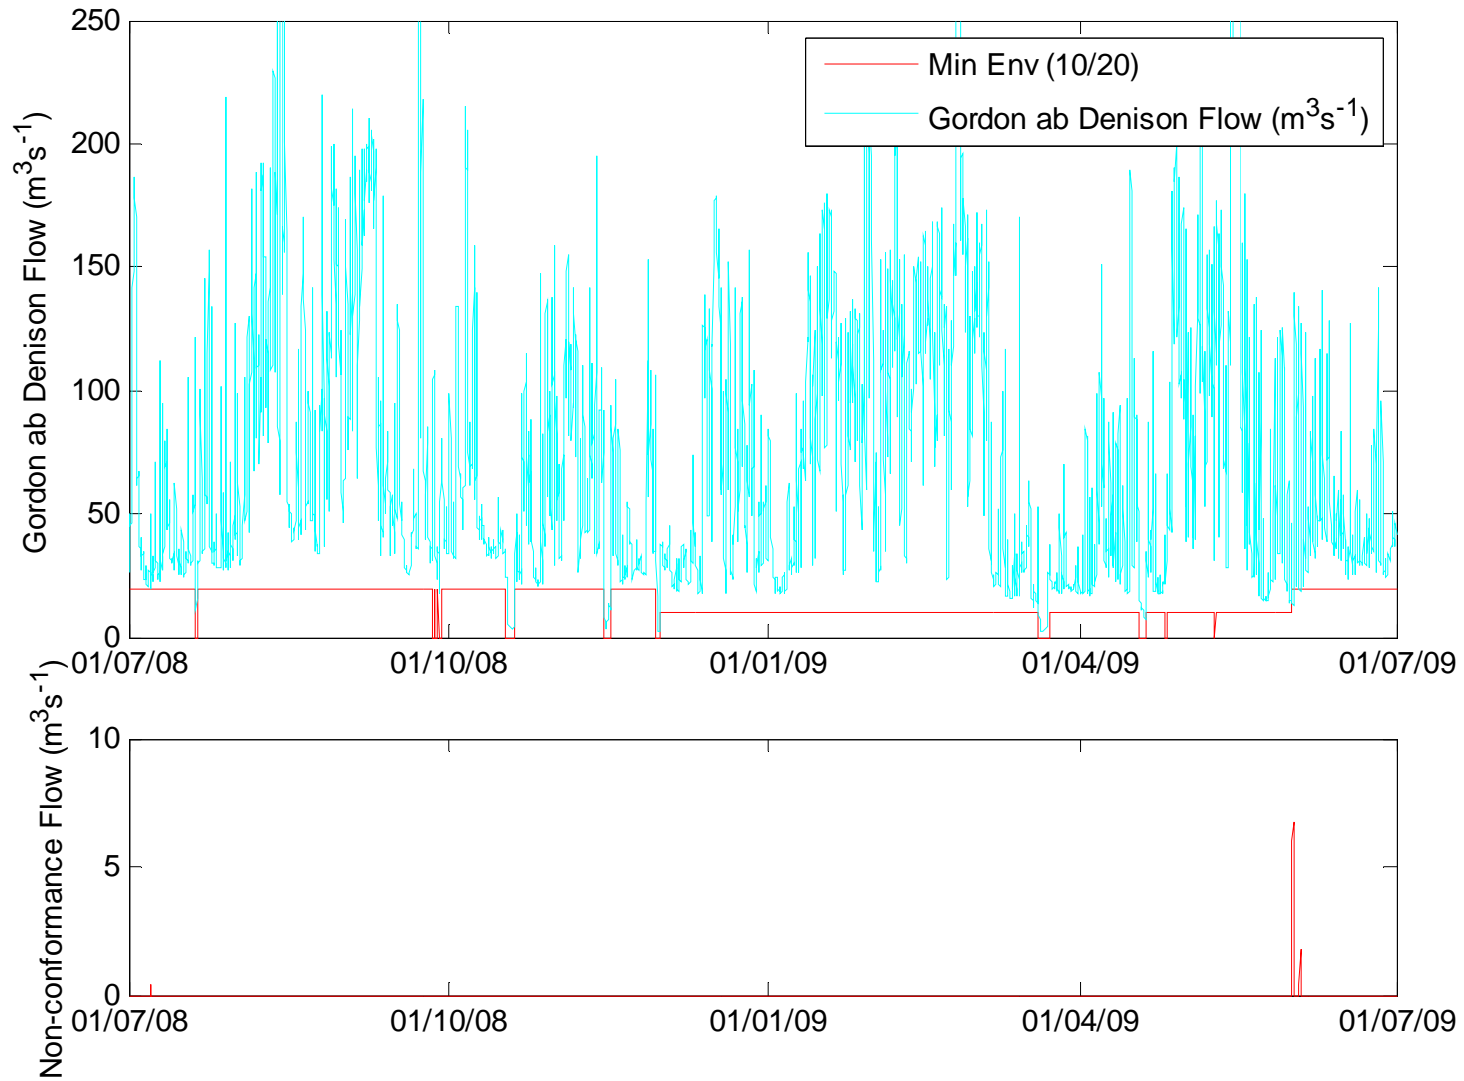
Figure 2-12. Flow recorded (hourly data) at site 65 (Gordon above Denison), from July 2008 to June 2009, and analysis of non-conforming flows

An analysis of hourly flows at site 65 (Figure 2-12 shows that for the winter period (July–November 2008 and June 2009), the minimum flow requirement of $20 \text{ m}^3\text{s}^{-1}$ was satisfied for 99.66 % of the time. The minimum summer (December 2008–May 2009) flow requirement of $10 \text{ m}^3\text{s}^{-1}$ was satisfied for 100 % of the time. Compliance with the environmental flow on an annual basis was 99.83 %. Note that times of shutdown of Gordon Power Station due to maintenance, NEMMCO conformance testing, and/or monitoring have been excluded from the analysis, as per the licence conditions.

Section 2.5.4.1 Flow, Figure 2-12 on Page 25 should be replaced with the following:
