Hydro Tasmania

Safety Alert

Clarence Pipeline PAHs Exposure

Alert Number (YYMMDD)	250626	Date Issued	26 June 2025
SAP Incident Number	65302	Approved By	Head of WHS
Alert Category	Safety	Action Required?	Yes

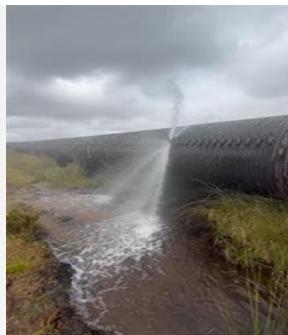
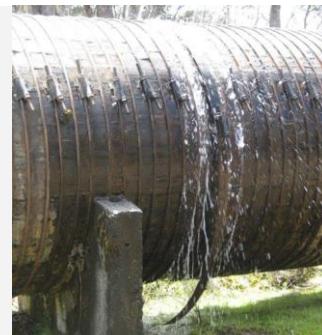
Alert/incident photos

During leak repairs on the Clarence pipeline, several workers developed red, irritated skin, initially thought to be sunburn. However, overcast conditions raised concerns of the potential for chemical exposure from historic use of chemicals on the pipeline. Redness and skin irritation cleared in a couple of days with no further issues.

IPM testing confirmed elevated PAHs, particularly Benzo(a)pyrene, in pipeline timber and lining, with residual creosote still present despite being phased out 25–30 years ago. Nine pipelines statewide are creosote-coated, and about half of the conveyance infrastructure uses similar lining. Soil sampling was also conducted for Benzo[a]pyrene. Low risk results were confirmed, below the health investigation levels (HIL) and below ecological investigation levels (EIL) for commercial and industrial land. IPM report also noted that elevated levels of Benzo[a]pyrene in relatively immobile sources, such as bitumen fragments, do not represent a significant health risk

- Work instructions updated to include chemical hazard controls, PPE, and sanitation procedures.
- PPE: waterproof coveralls, double gloves, taped gumboots, face shield, and barrier creams.
- Additional site supplies: fresh water, wipes, plastic bags, and sanitiser.
- Tools must be cleaned post-use; disposable PPE to be safely removed and sealed for disposal.
- Hazard register to be updated to reflect PAH presence.
- PPE and hygiene requirements to be communicated to contractors working on affected pipelines
