Mersey-Forth Water Management Review

FACT SHEET

Mersey-Forth Acid Drainage Investigation Study

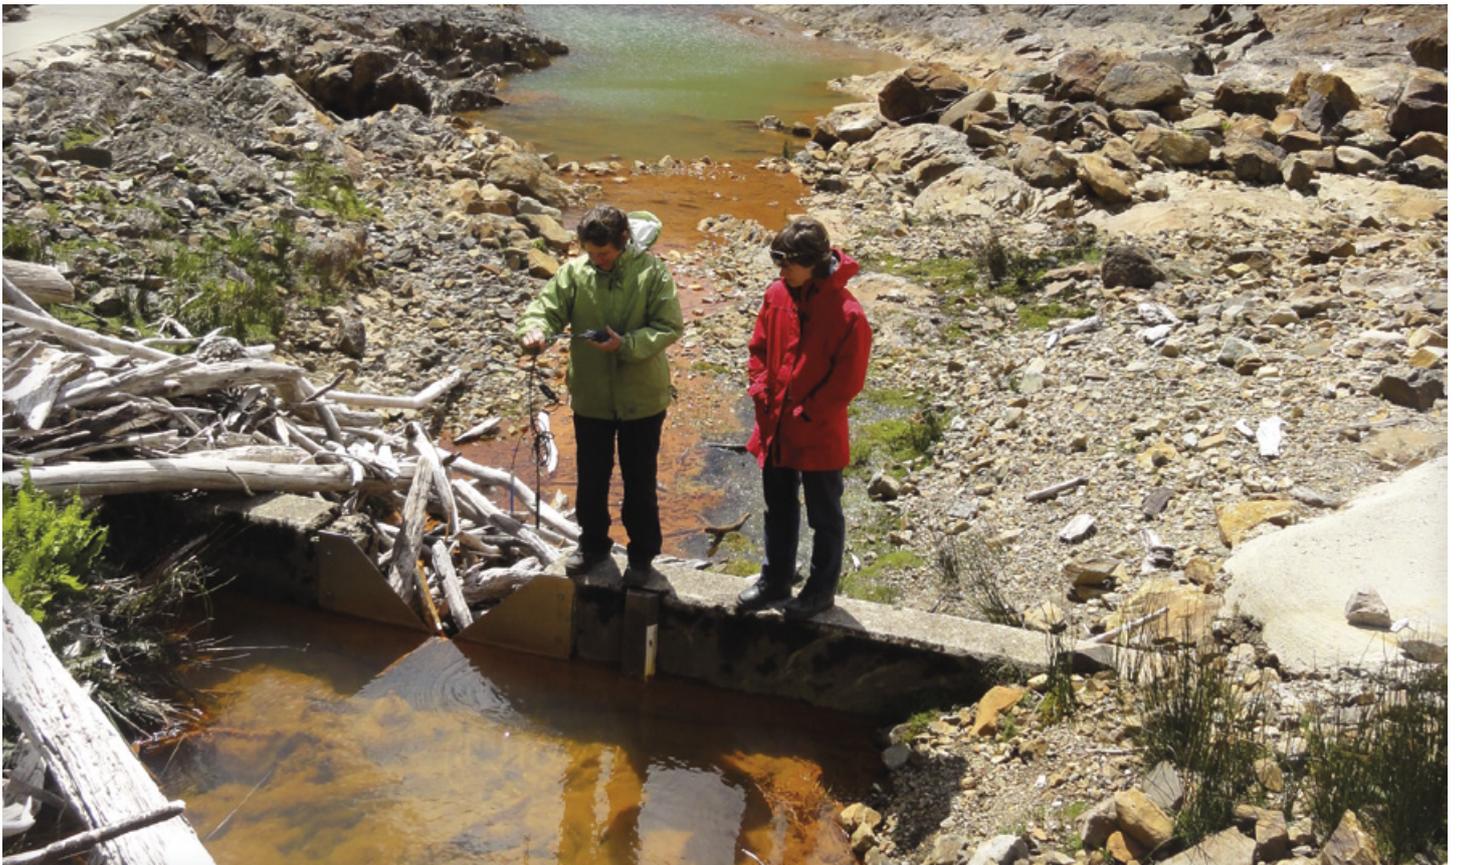
Field investigations to assess the acid drainage potential at the toe of Wilmot Dam.

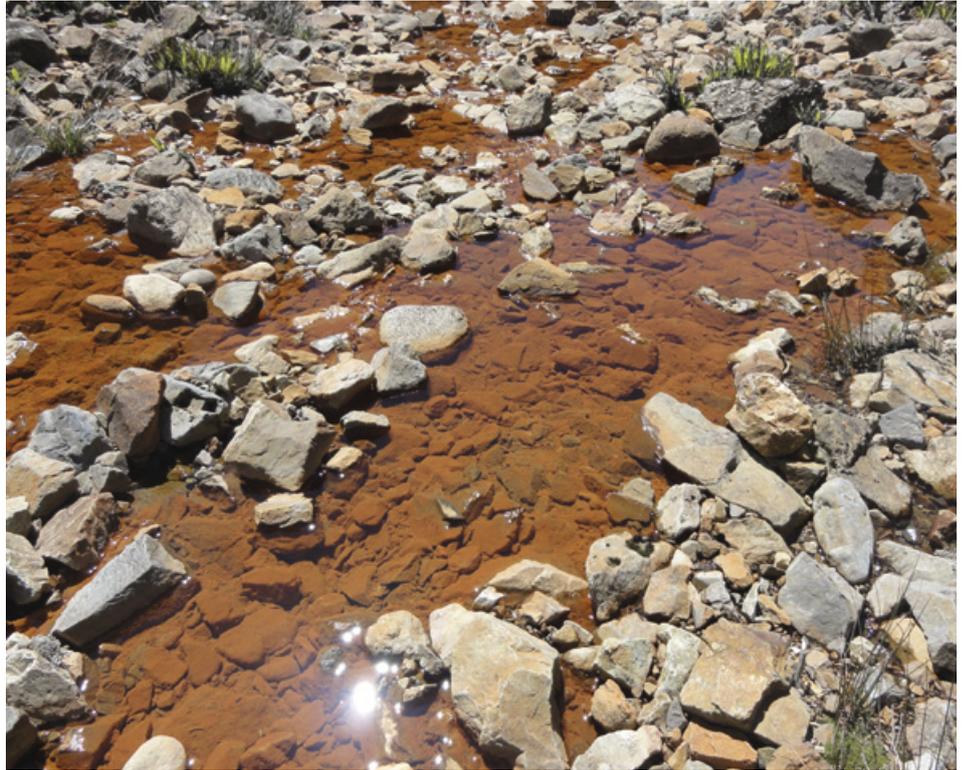
Iron oxidation at the toe of Wilmot Dam.

- Wilmot Dam was constructed using local material which contains acid forming sulphide materials. This is the most likely source of the acid drainage as there is no evidence of acidification within Lake Gairdner. It is considered likely that the flushing of acid drainage from the dam wall increases as the level of Lake Gairdner increases. The acid drainage at the toe of the dam is not considered to pose a significant environmental threat as impacts are localised to a small pond at the toe of the dam and the volumes are low and rapidly diluted in the Wilmot River;
